FACILITY ASSESSMENT REPORT

APPENDIX D

Appendix D Service Garage

Knoxville Civic Auditorium and Coliseum Assessment

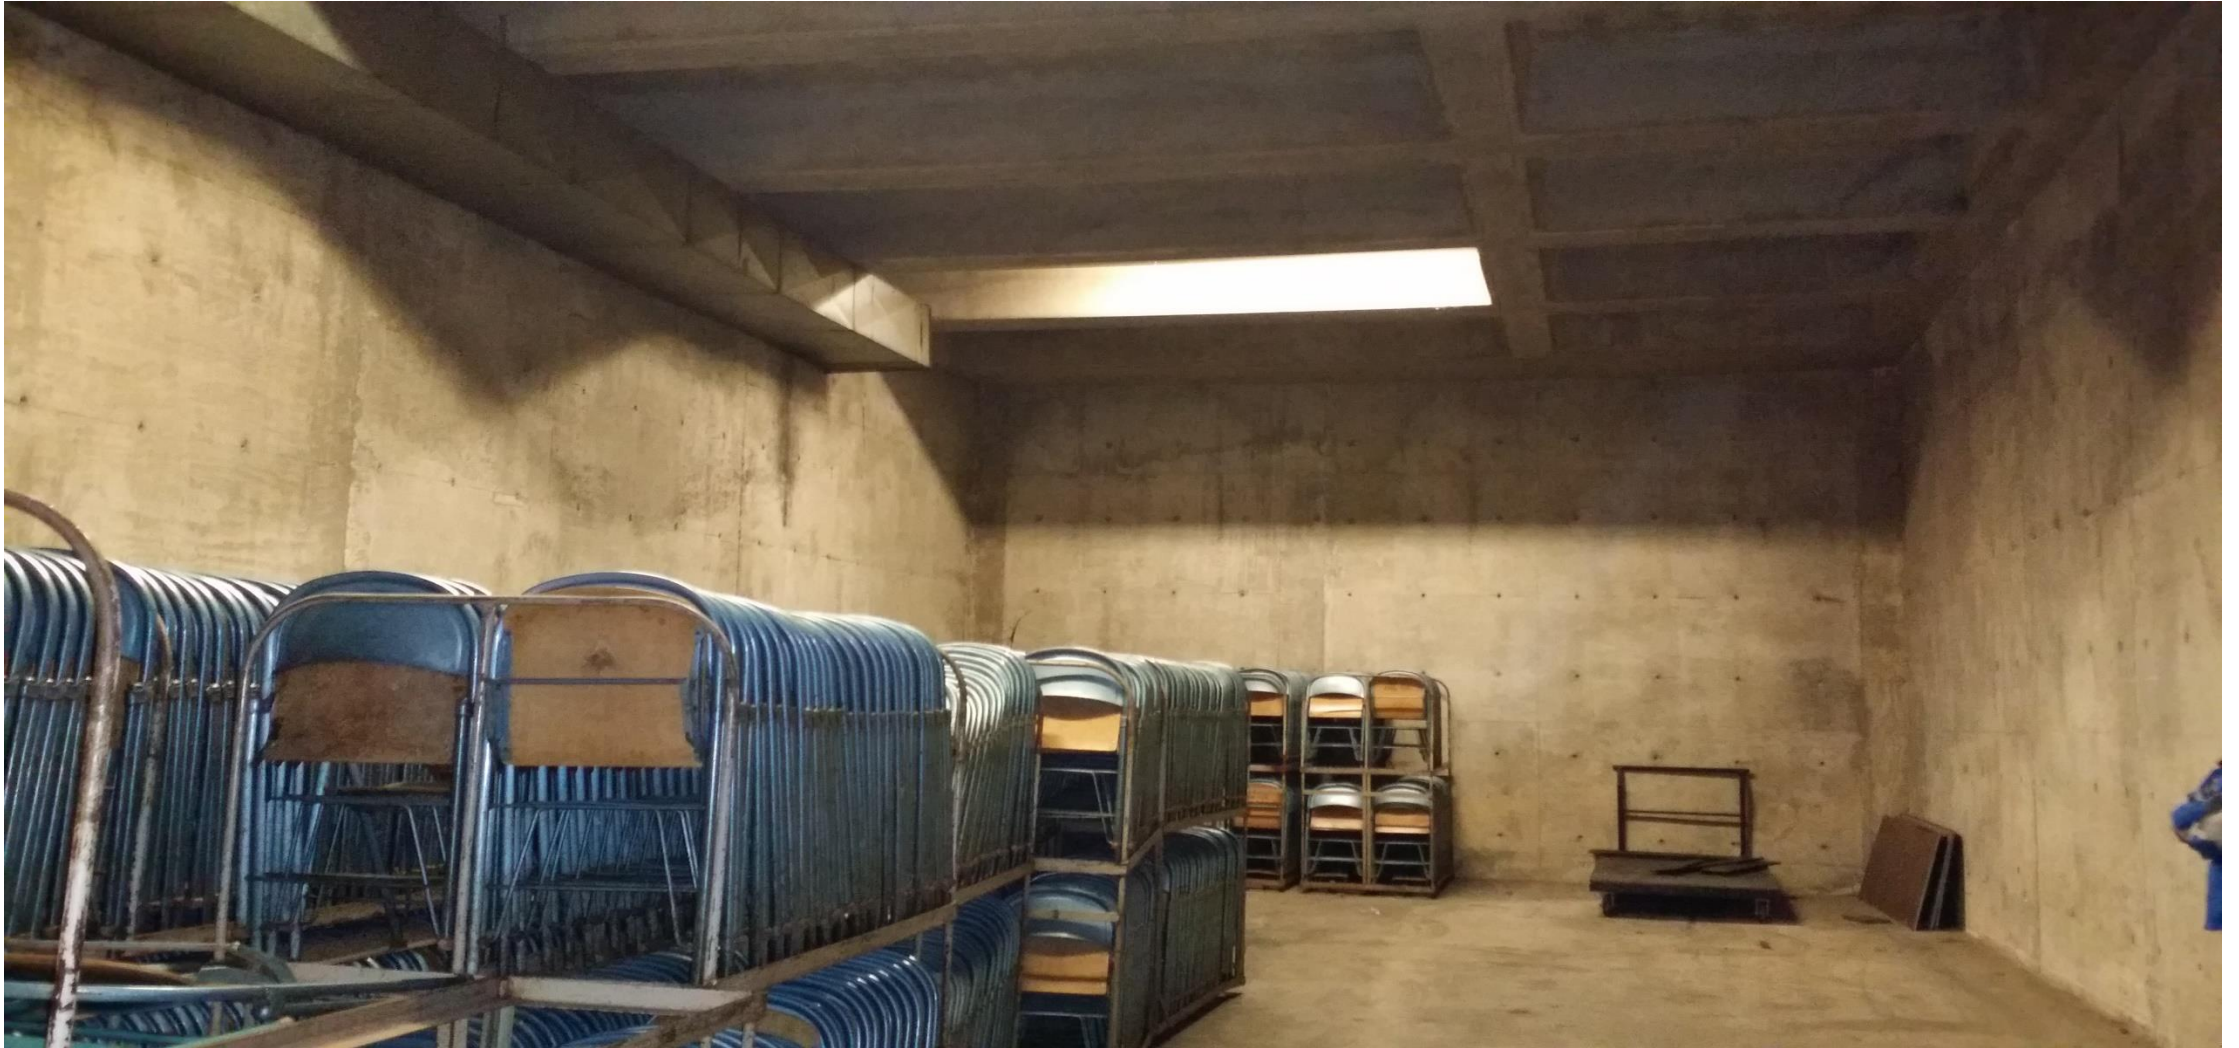
Service Garage

Truck turn area used for storage

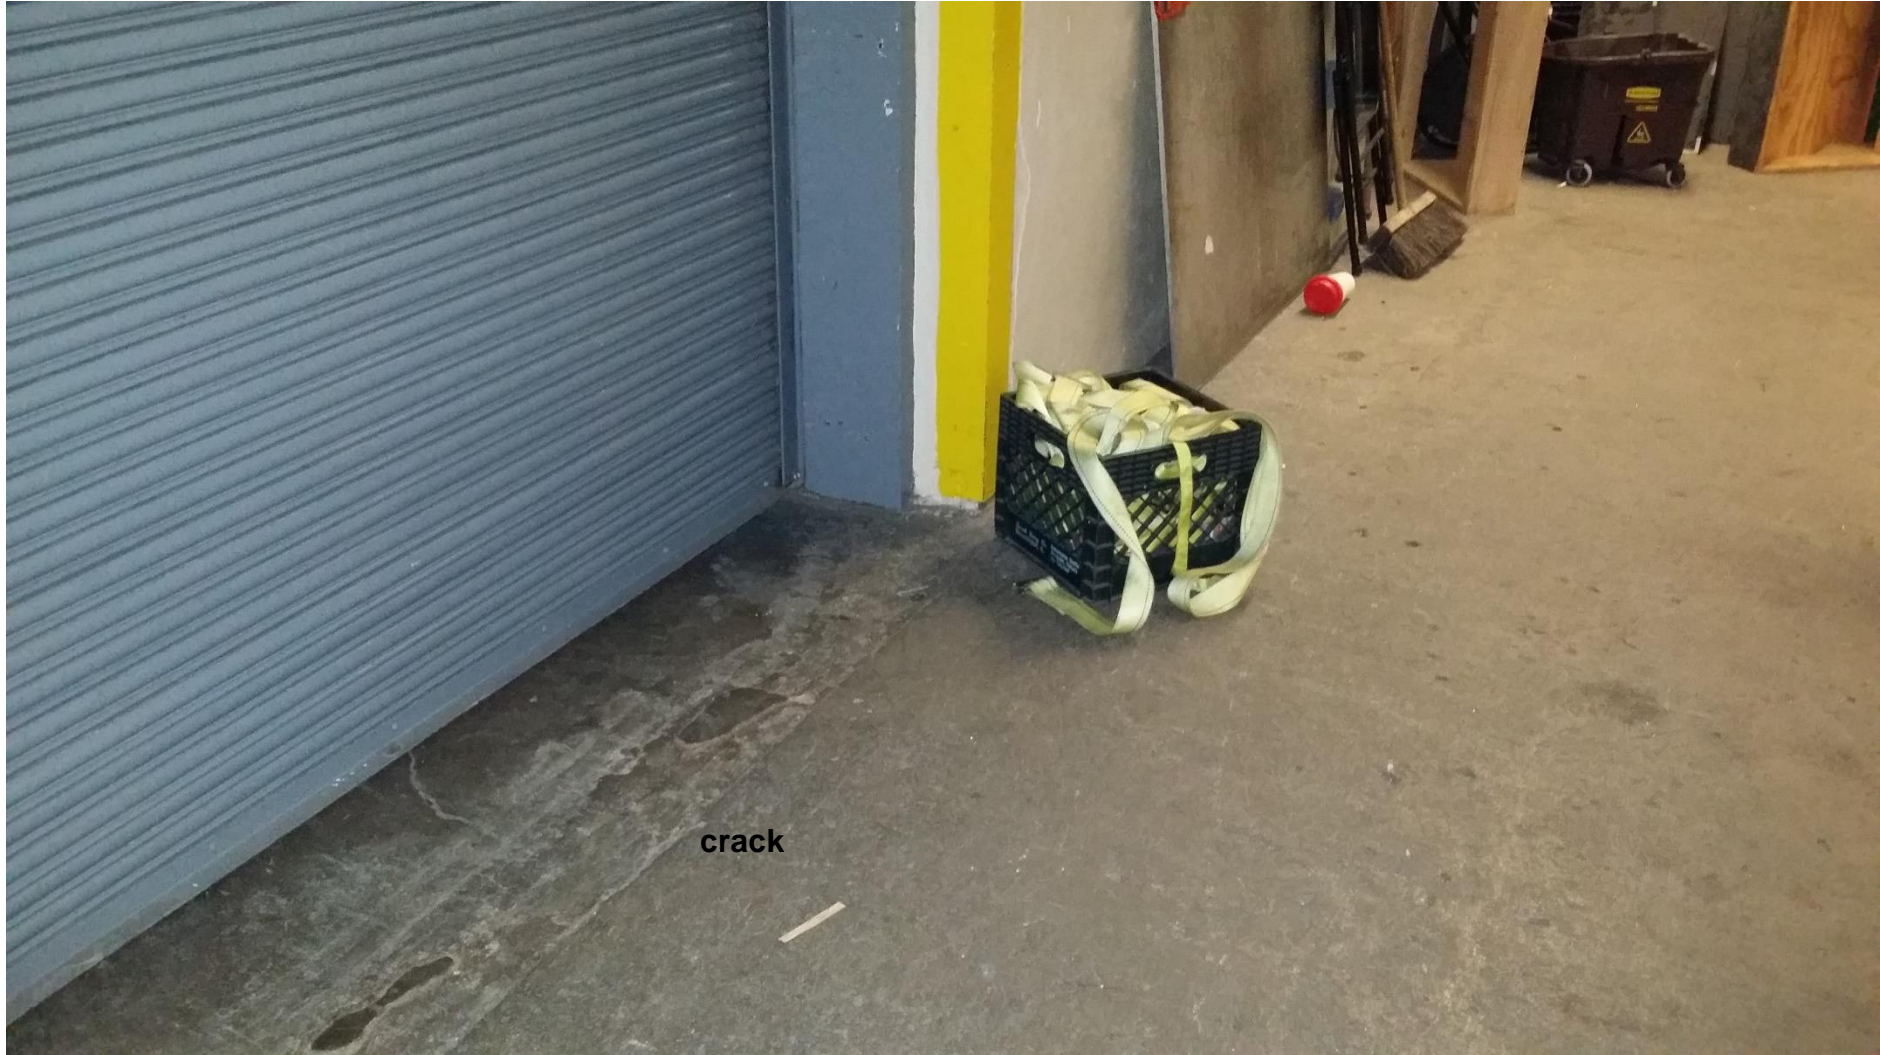
Auditorium Loading Dock

crack

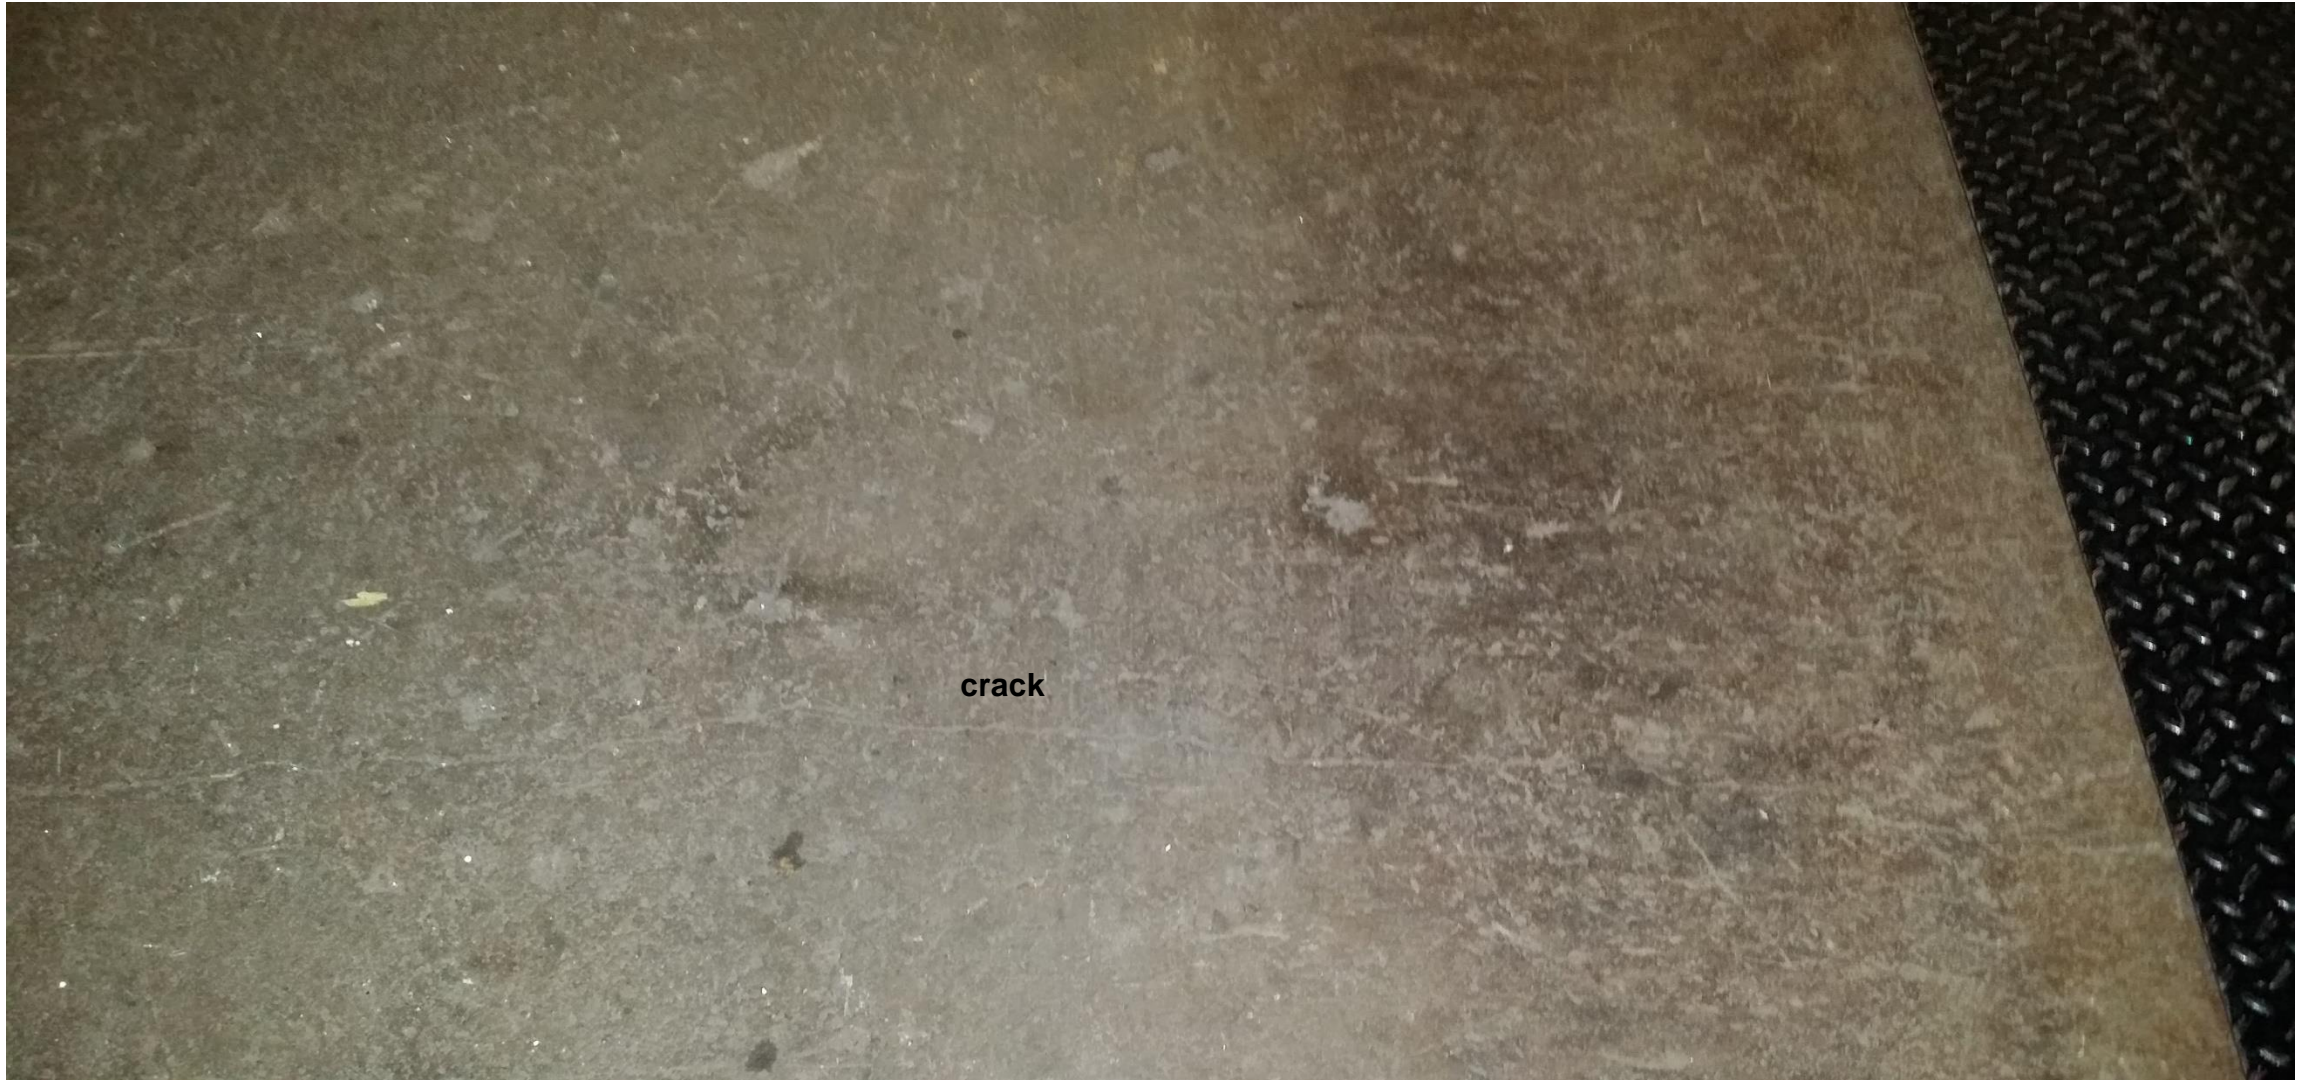
Auditorium Loading Dock

crack

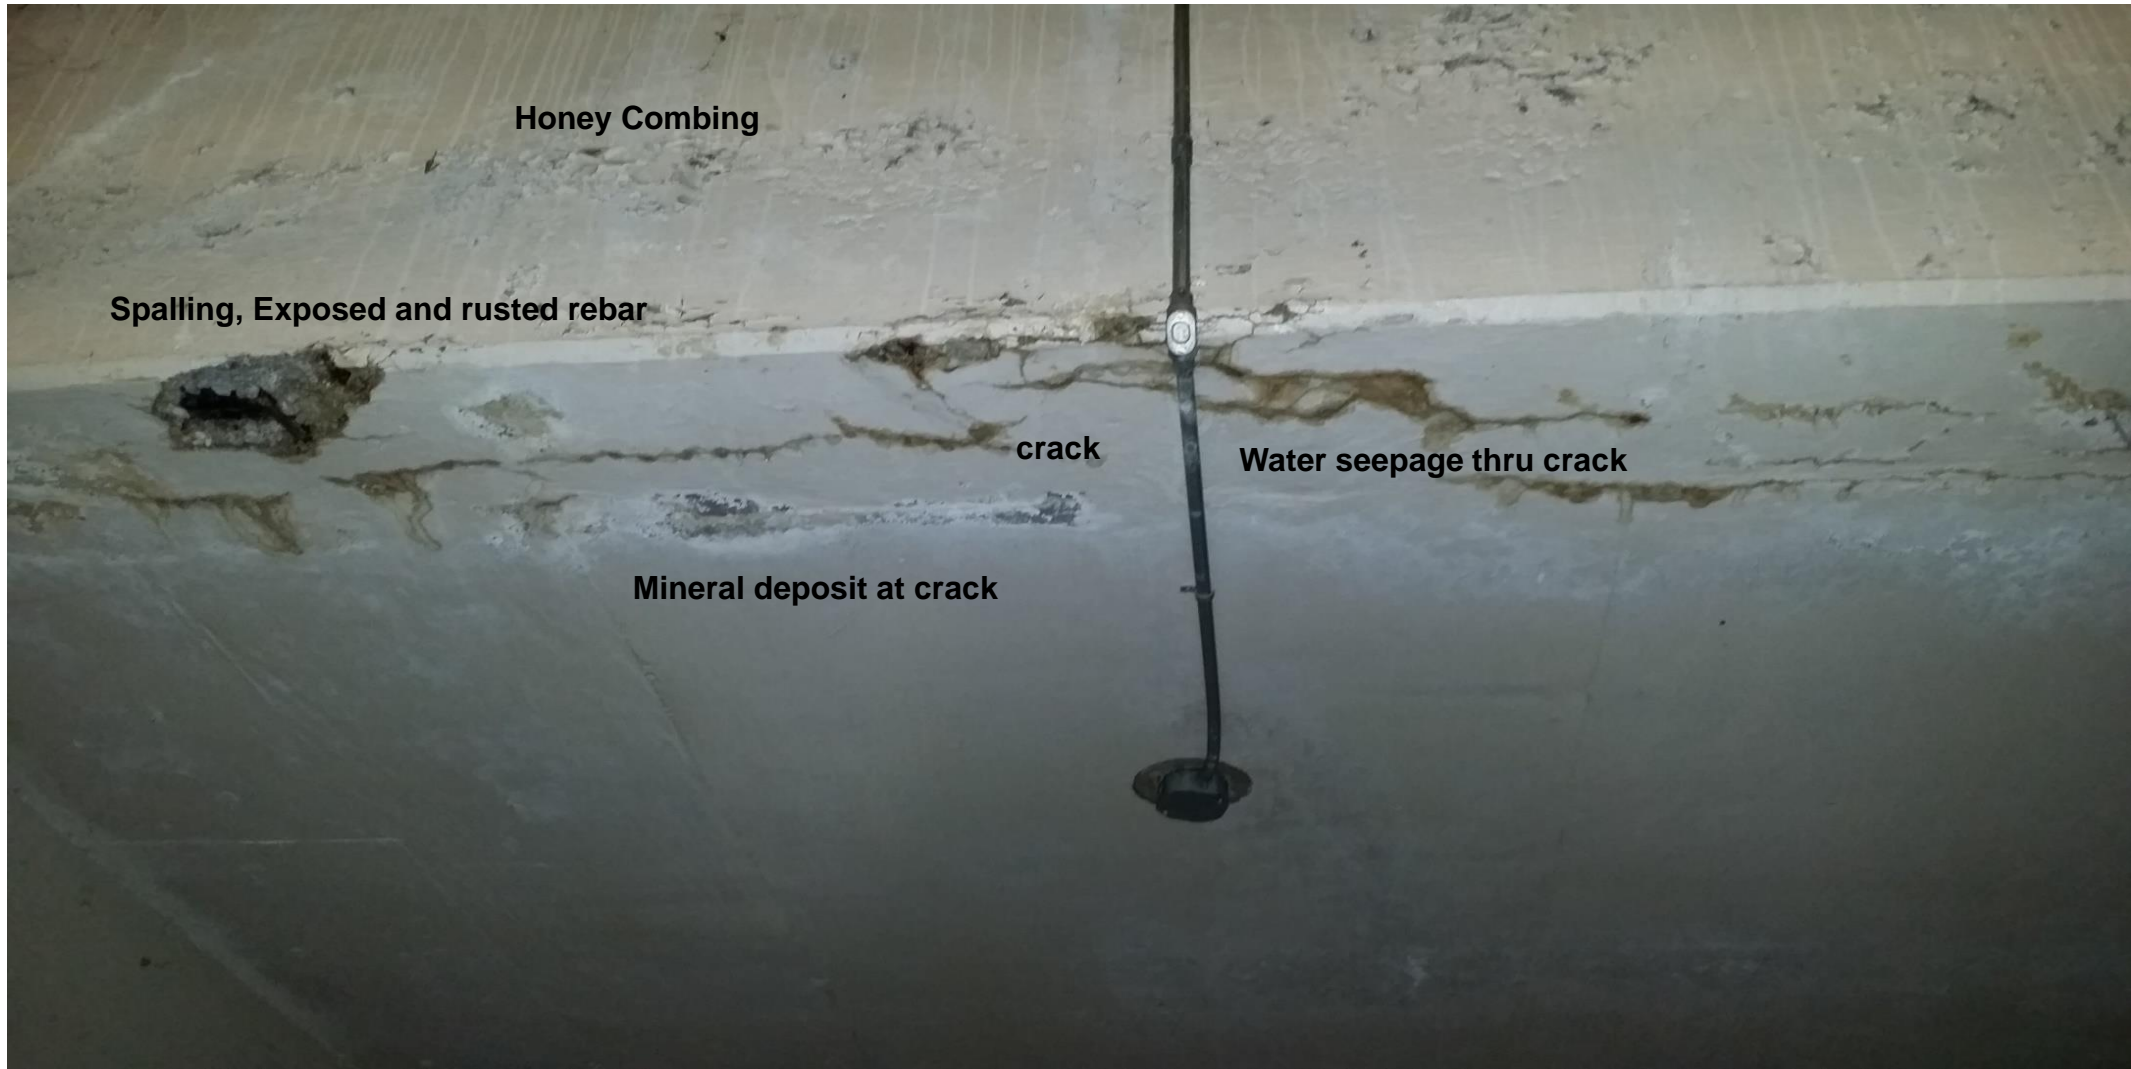
North west access entrance

Honey Combing

Spalling, Exposed and rusted rebar

crack

Water seepage thru crack

Mineral deposit at crack

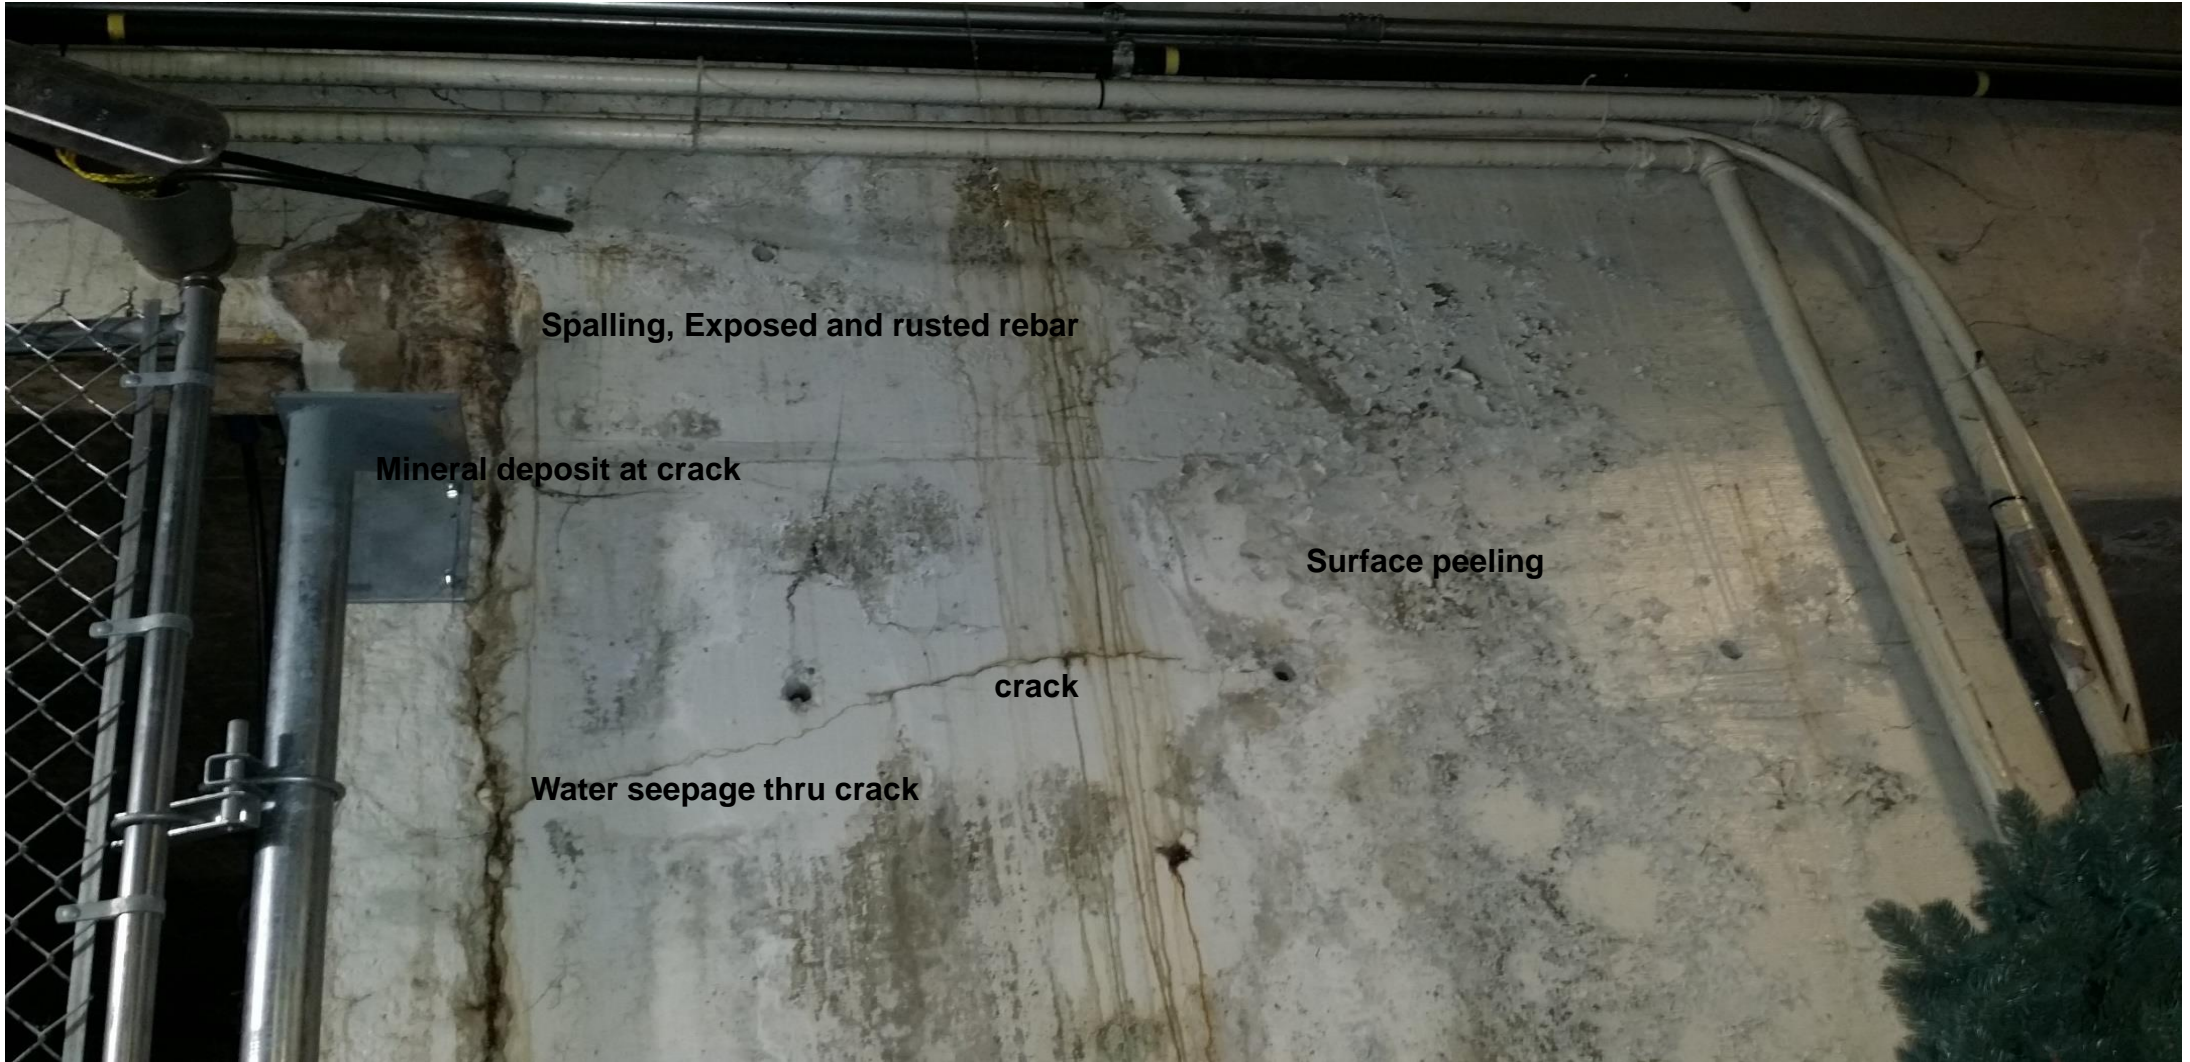
North west access entrance

Spalling, Exposed and rusted rebar

Mineral deposit at crack

Surface peeling

crack

Water seepage thru crack

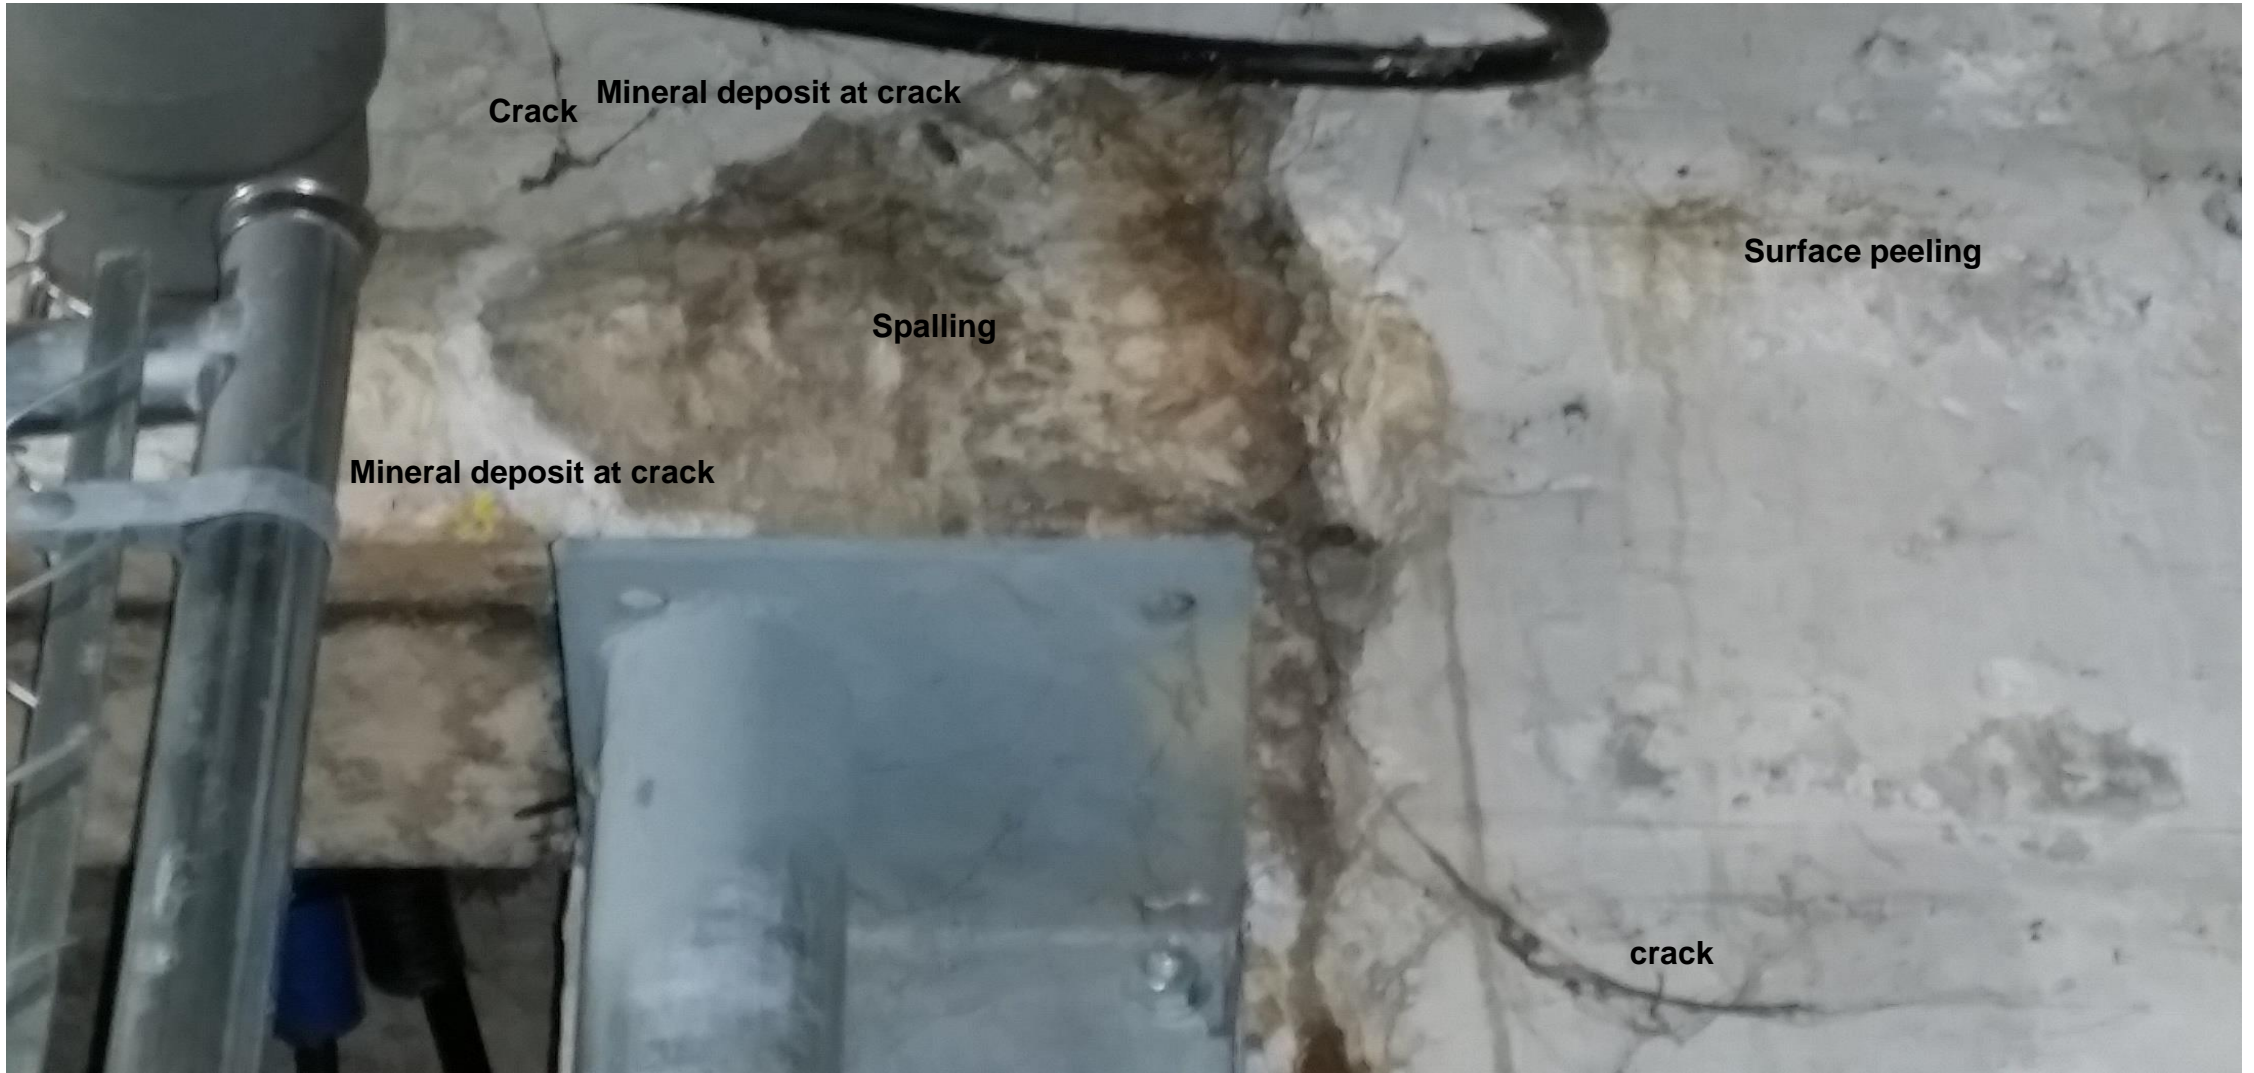
North west access entrance

Crack

Mineral deposit at crack

Surface peeling

Spalling

crack

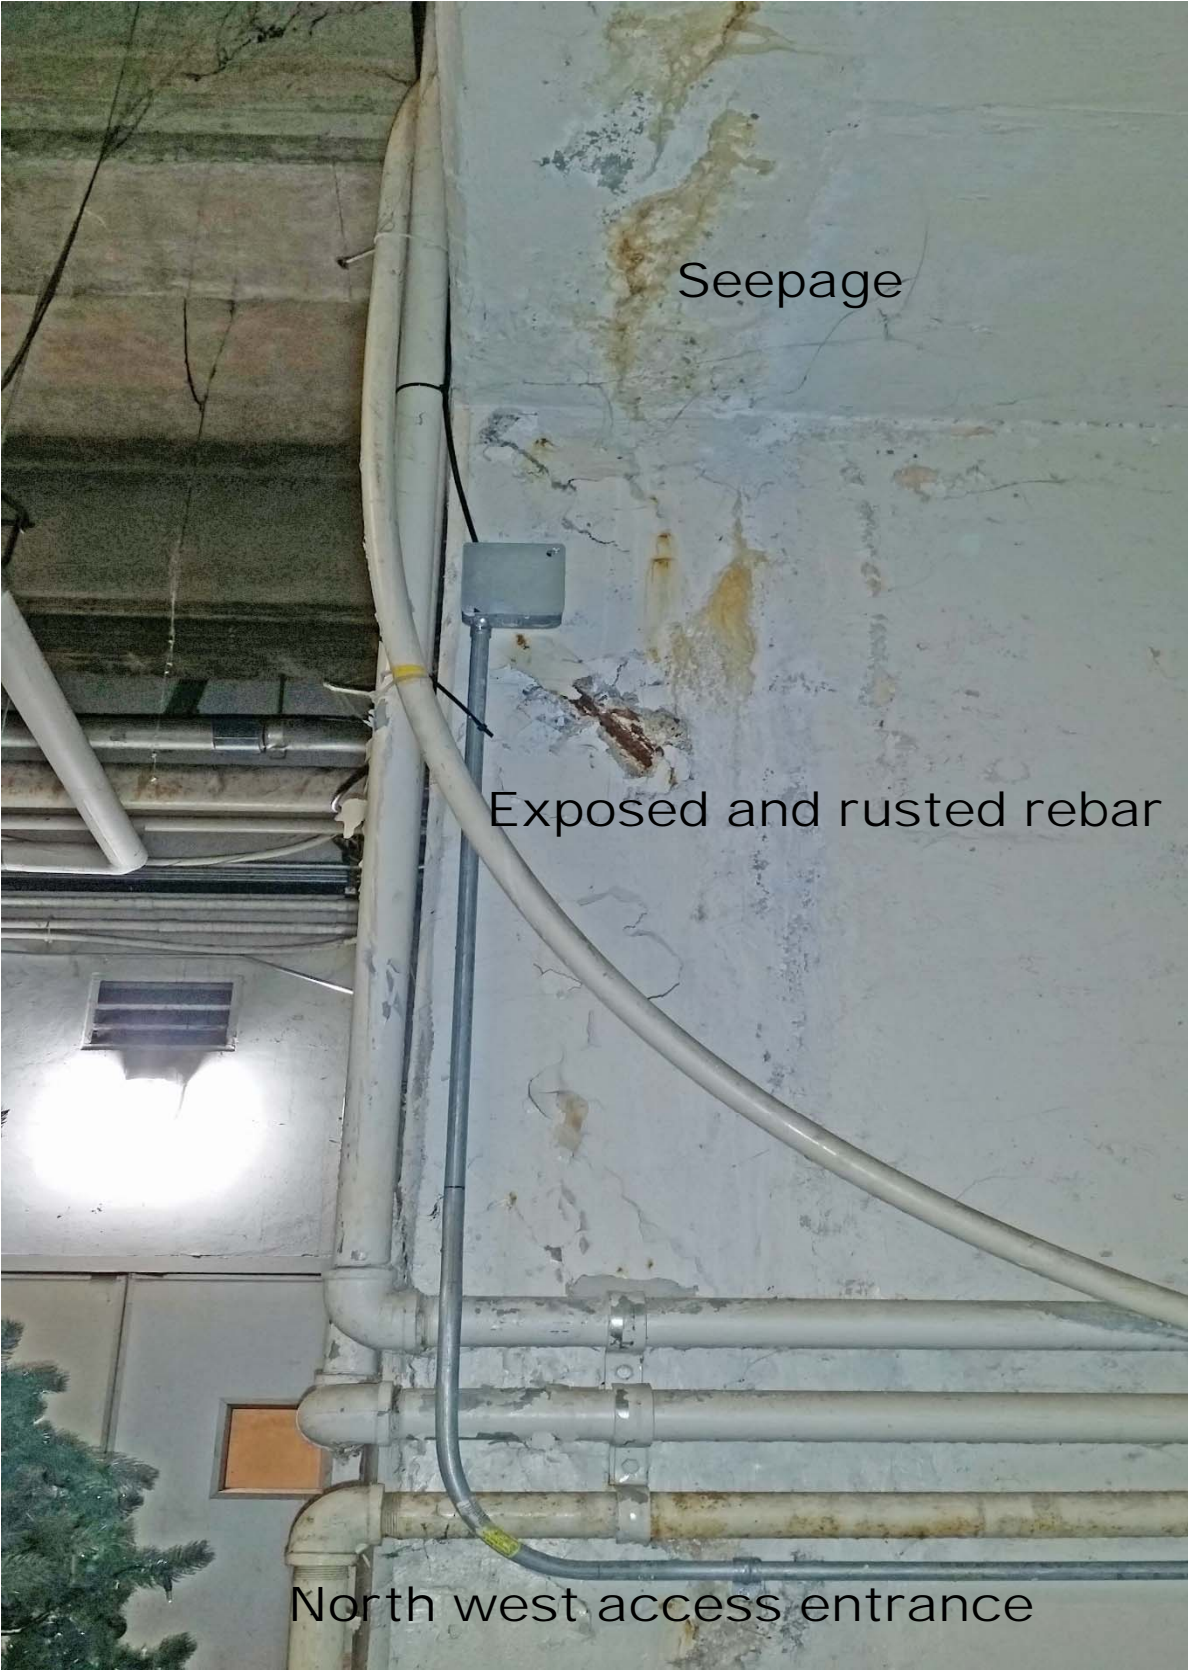
North west access entrance

Seepage

Exposed and rusted rebar

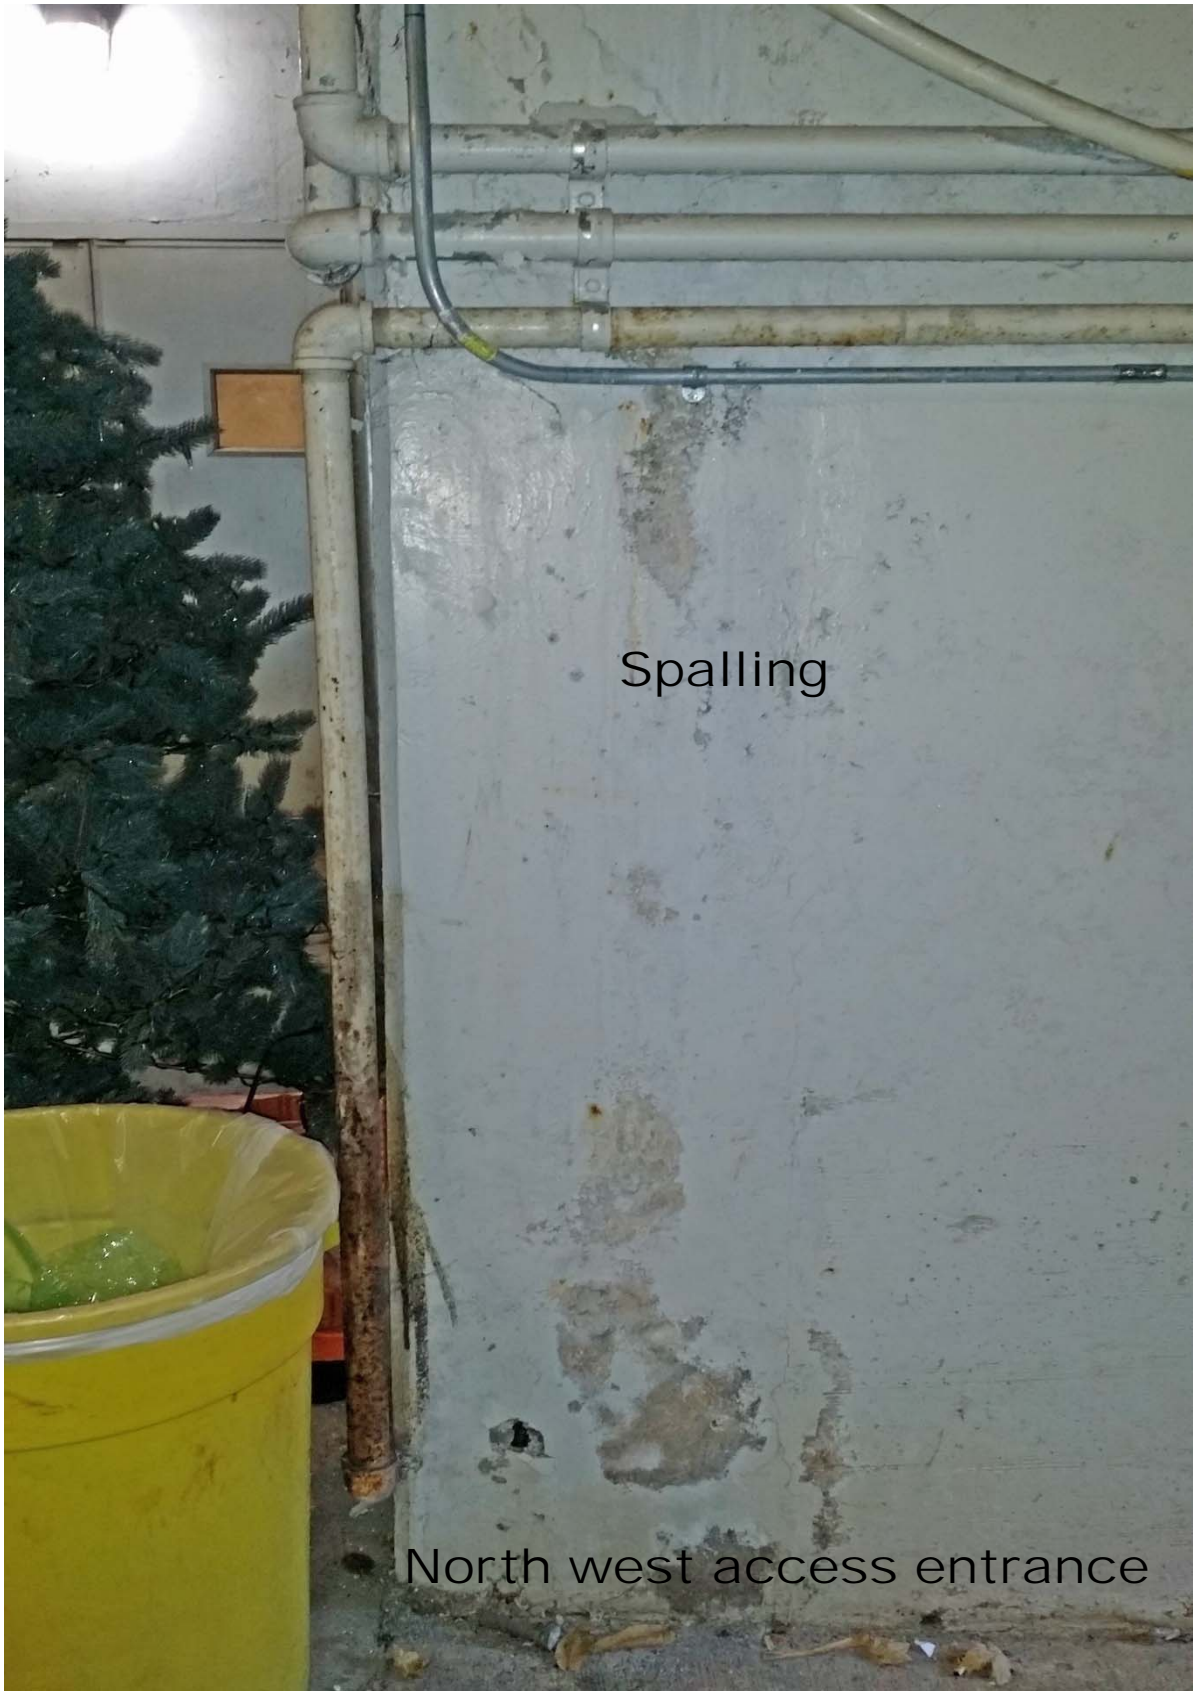
North west access entrance

Spalling

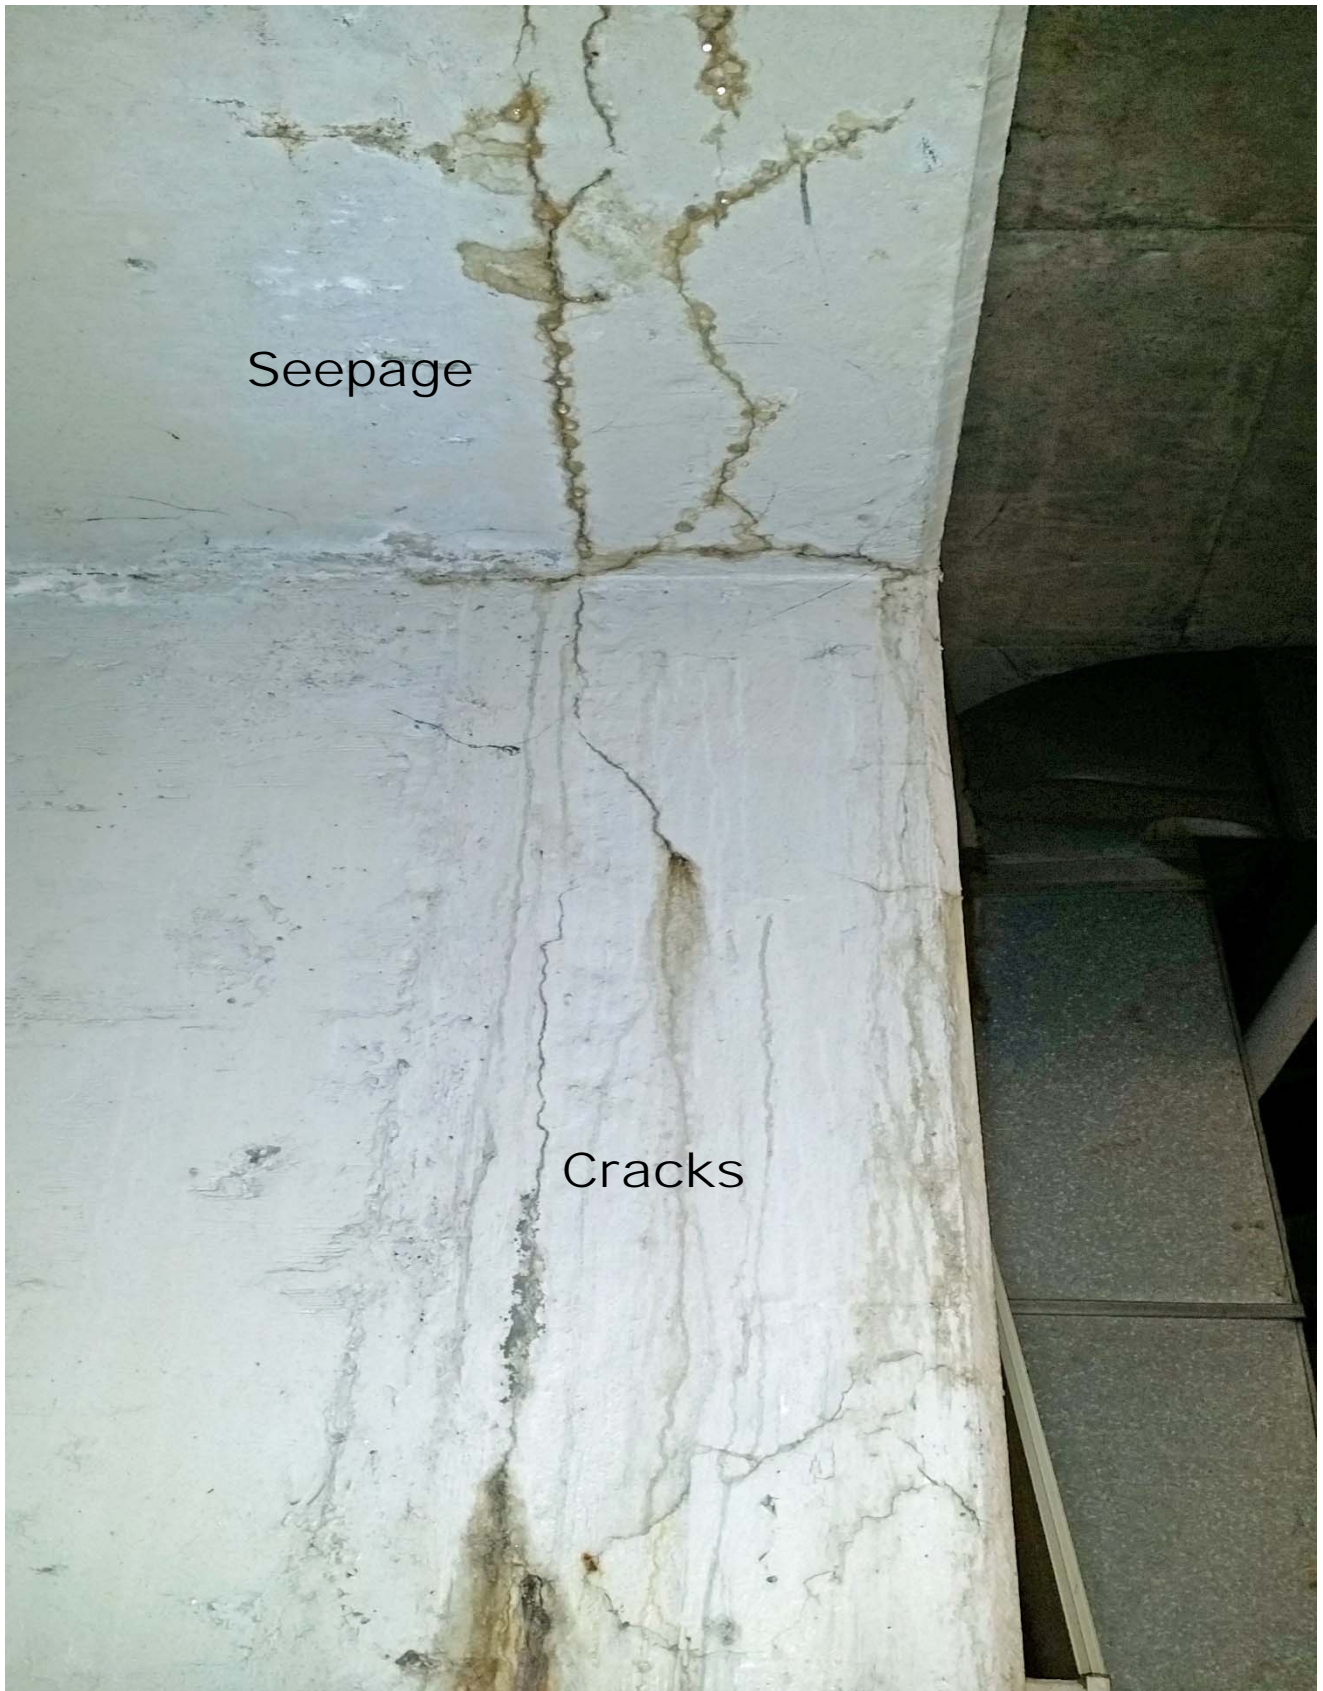
Seepage

Cracks

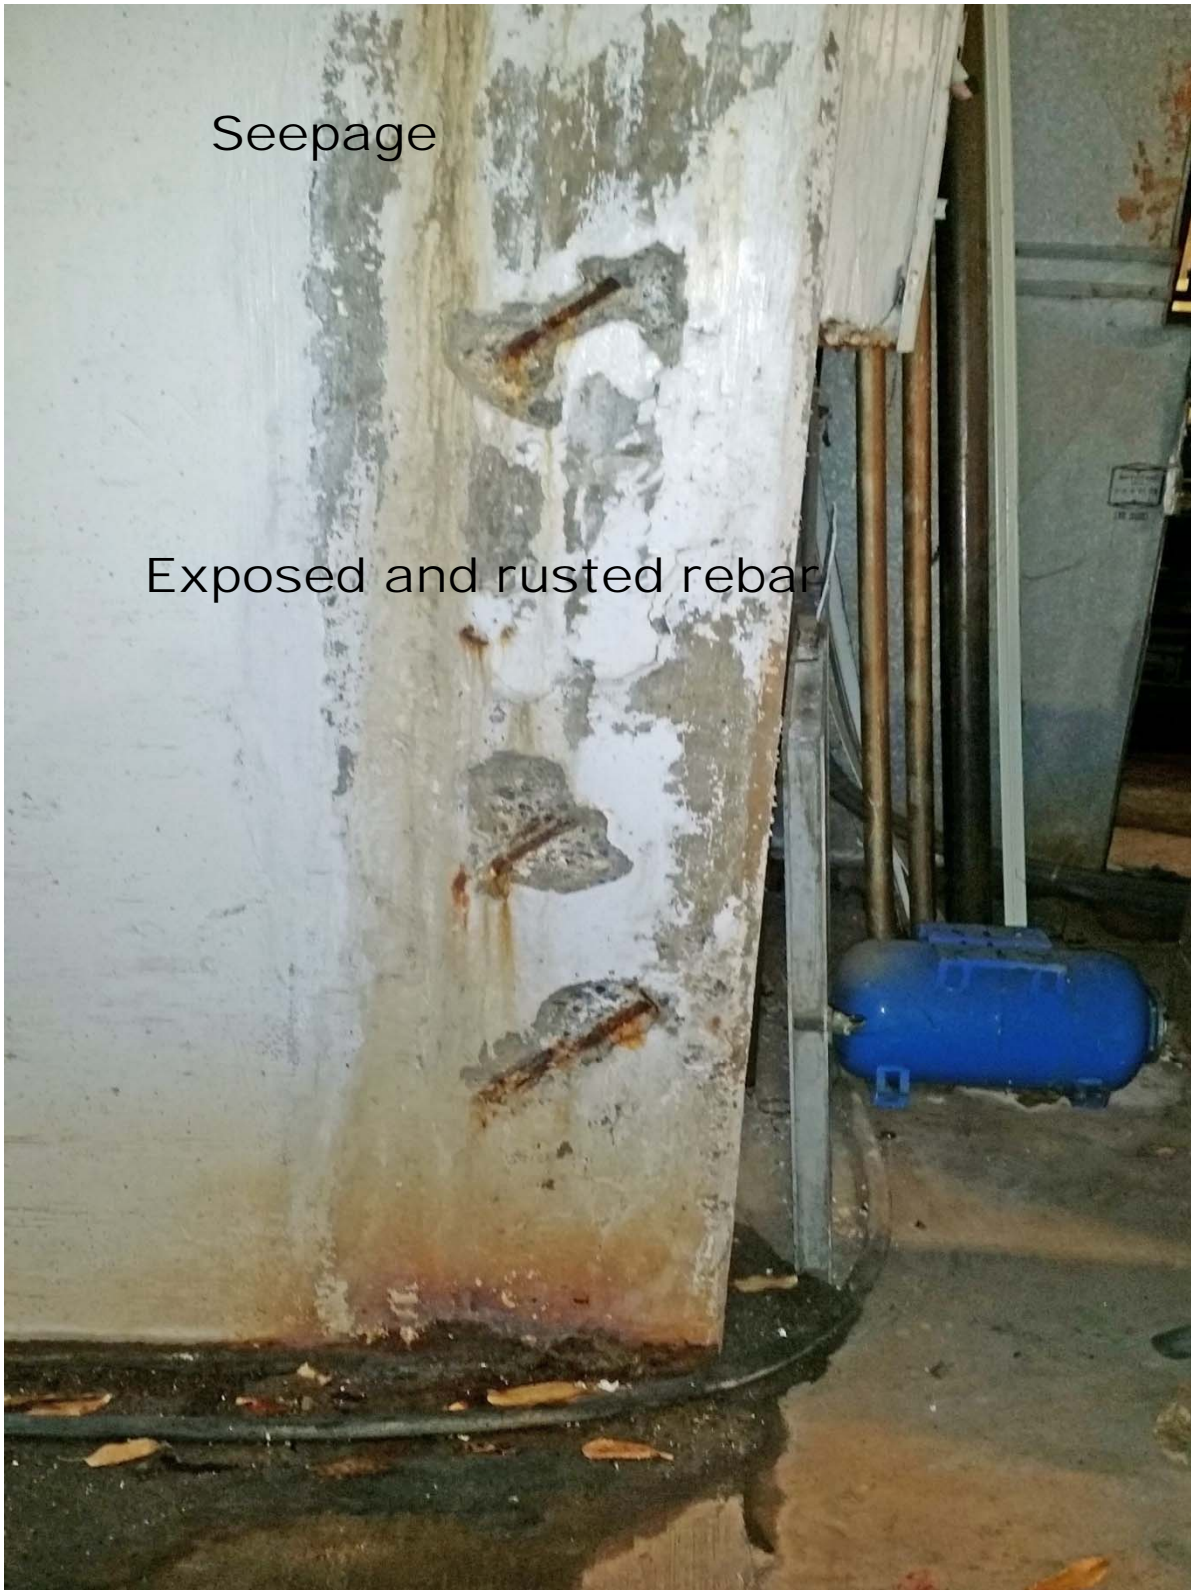
North west access entrance

Seepage

Exposed and rusted rebar
