FACILITY ASSESSMENT REPORT

APPENDIX D

Appendix D Service Garage

Knoxville Civic Auditorium and Coliseum Assessment

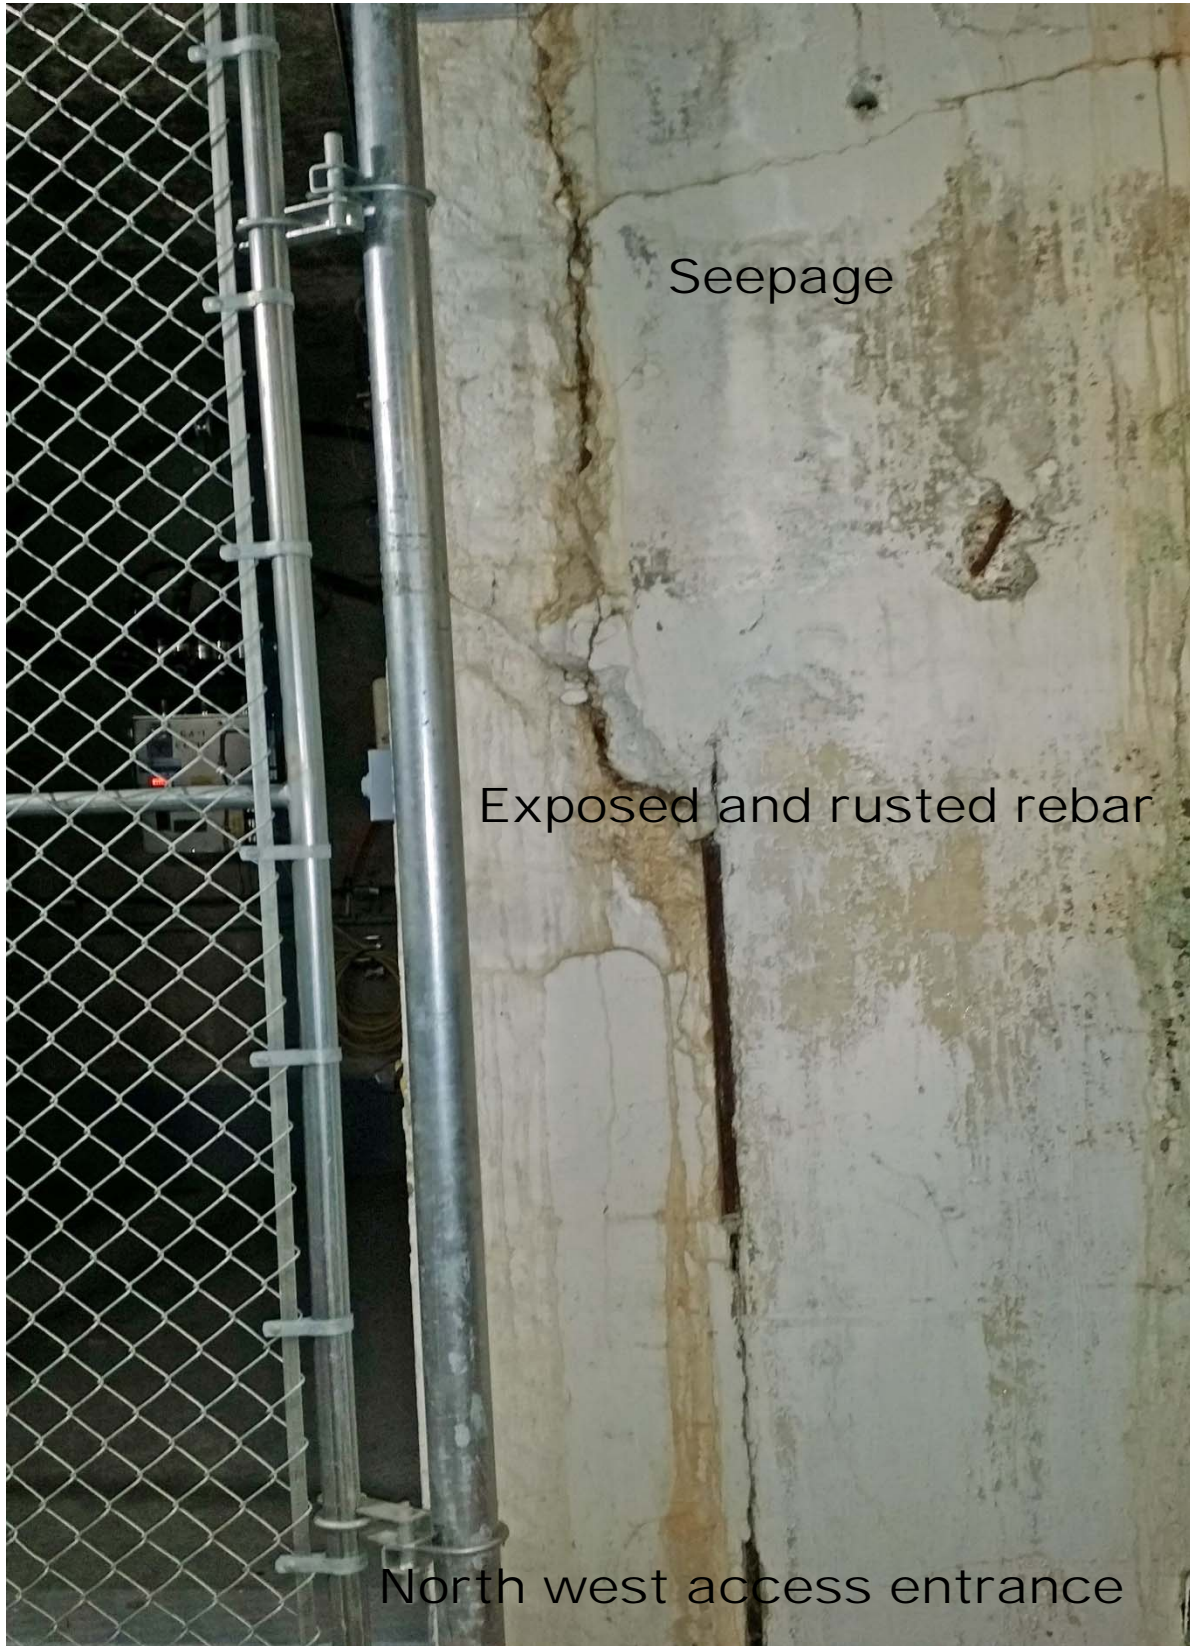
North west access entrance

Seepage

Exposed and rusted rebar

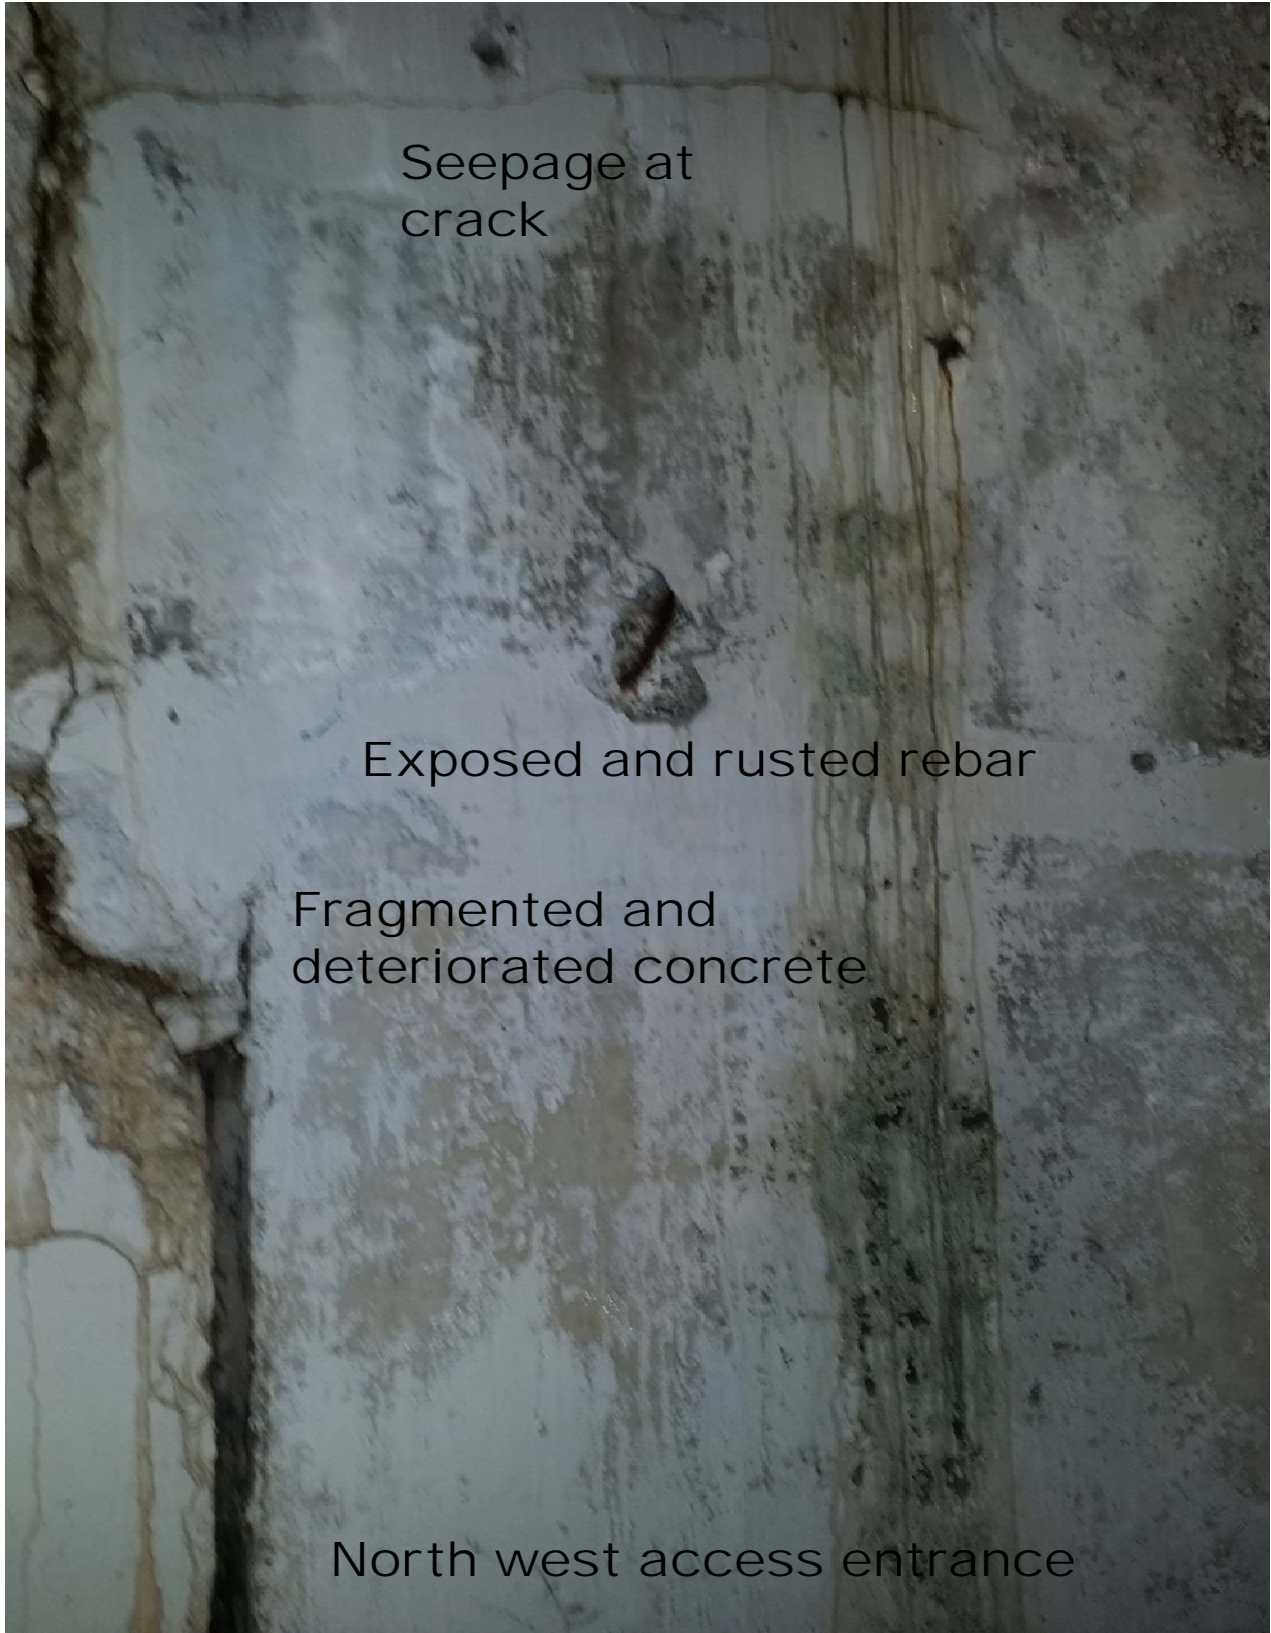
North west access entrance

Seepage at
crack

Exposed and rusted rebar

Fragmented and
deteriorated concrete

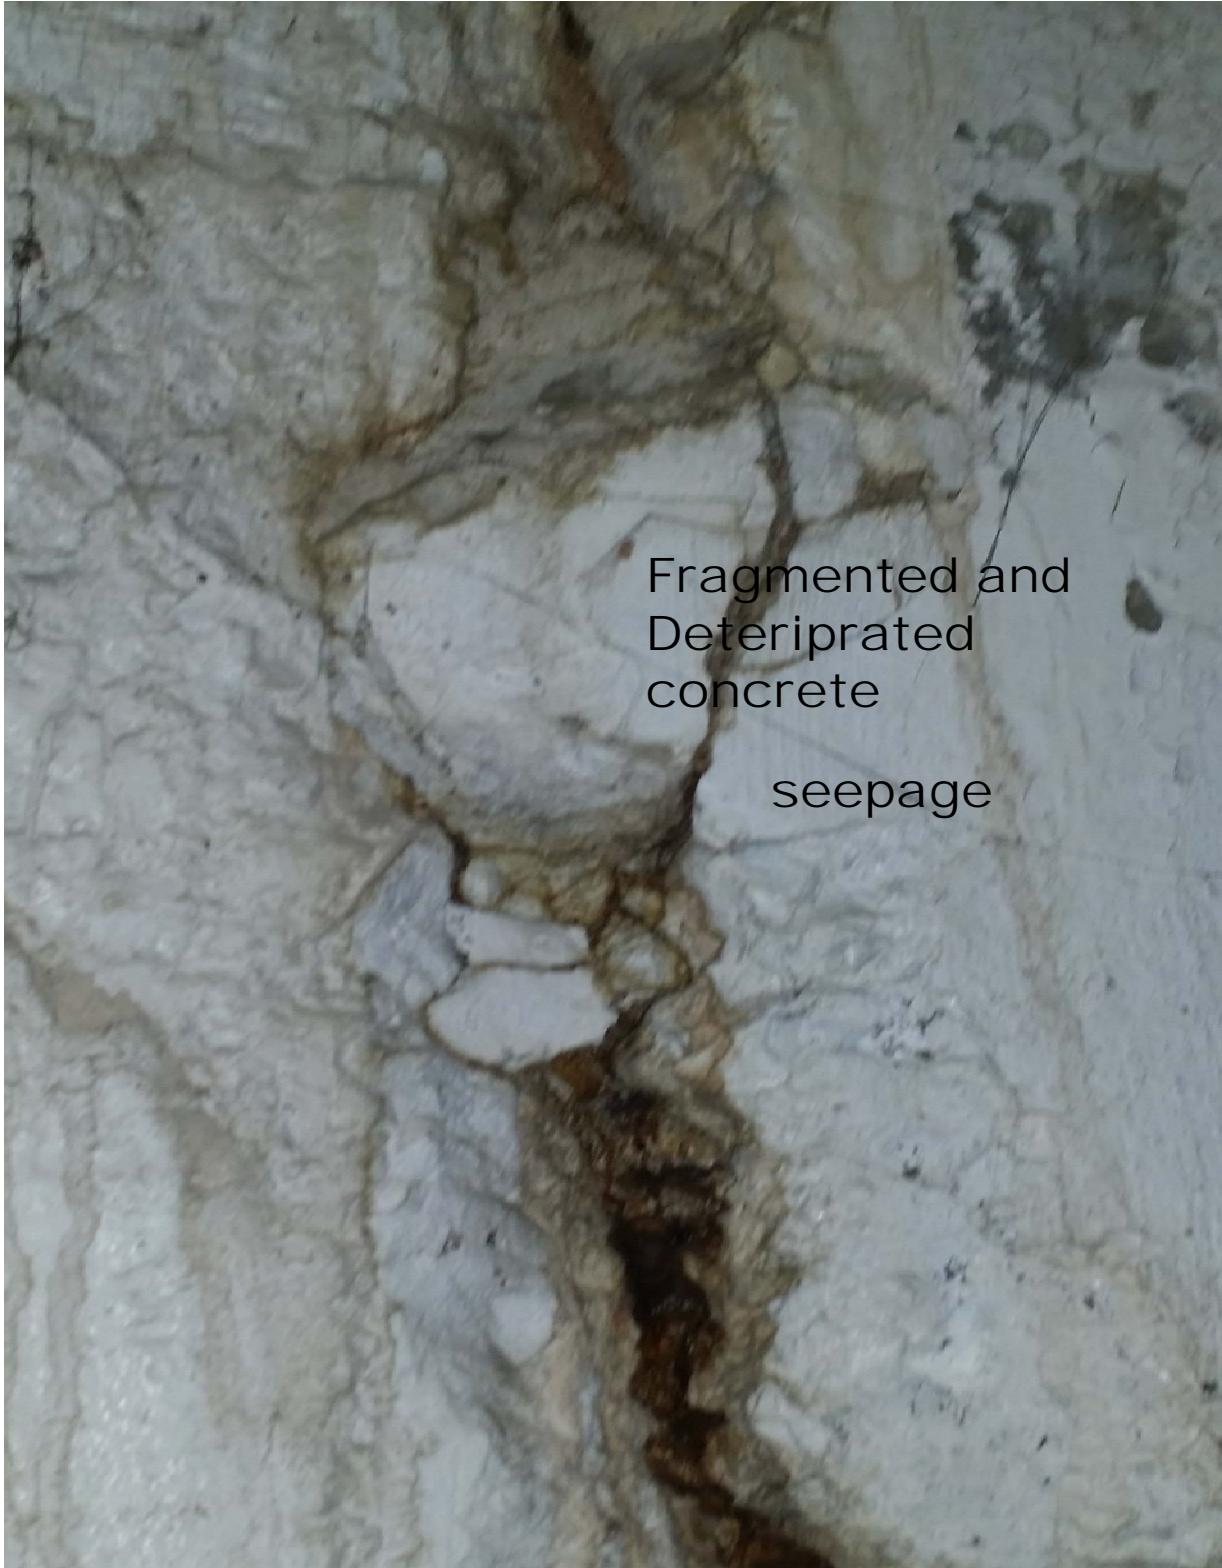
North west access entrance

Fragmented and
Deteriorated
concrete

seepage

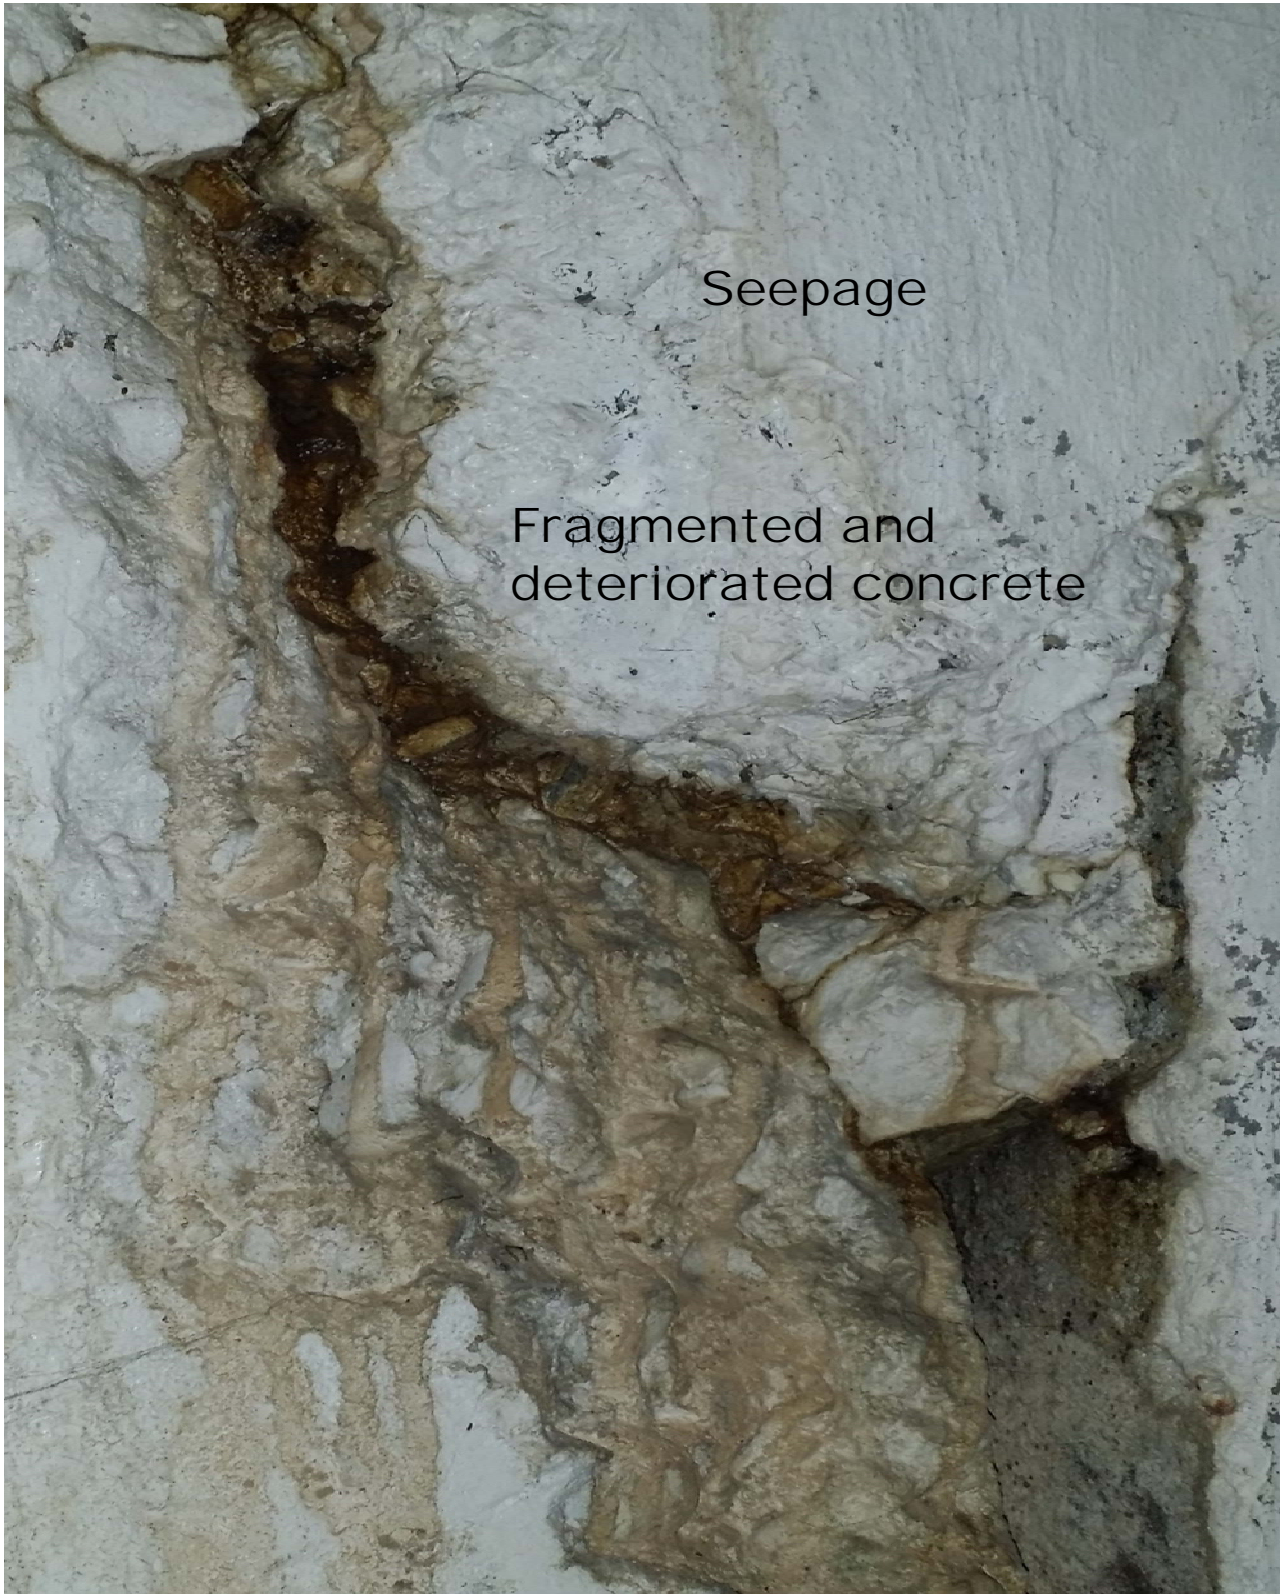
North west access entrance

Seepage

Fragmented and
deteriorated concrete

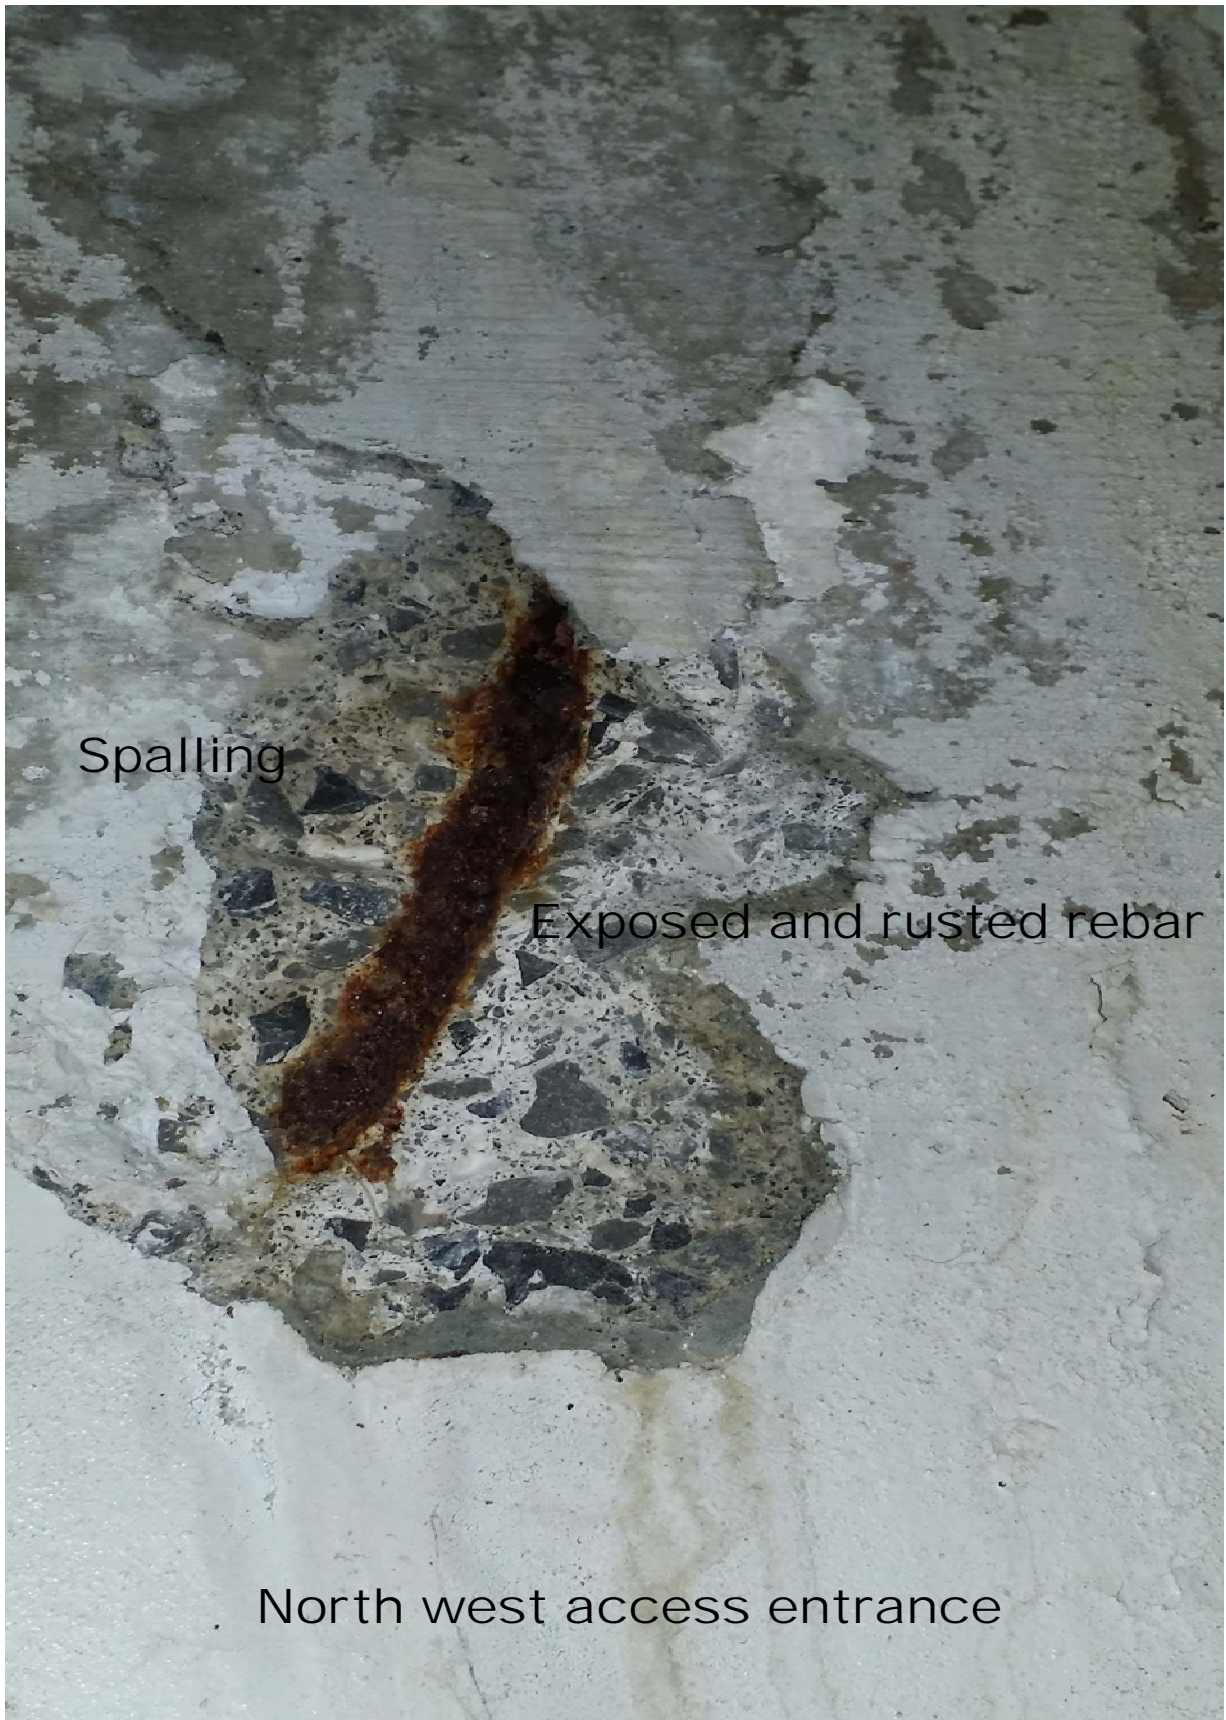
North west access entrance

Spalling

Exposed and rusted rebar

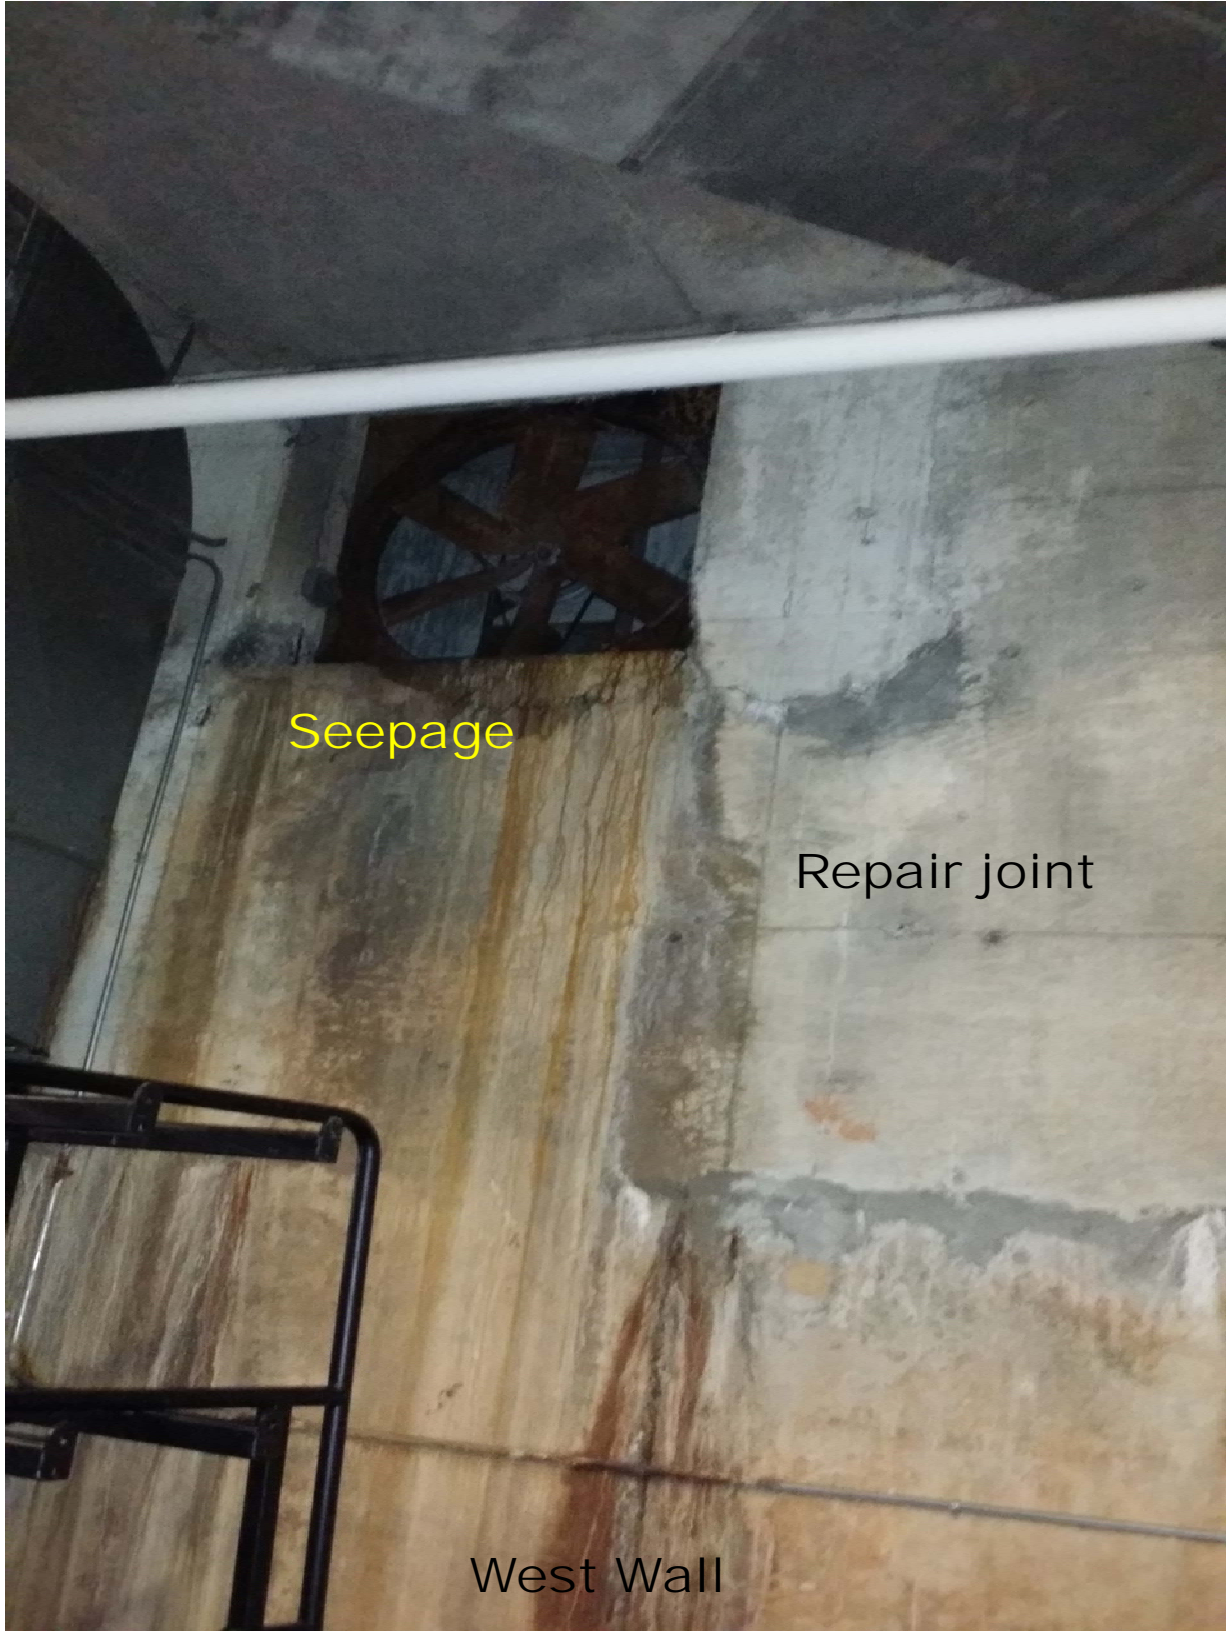
West Wall

Seepage

Repair joint

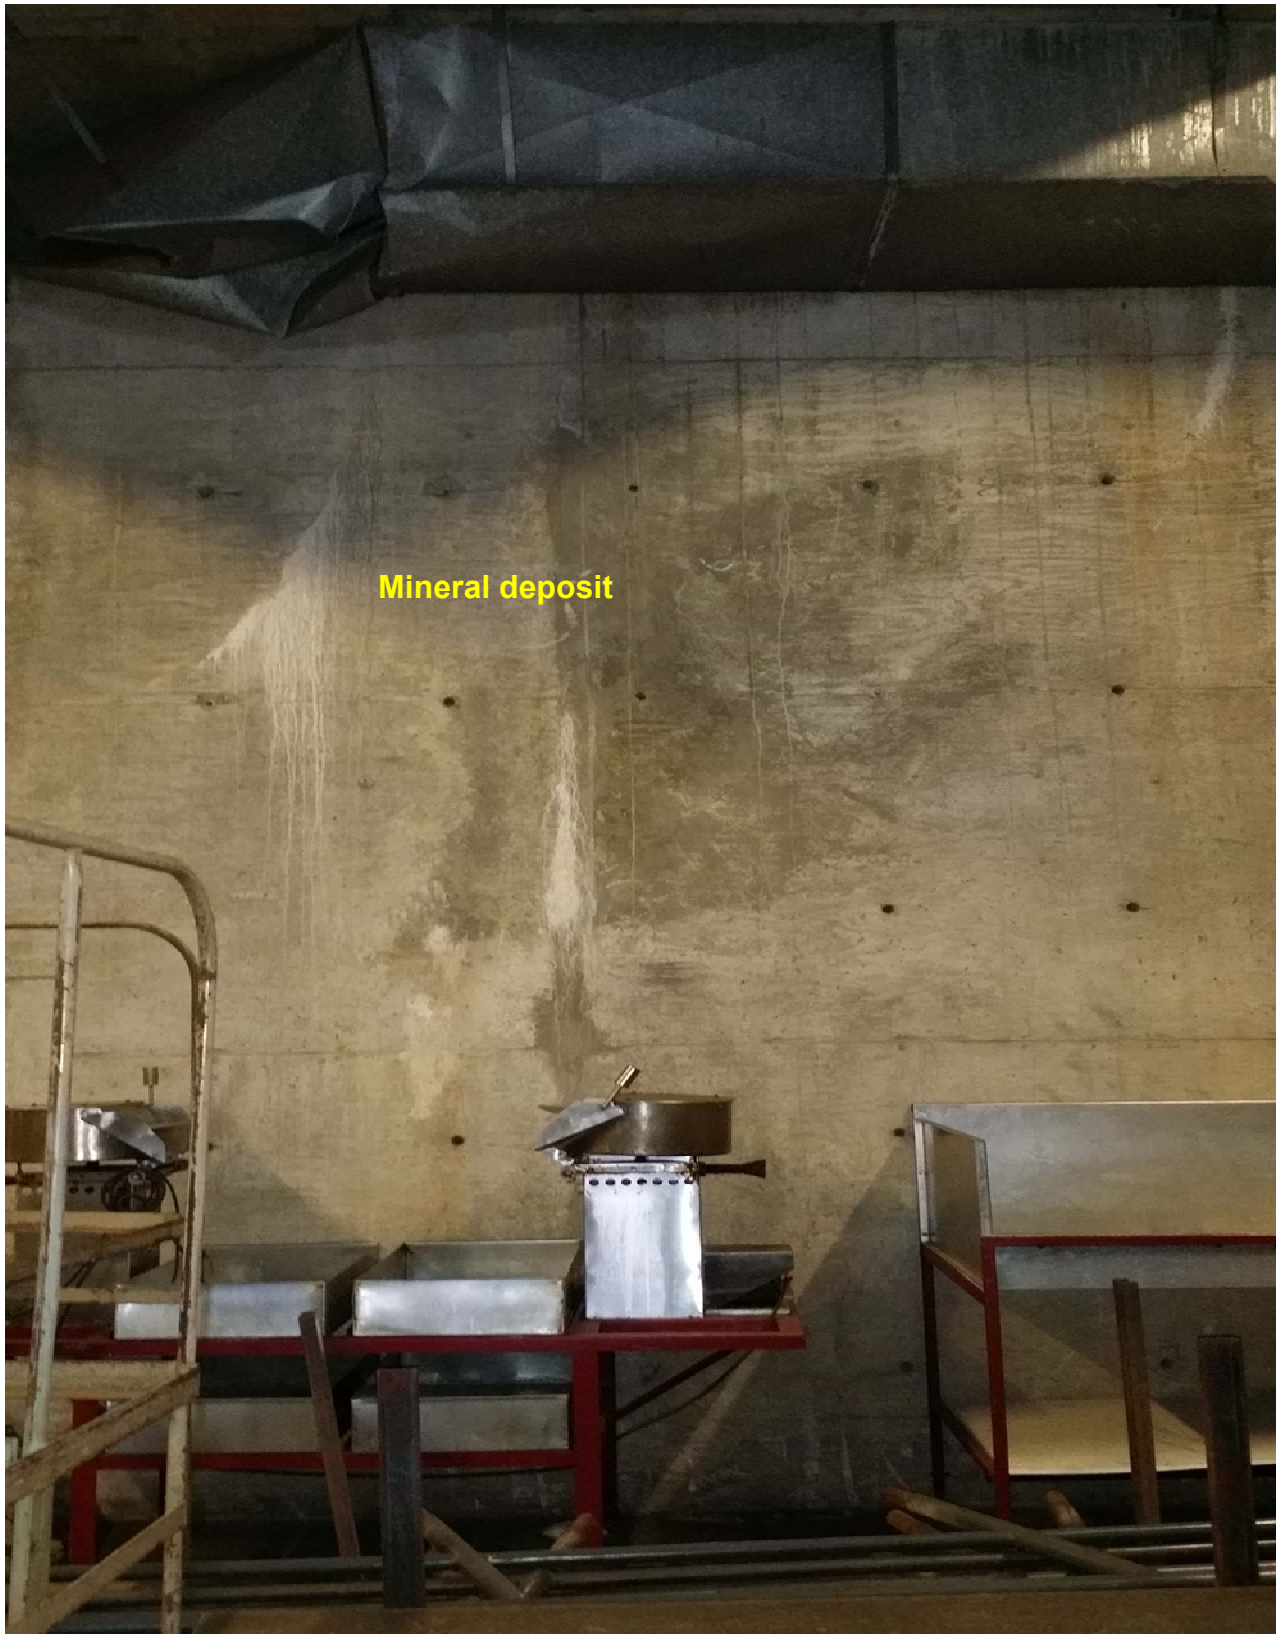
West Wall

Mineral deposit

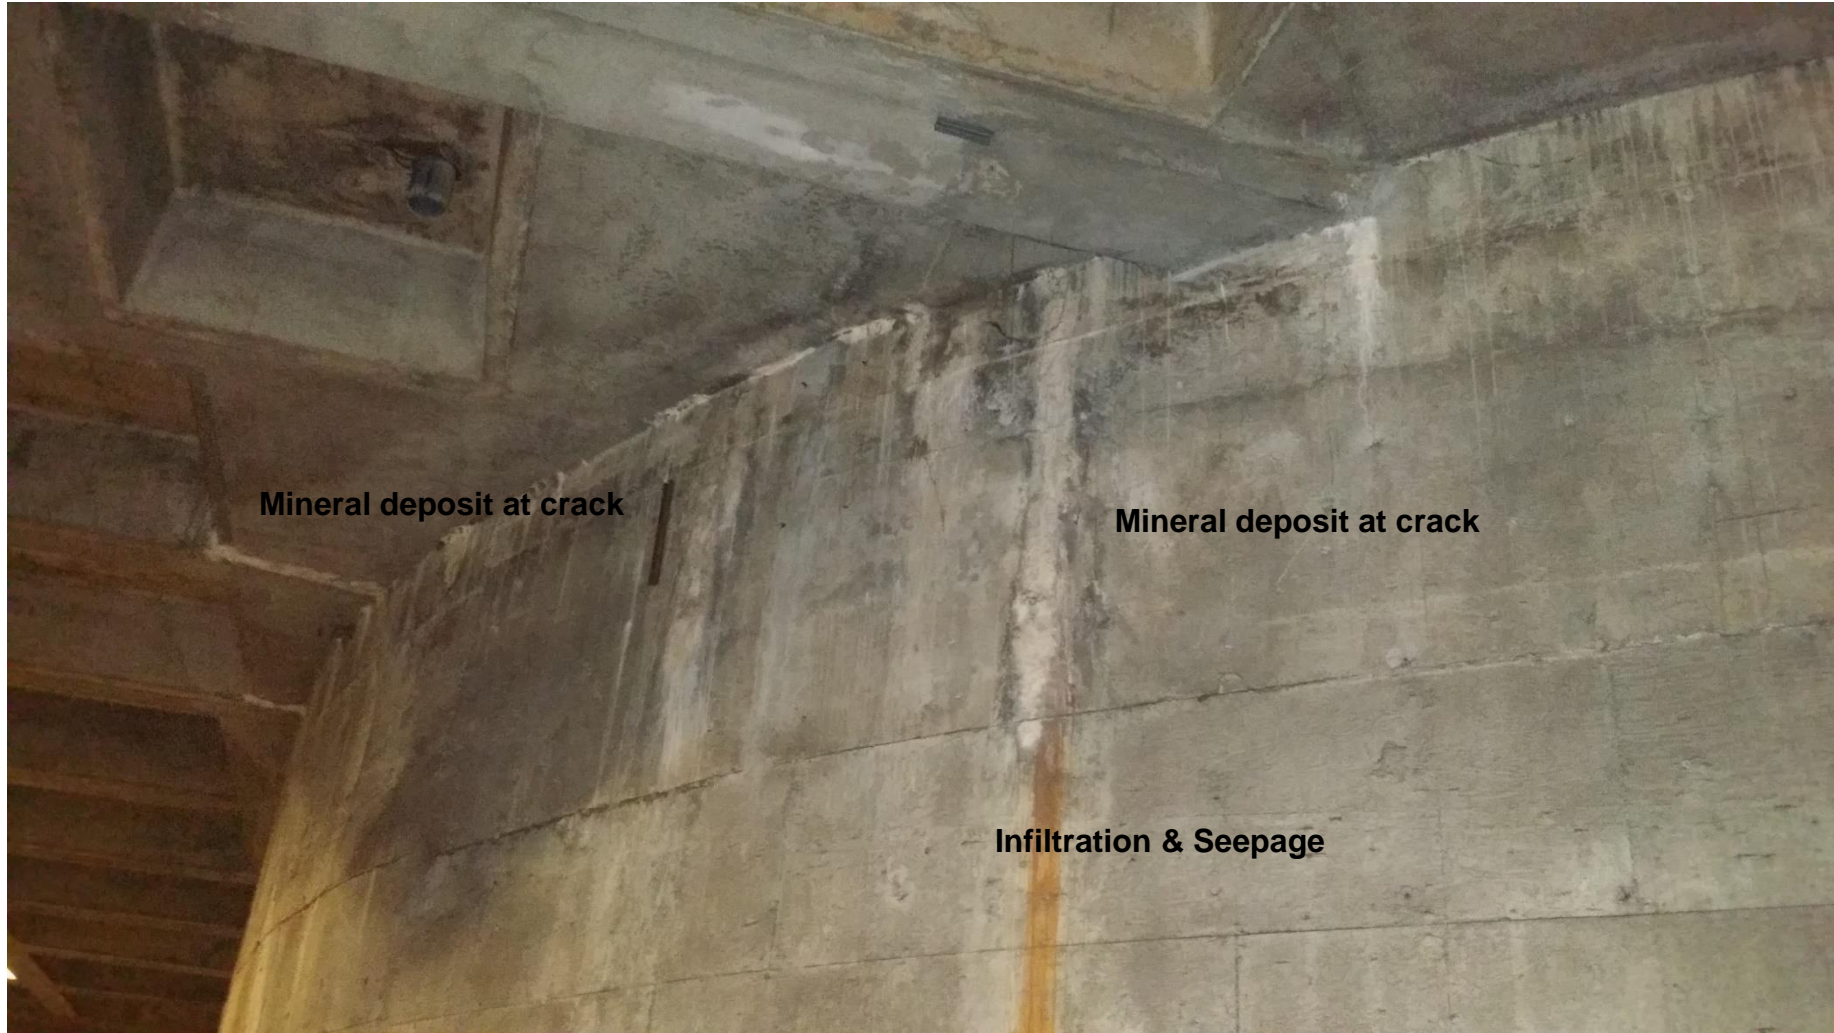
East Wall

Mineral deposit at crack

Infiltration & Seepage

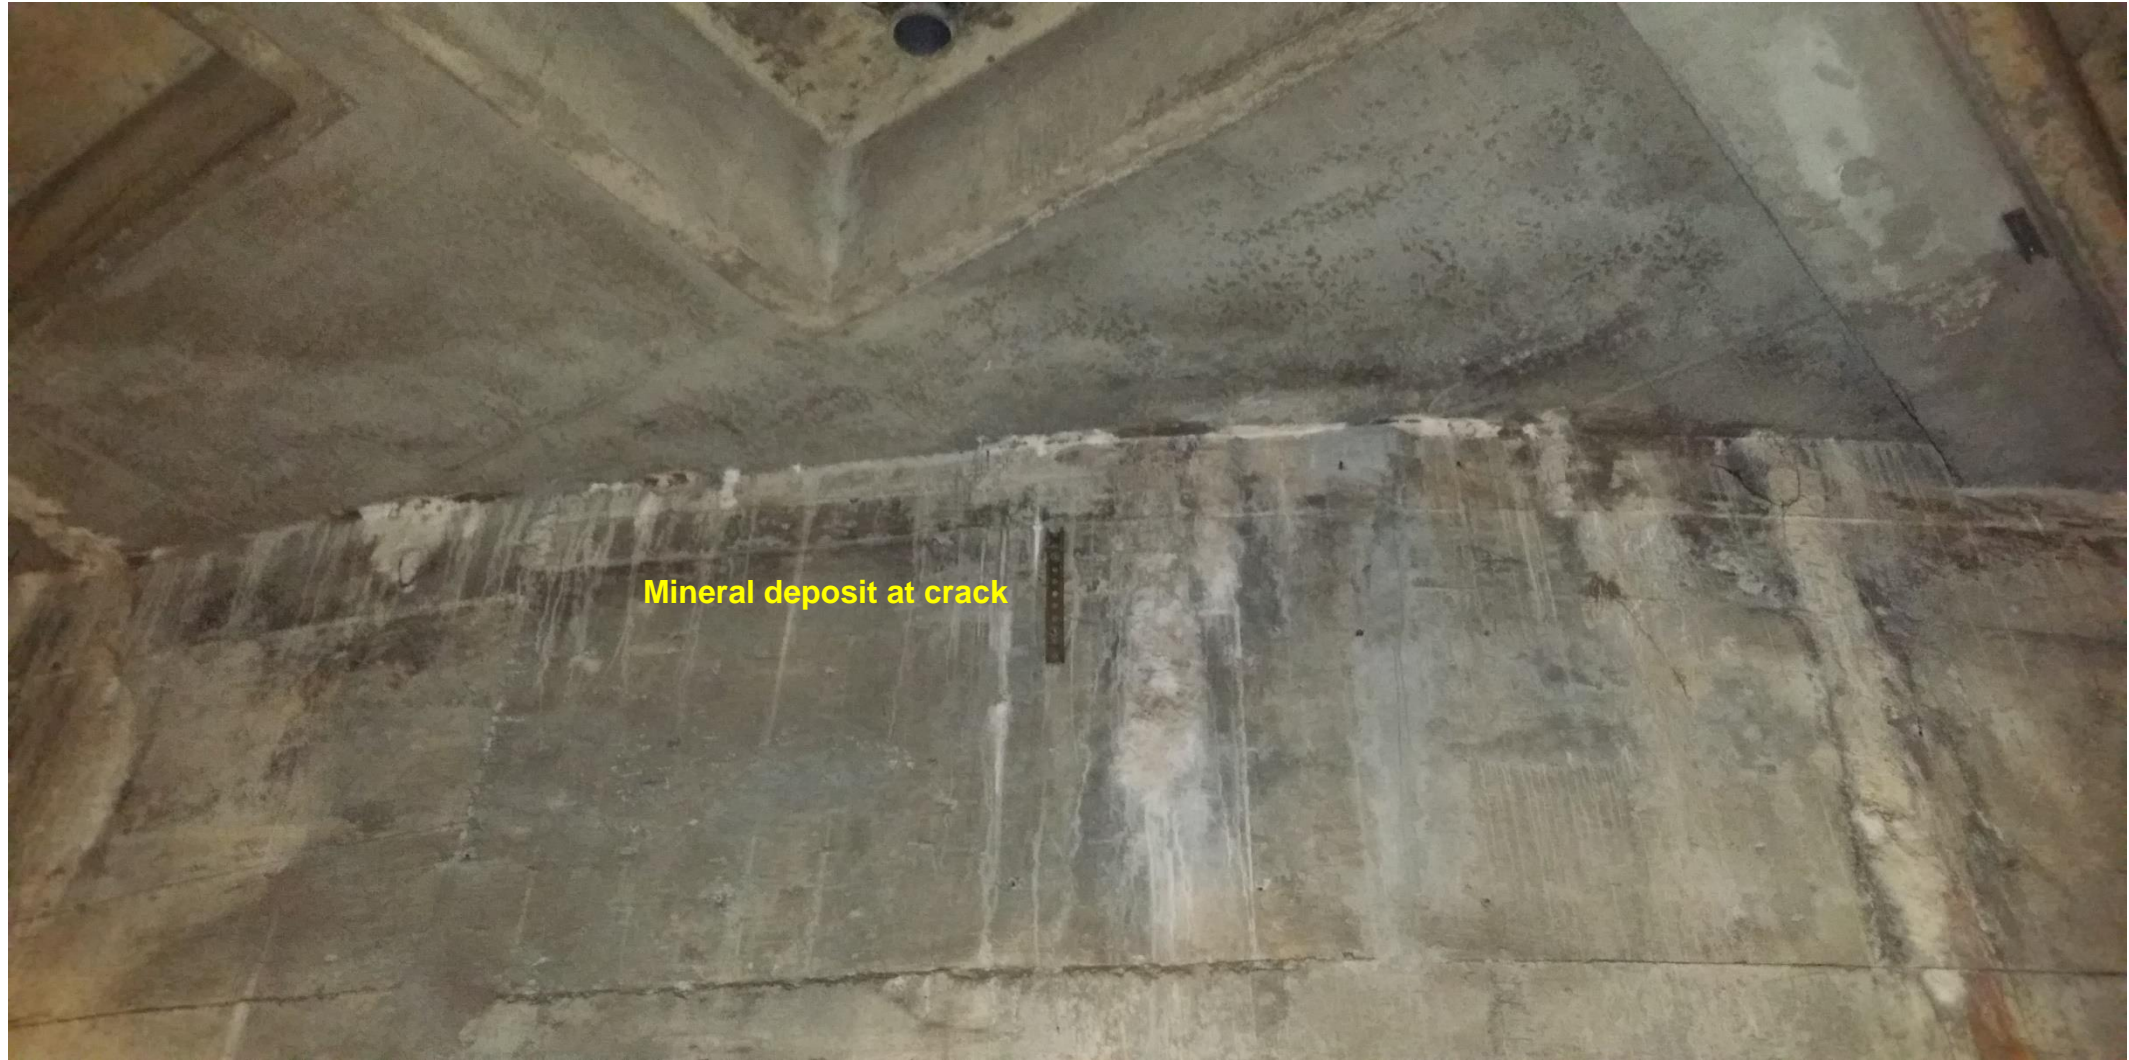
East Wall

Mineral deposit at crack

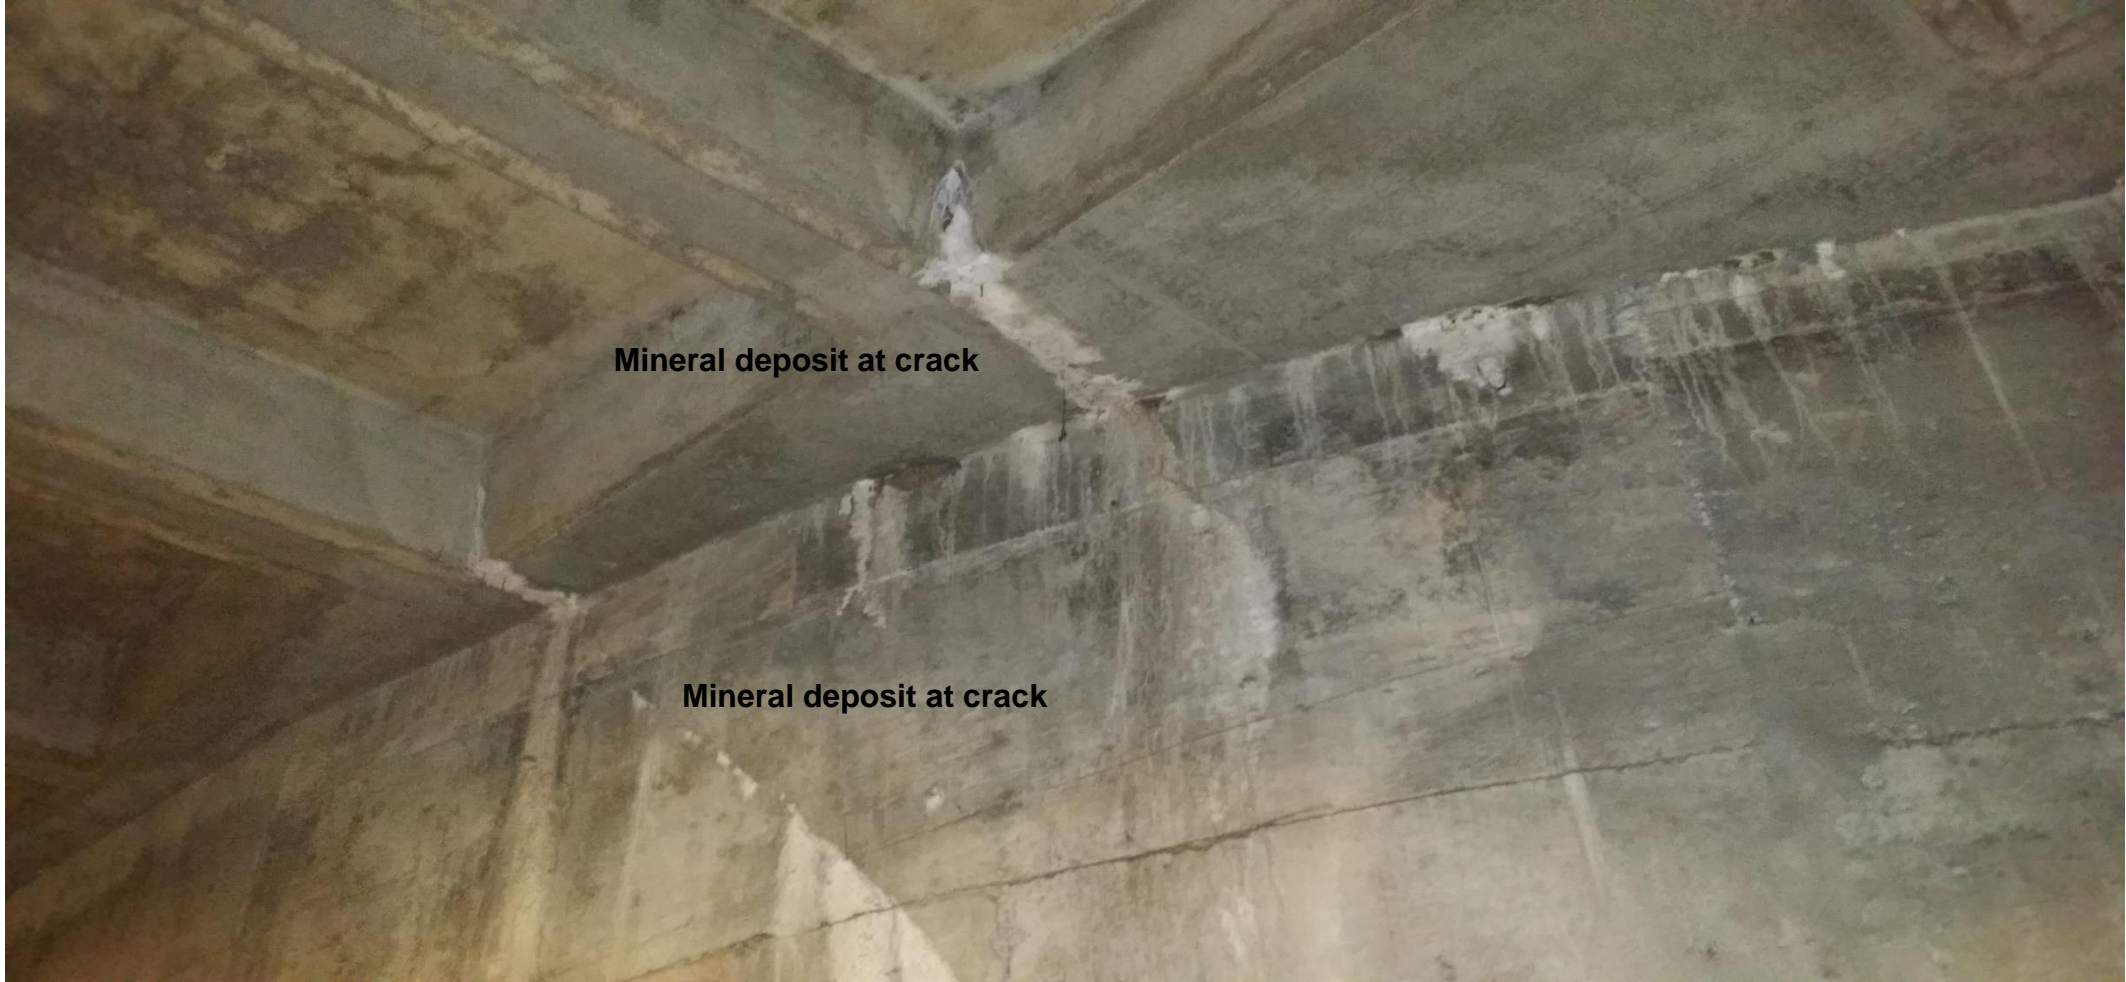
East Wall

Mineral deposit at crack

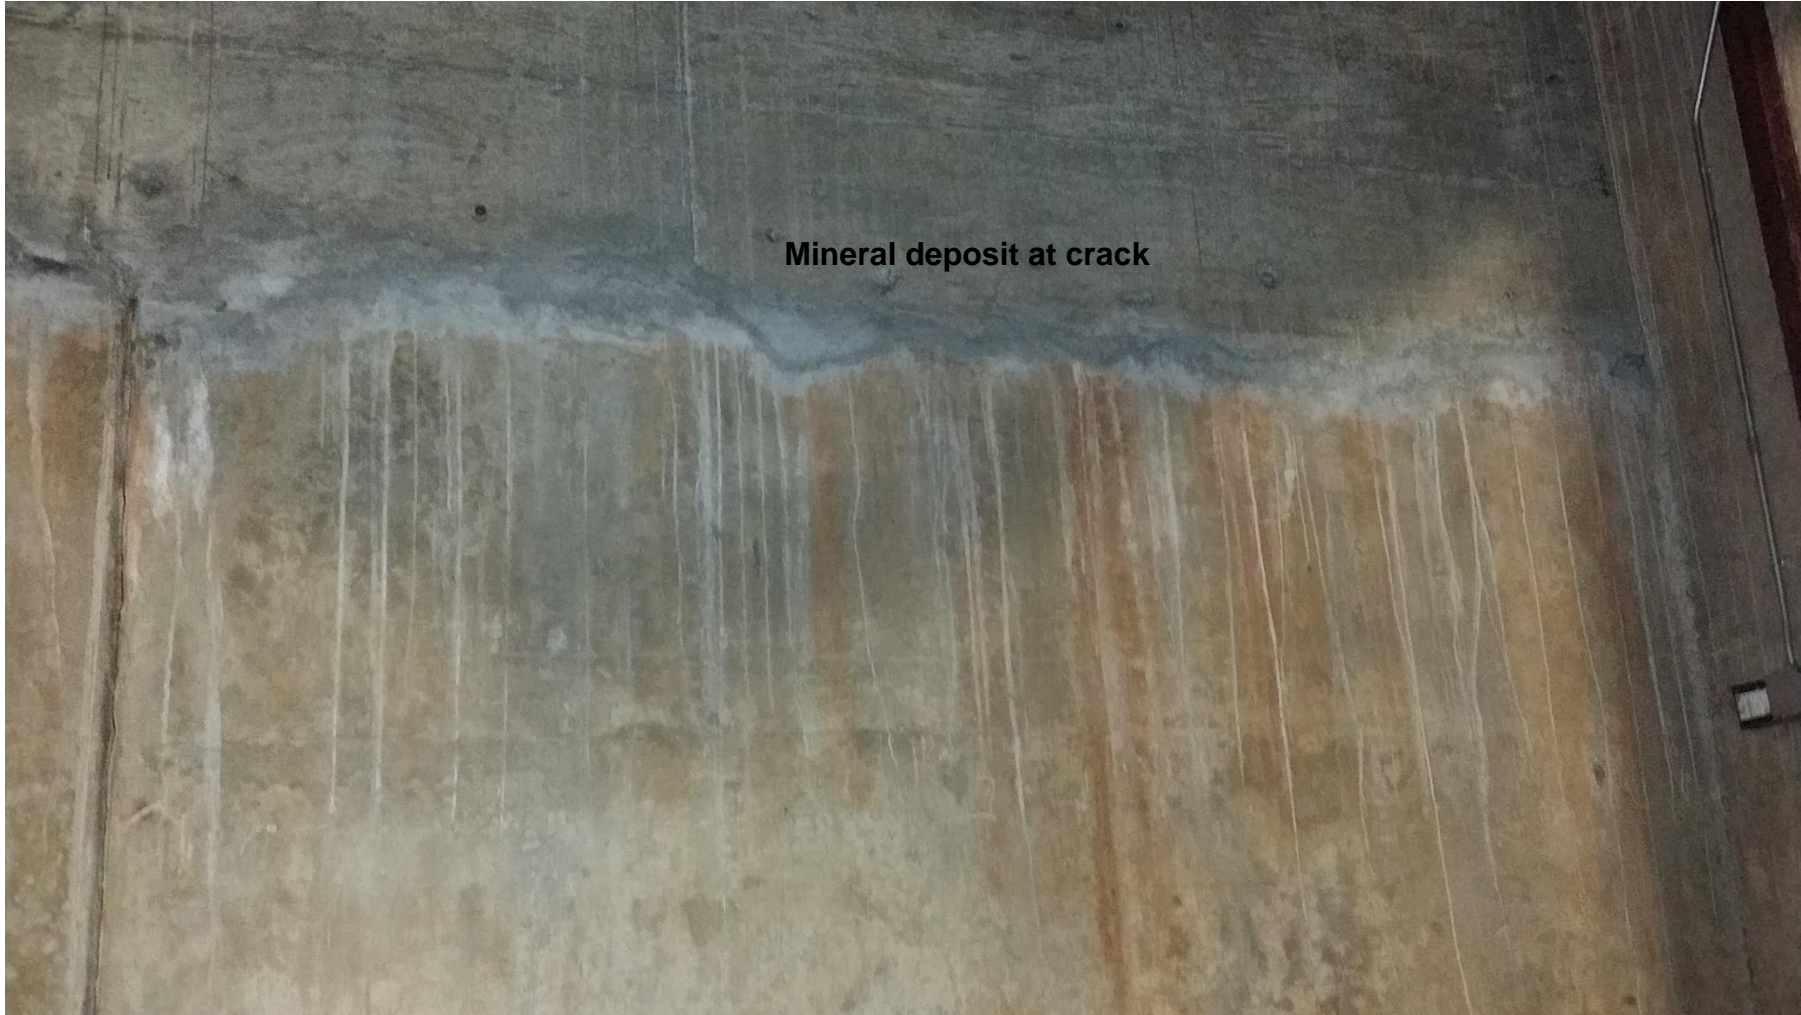
East Wall

Mineral deposit at crack
