FACILITY ASSESSMENT REPORT

APPENDIX D

Appendix D Service Garage

Knoxville Civic Auditorium and Coliseum Assessment

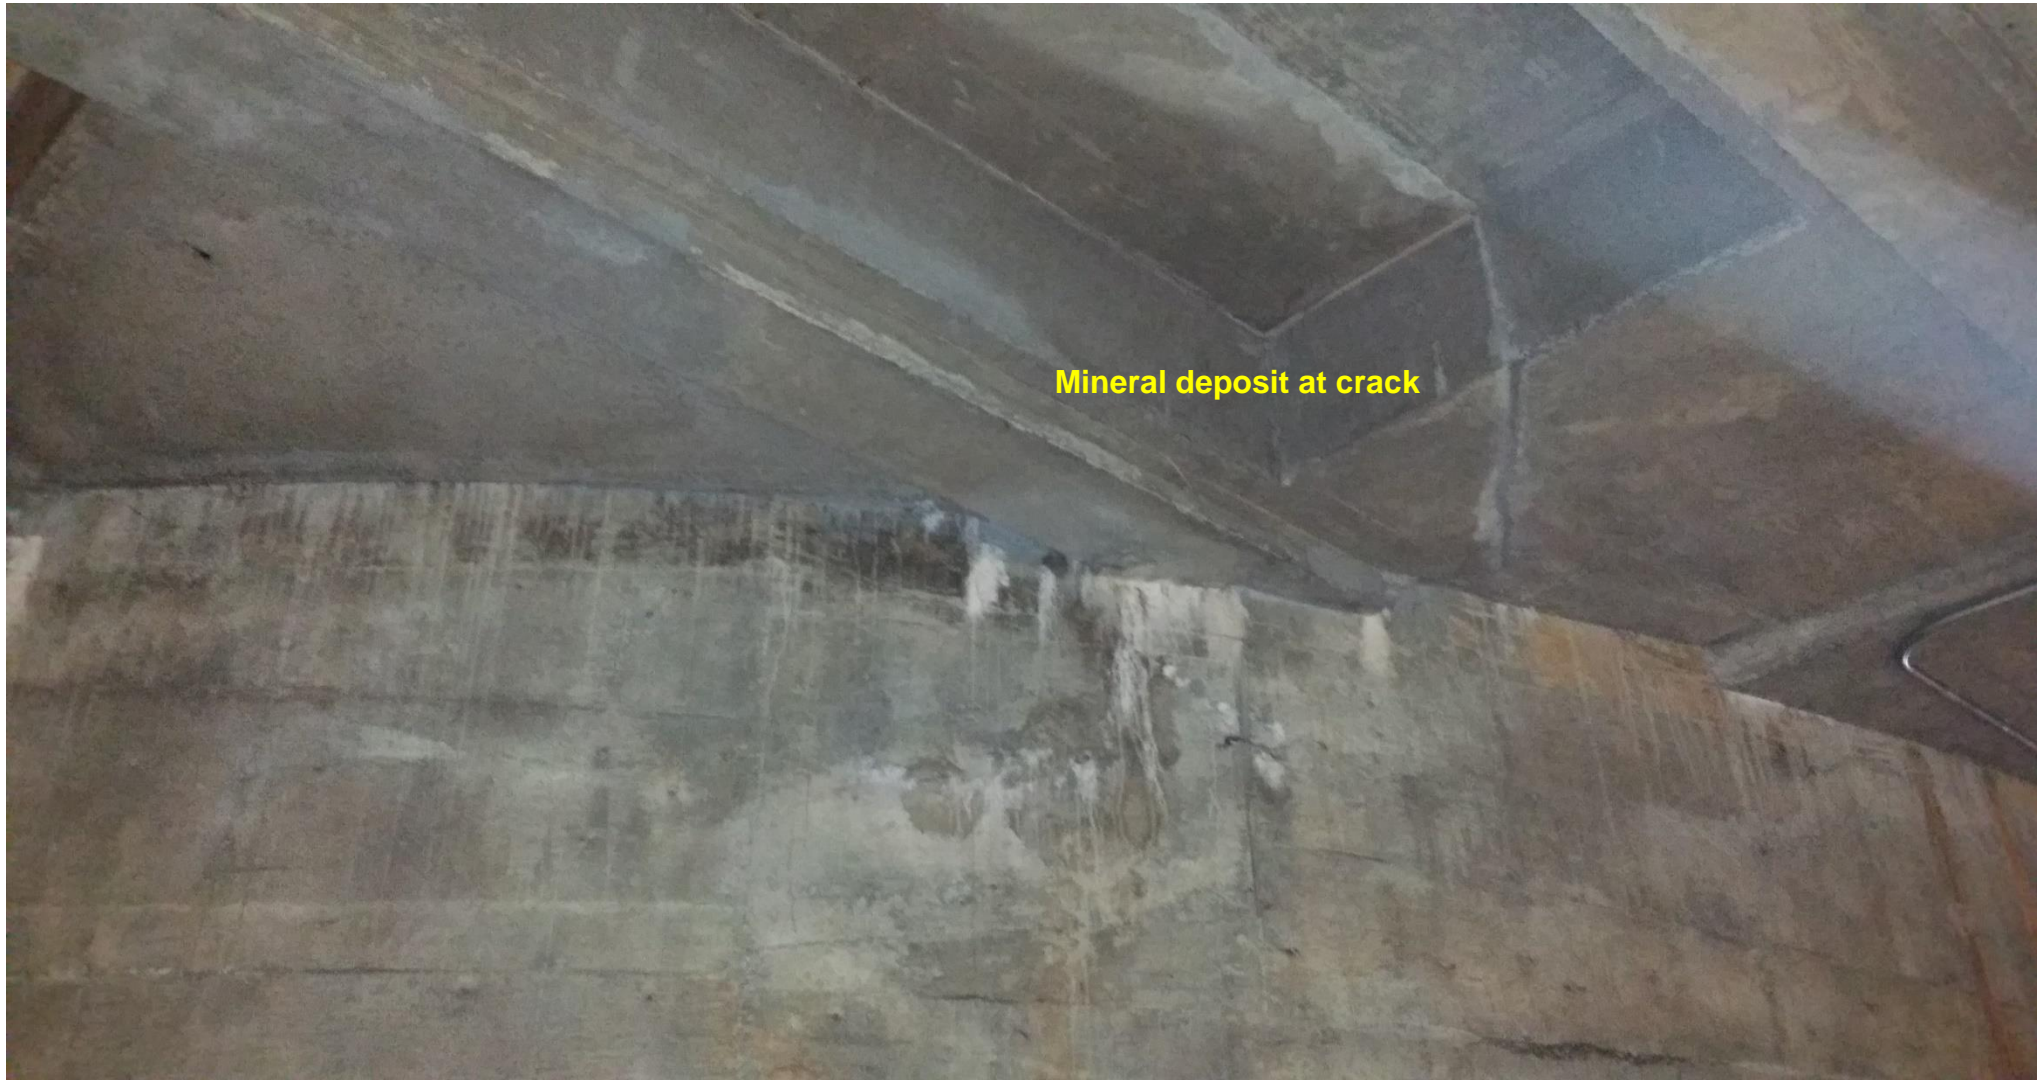
East Wall

Mineral deposit at crack

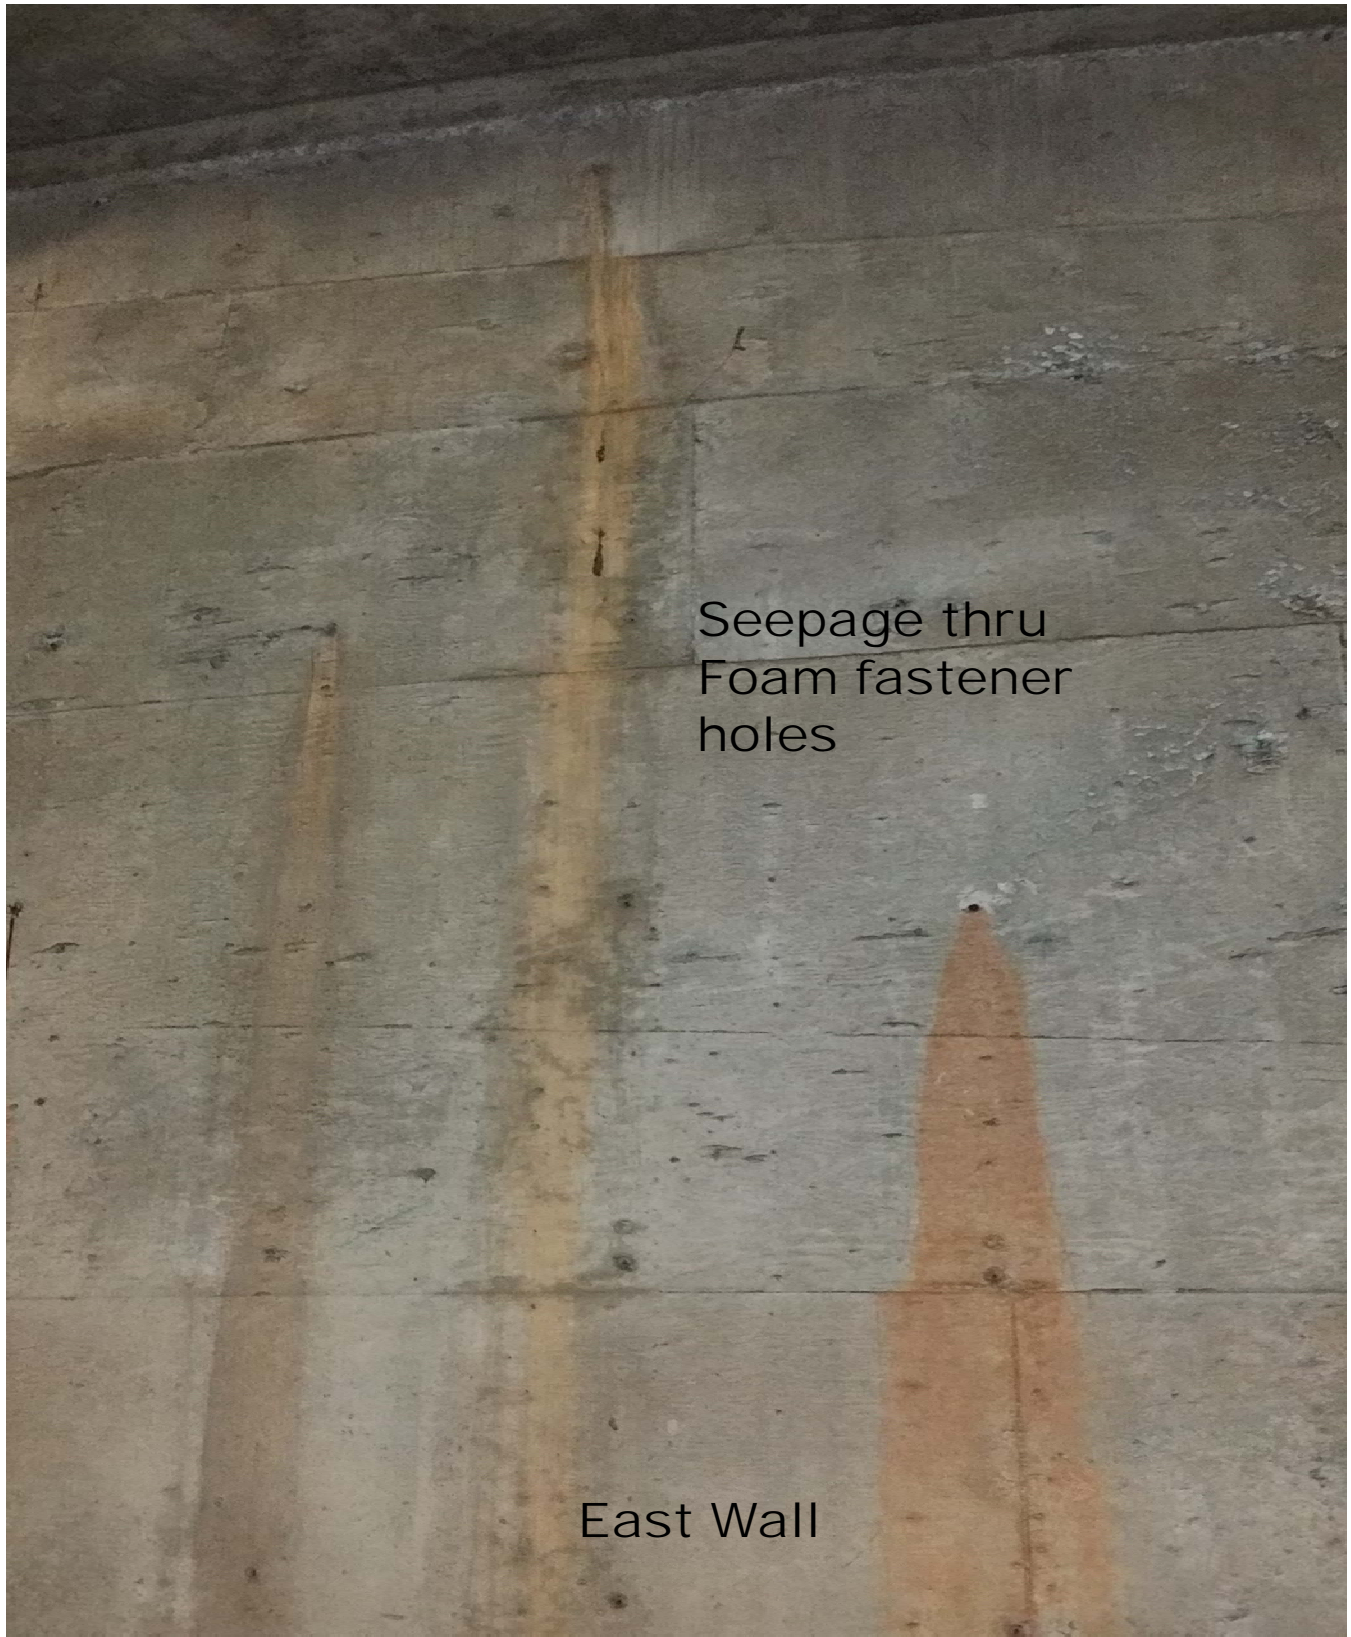
East Wall

Seepage thru
Foam fastener
holes

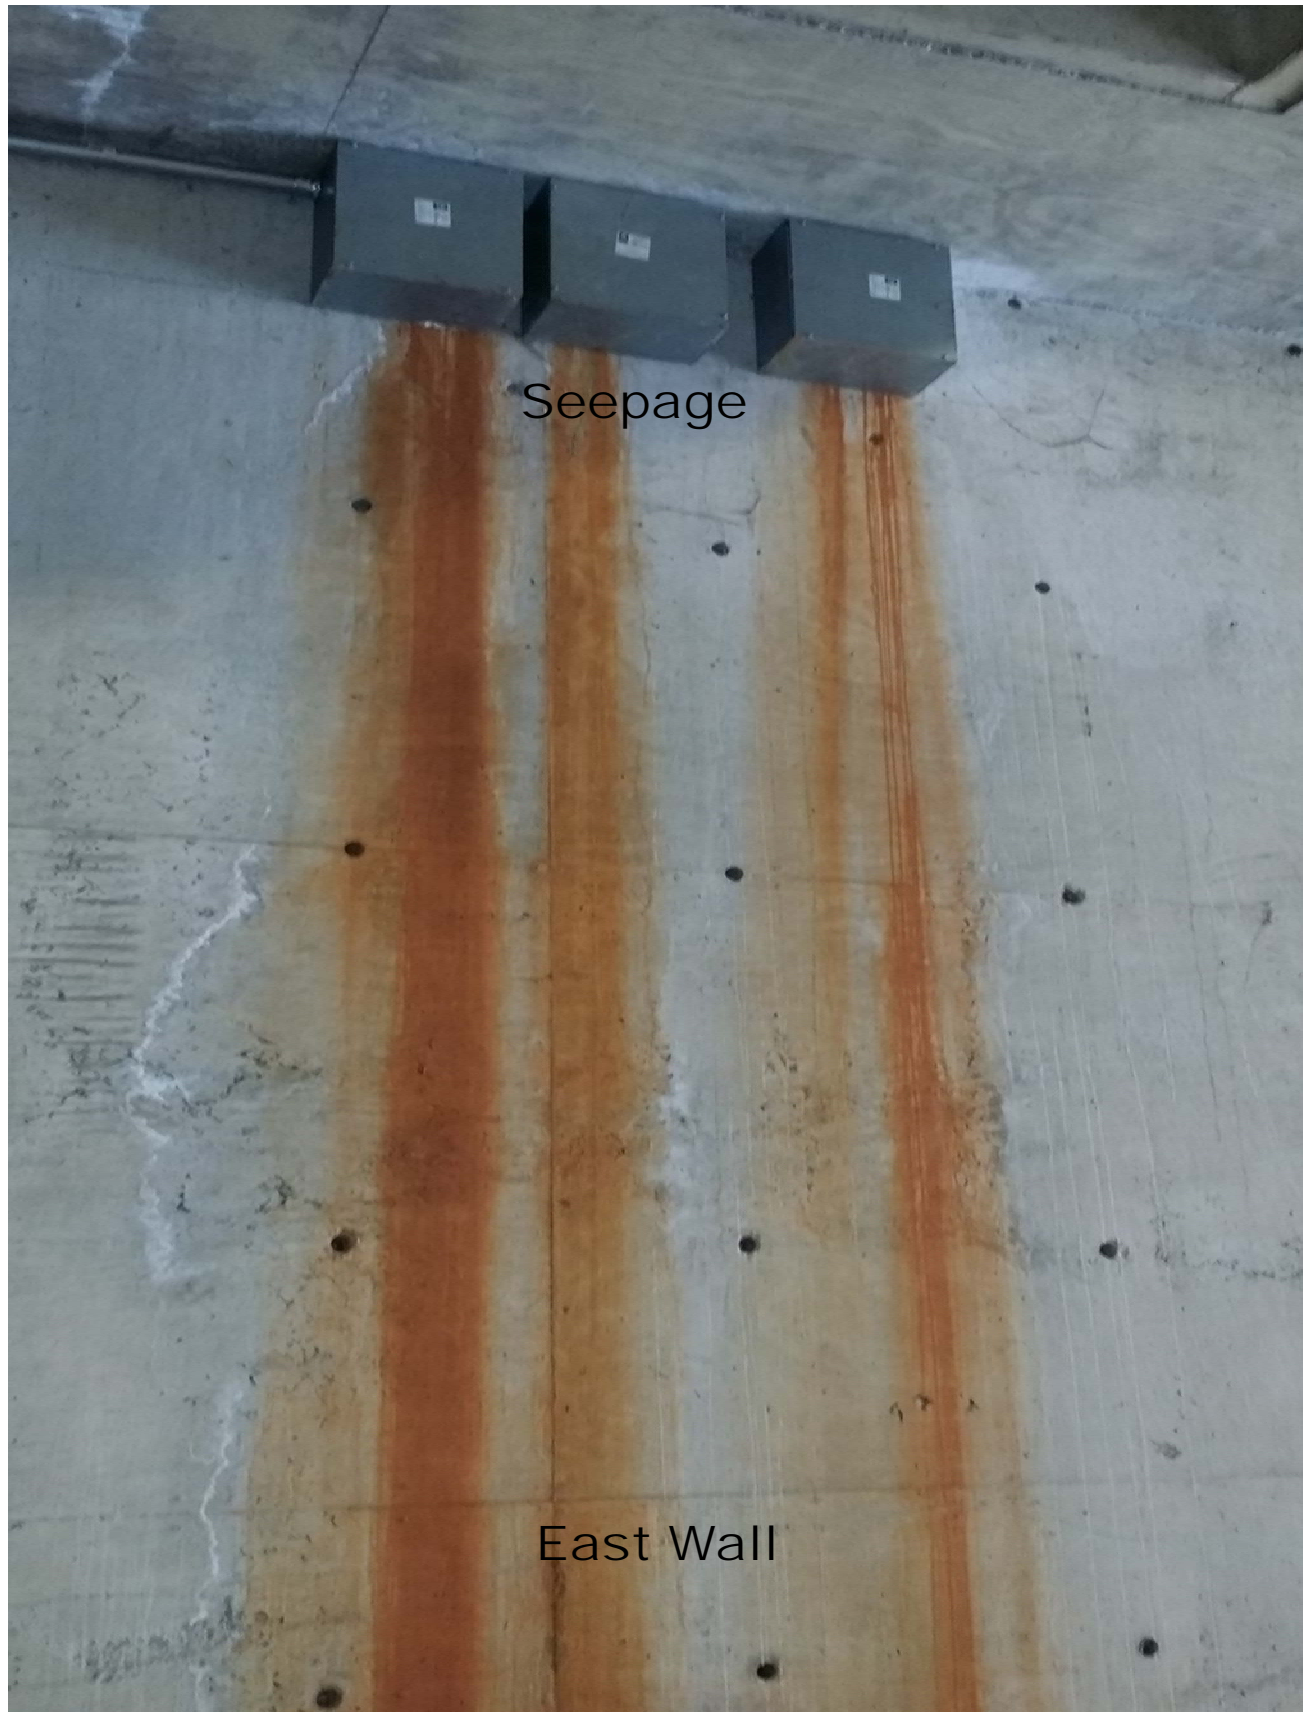
East Wall

Seepage

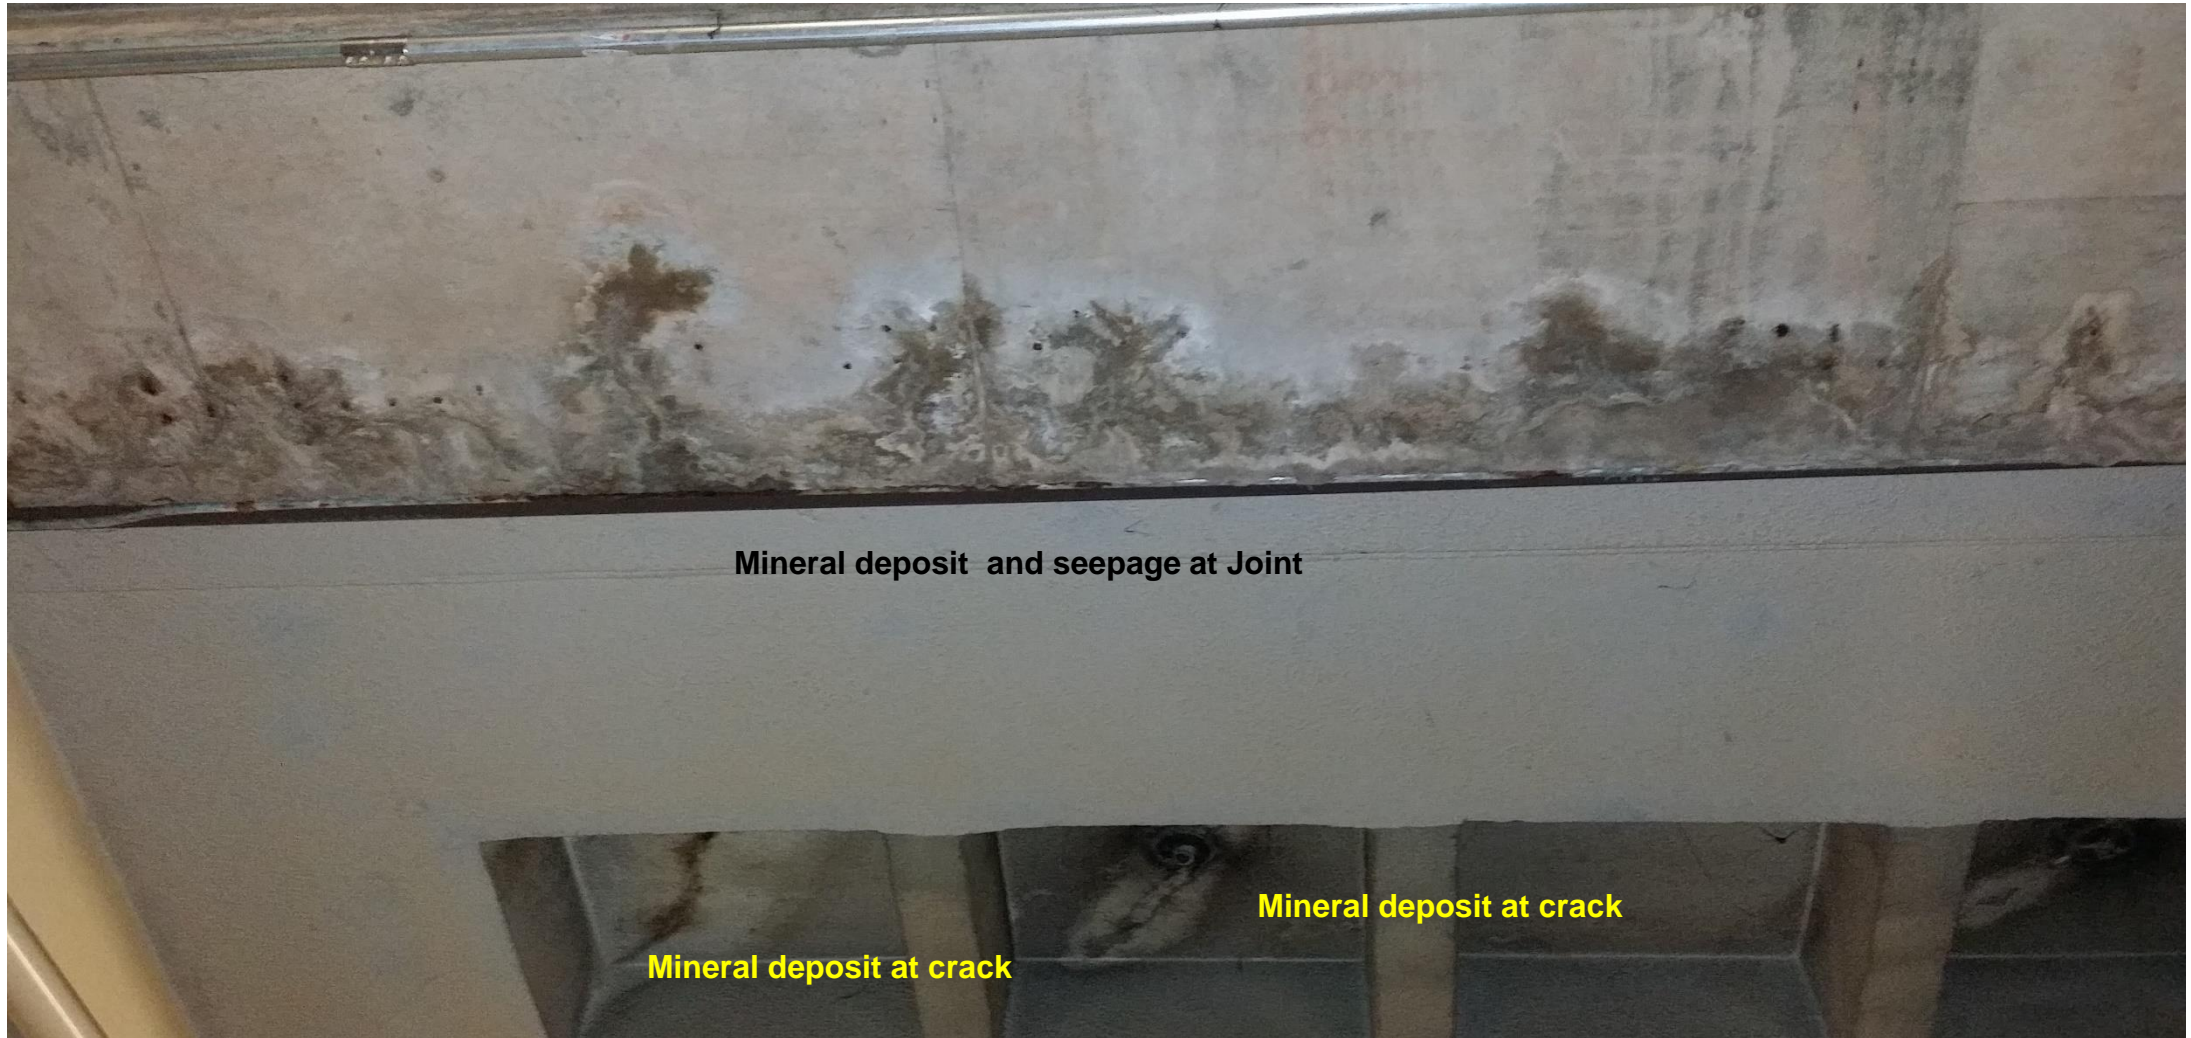
Coliseum Access Ceiling

Mineral deposit and seepage at Joint

Mineral deposit at crack

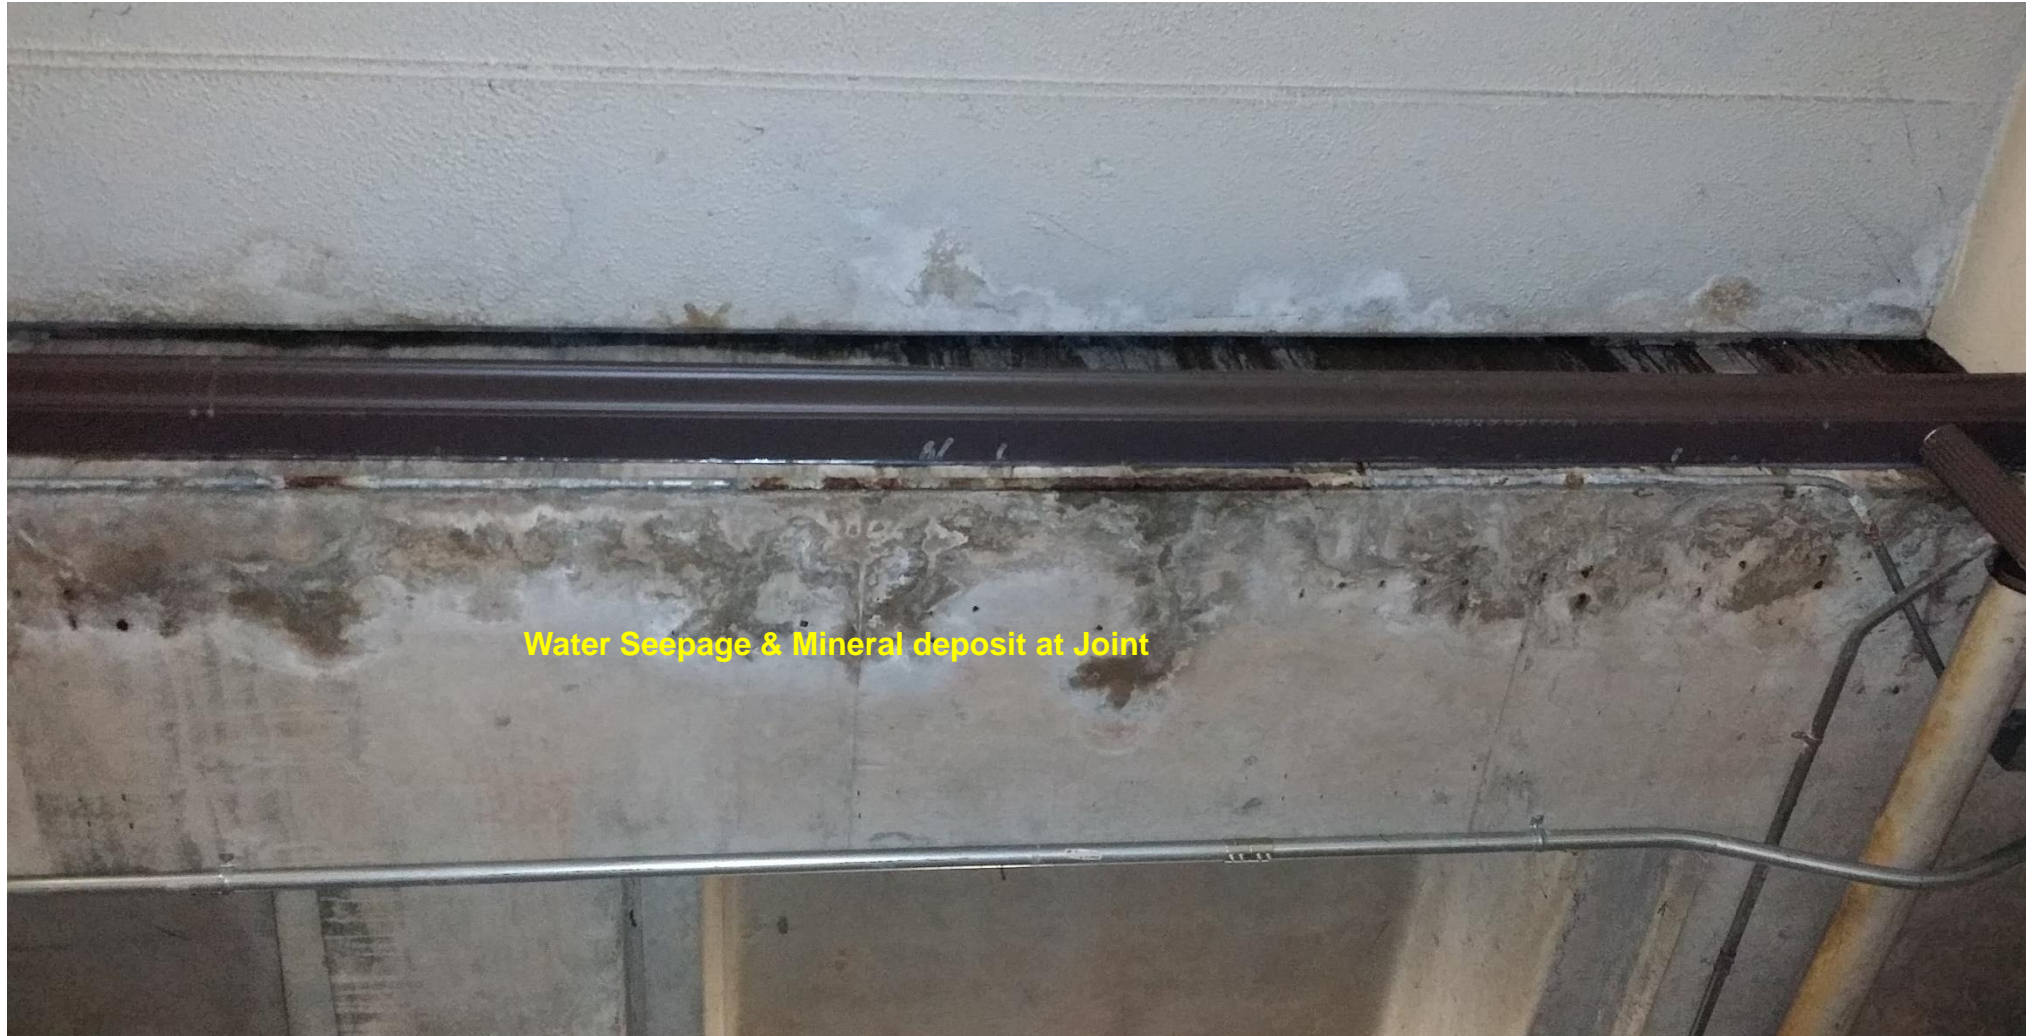
Coliseum Access Ceiling

Water Seepage & Mineral deposit at Joint

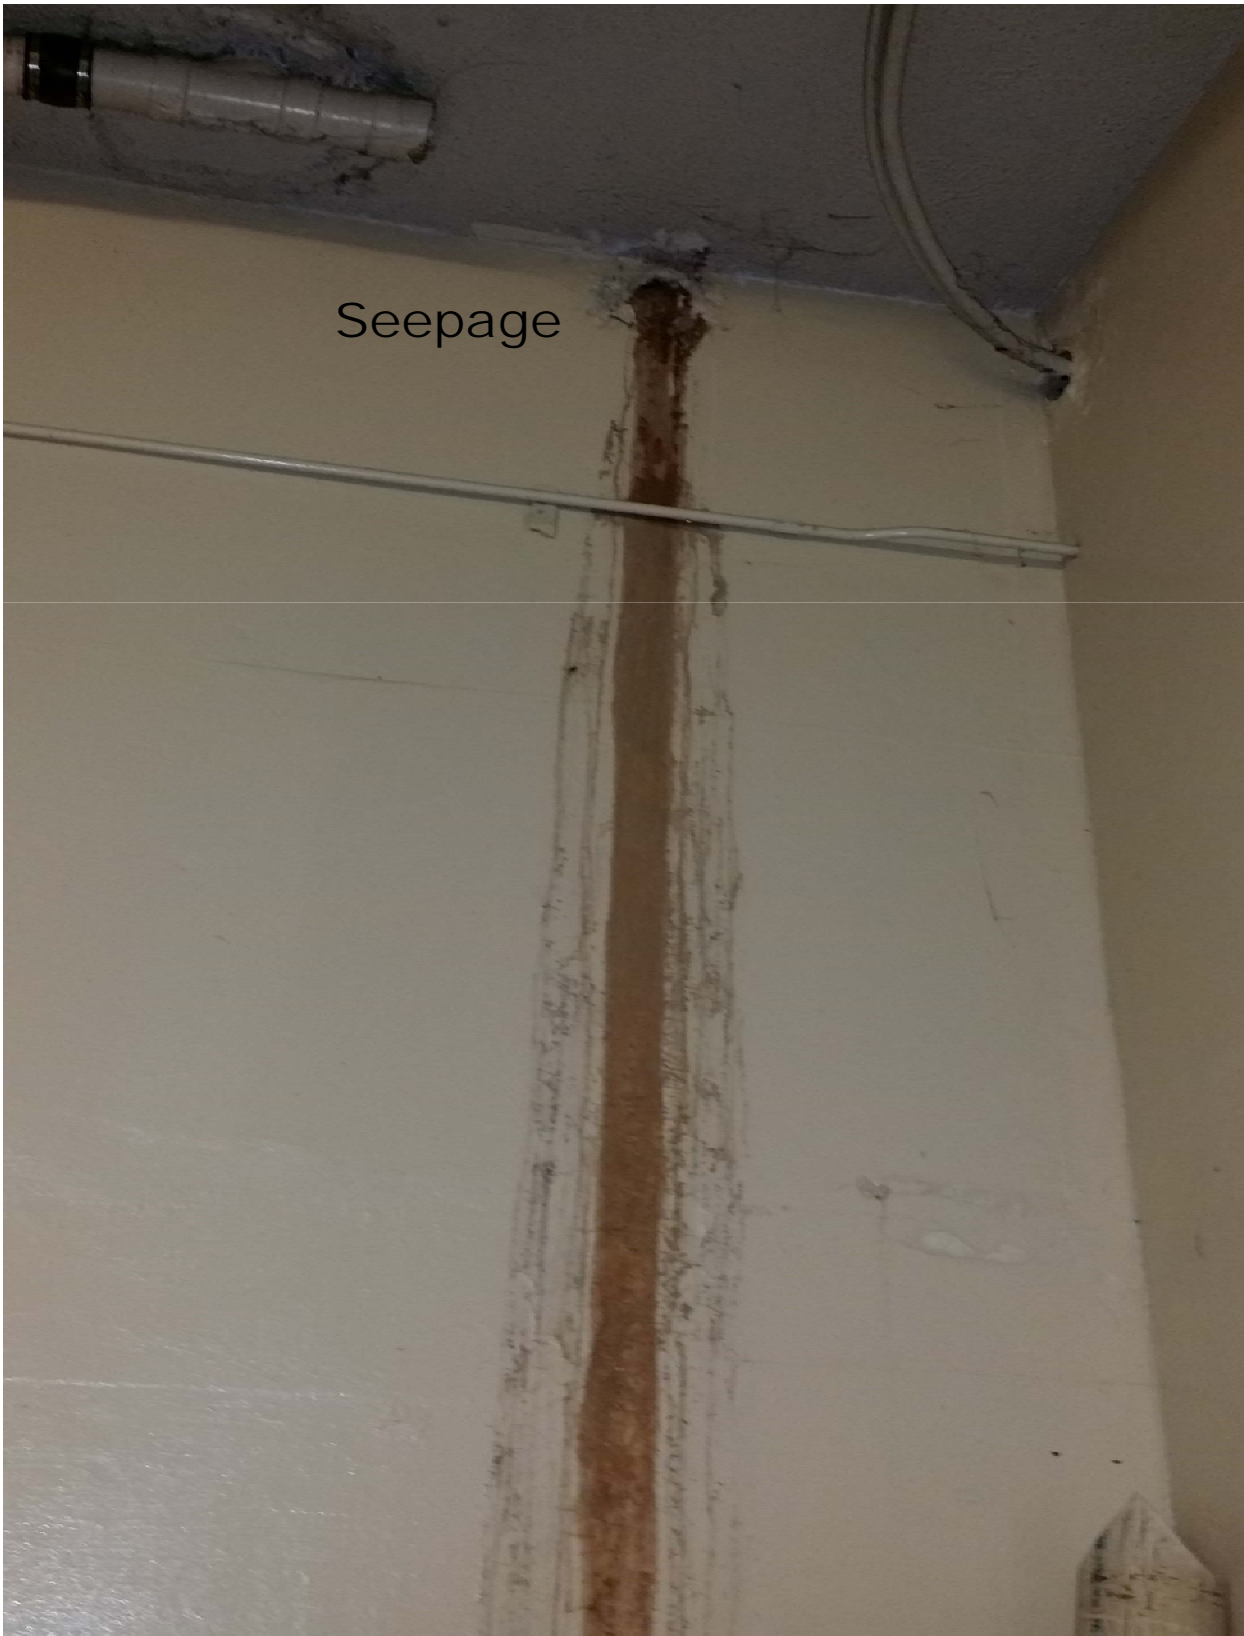
Coliseum Entrance

Seepage

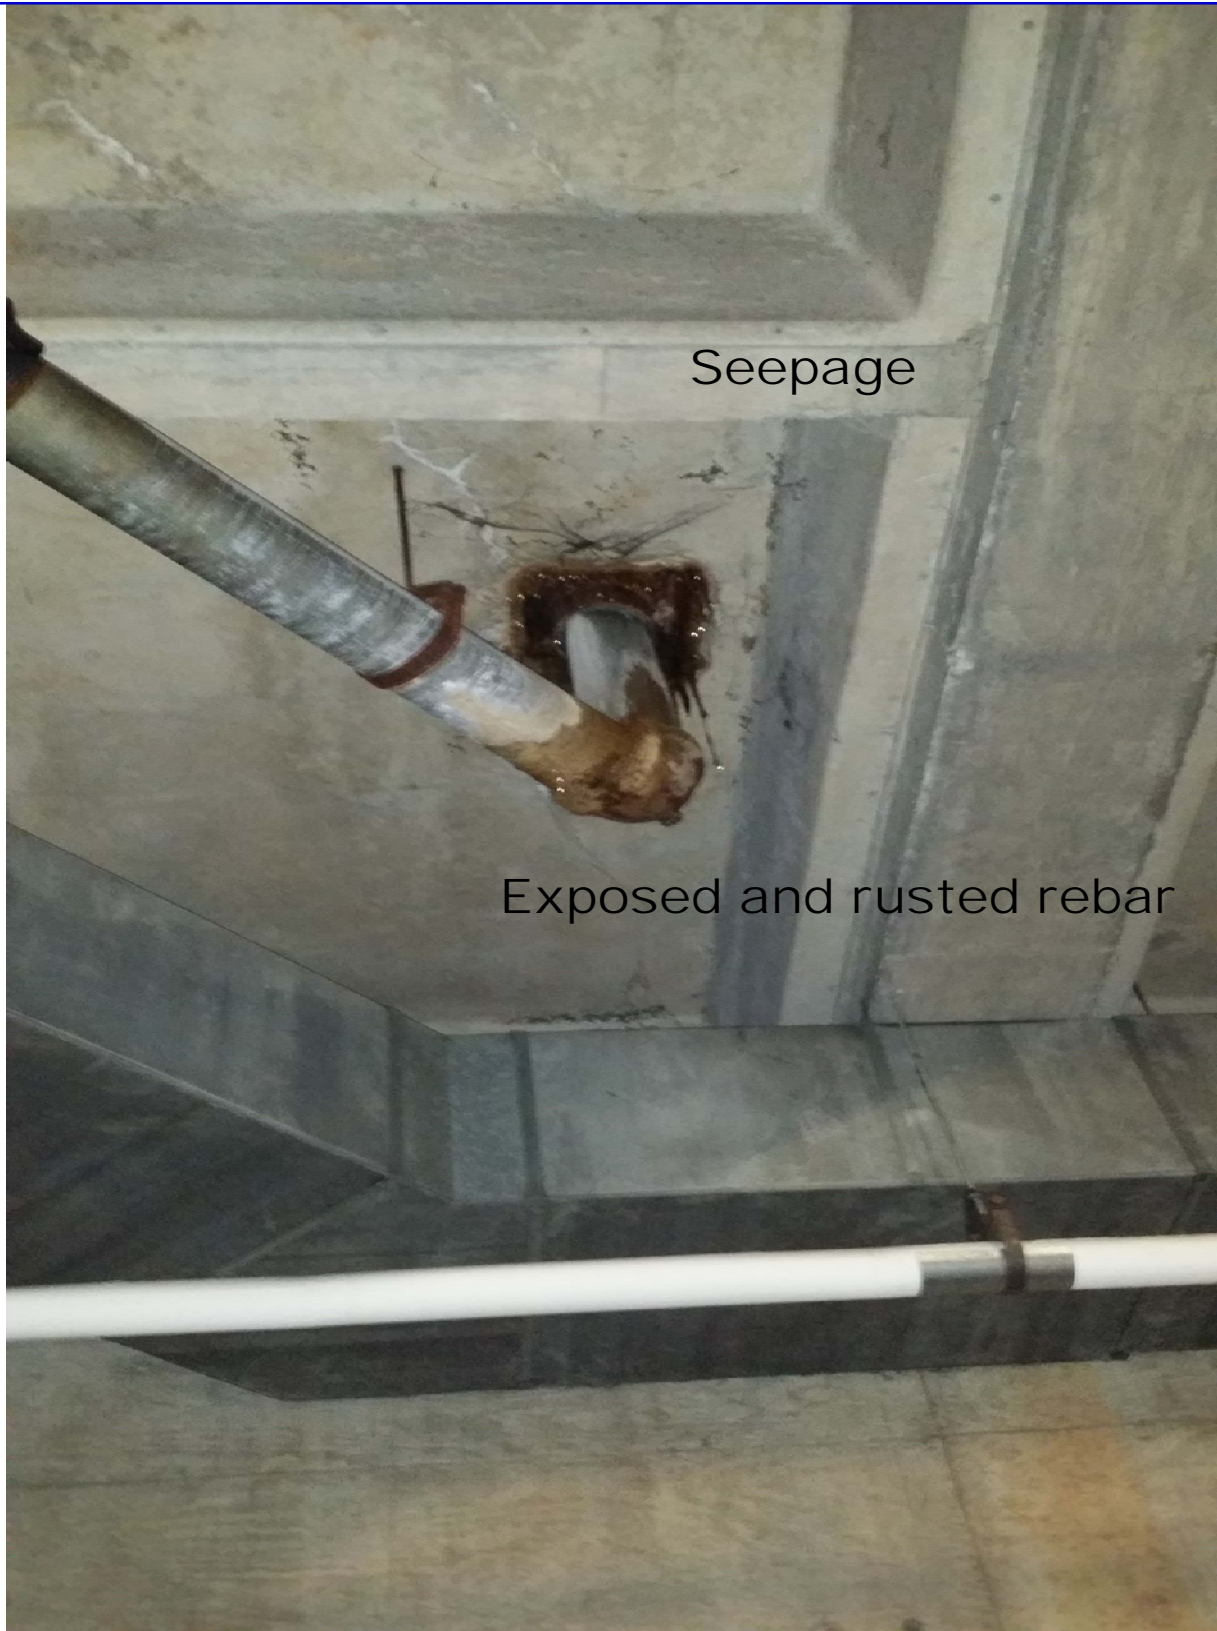
Coliseum Entrance Ceiling

Seepage

Exposed and rusted rebar

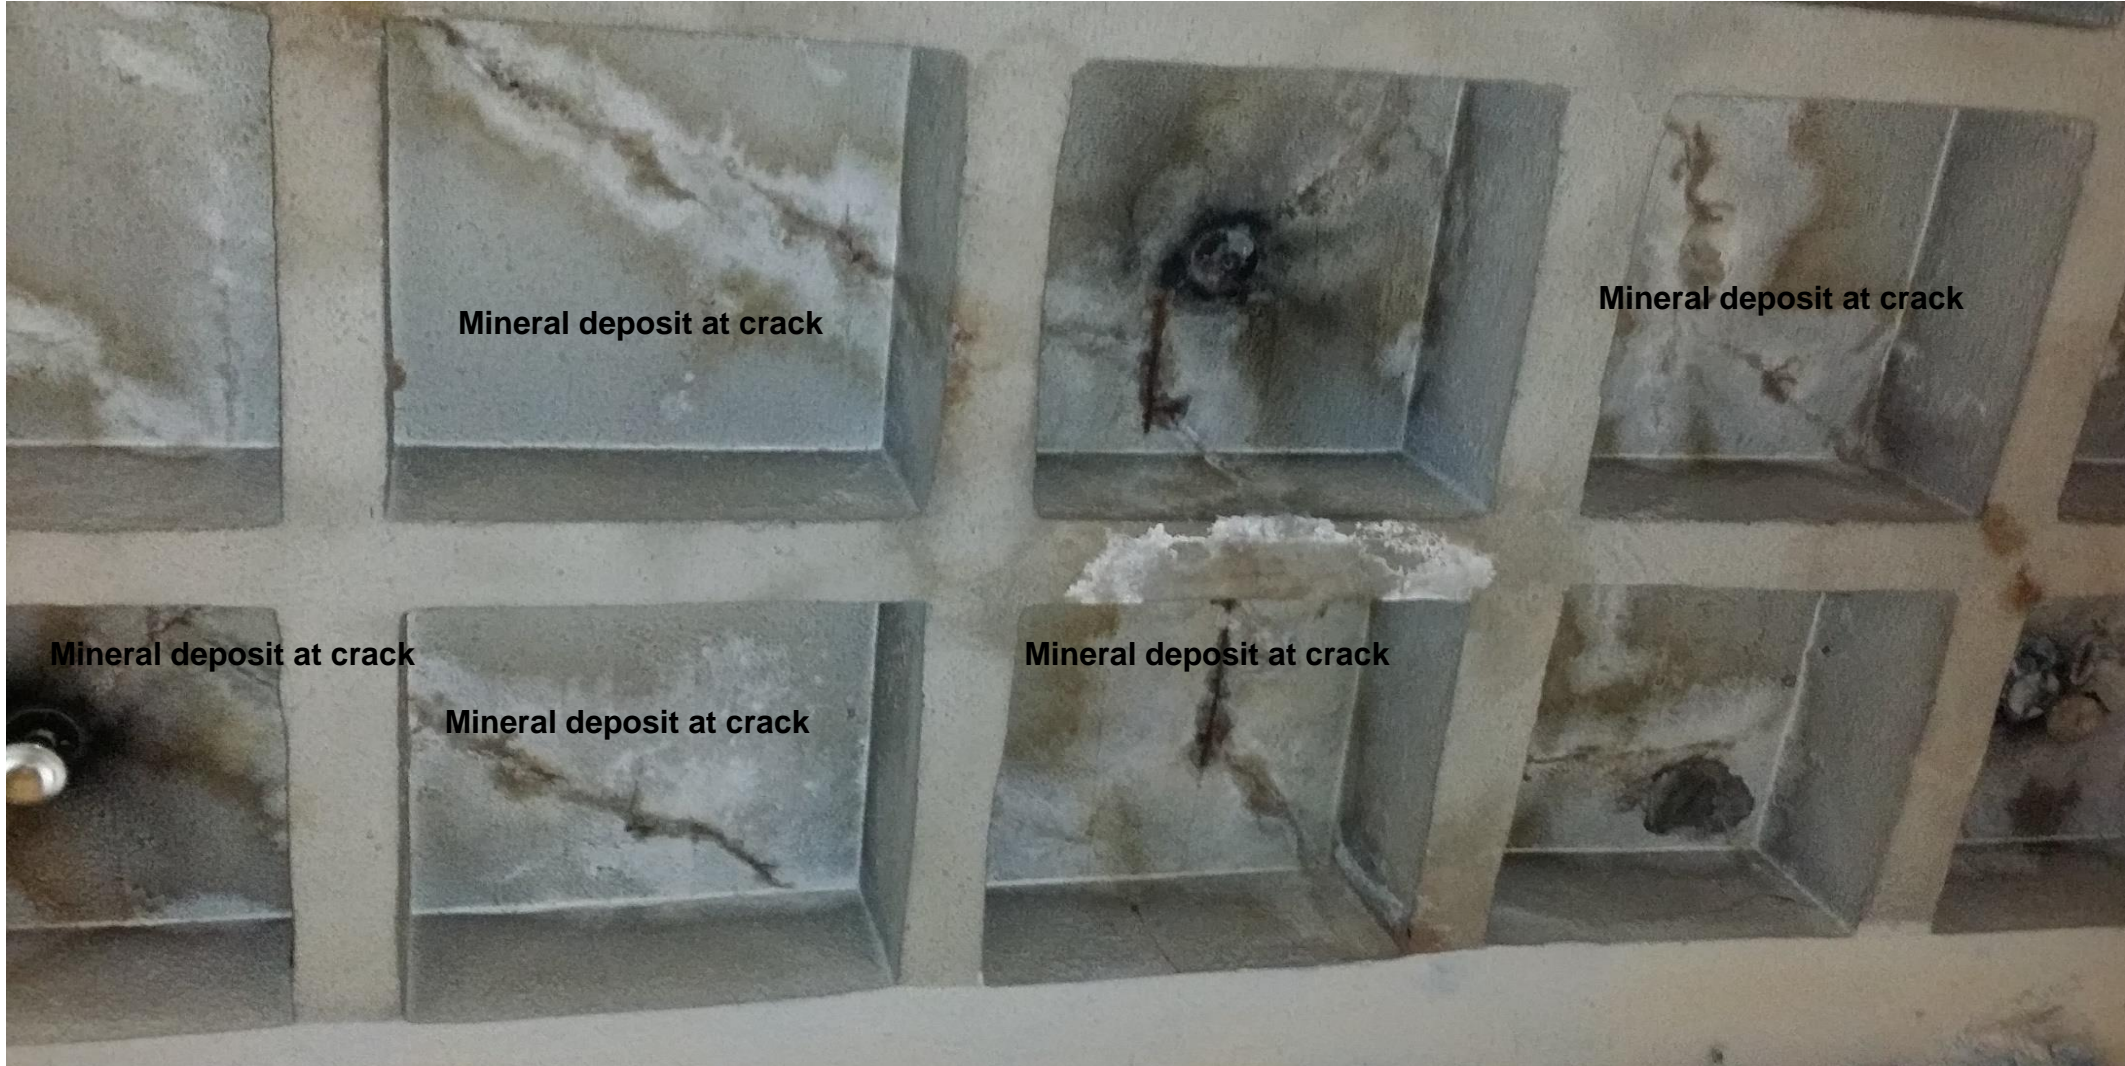
Coliseum Access Ceiling

Mineral deposit at crack

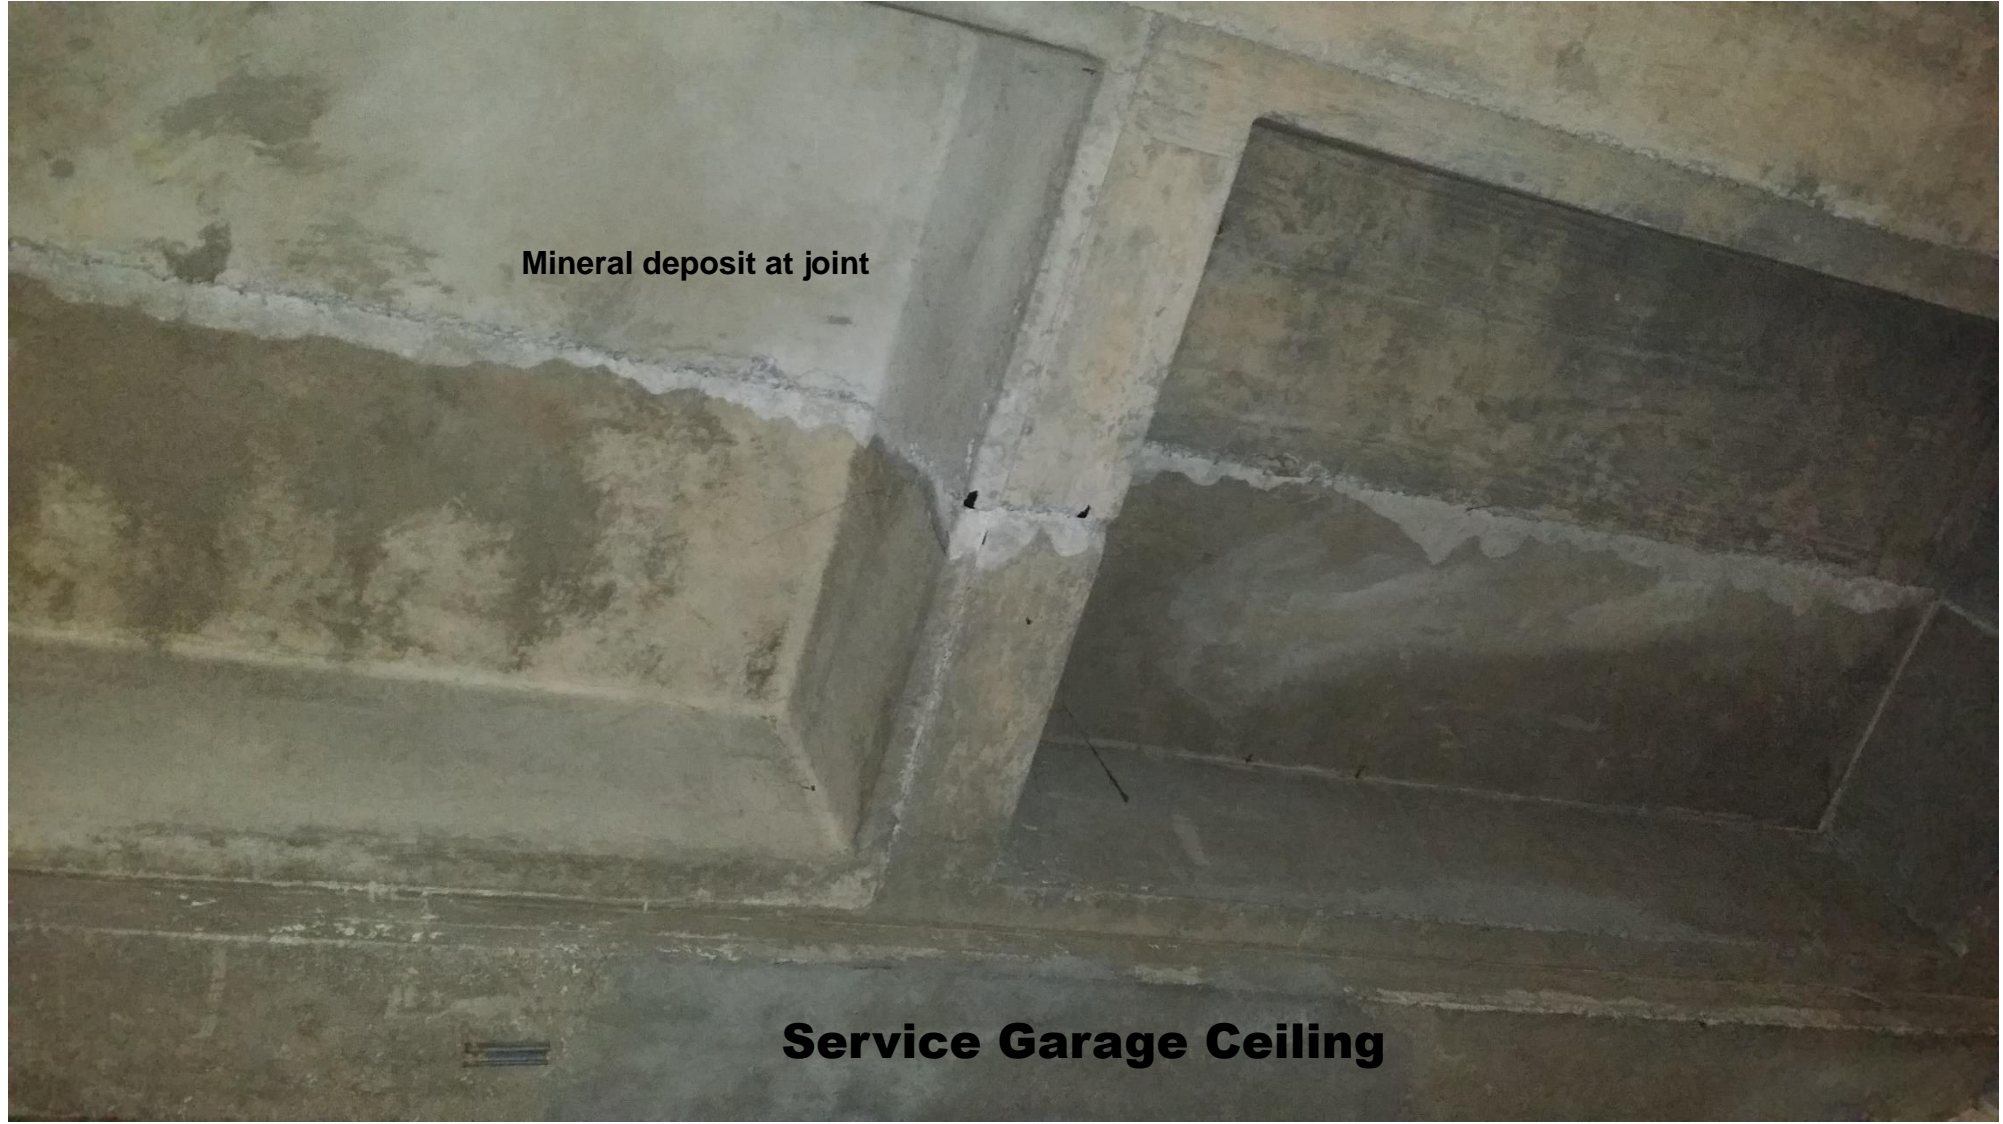
Service Garage Ceiling

Mineral deposit at joint

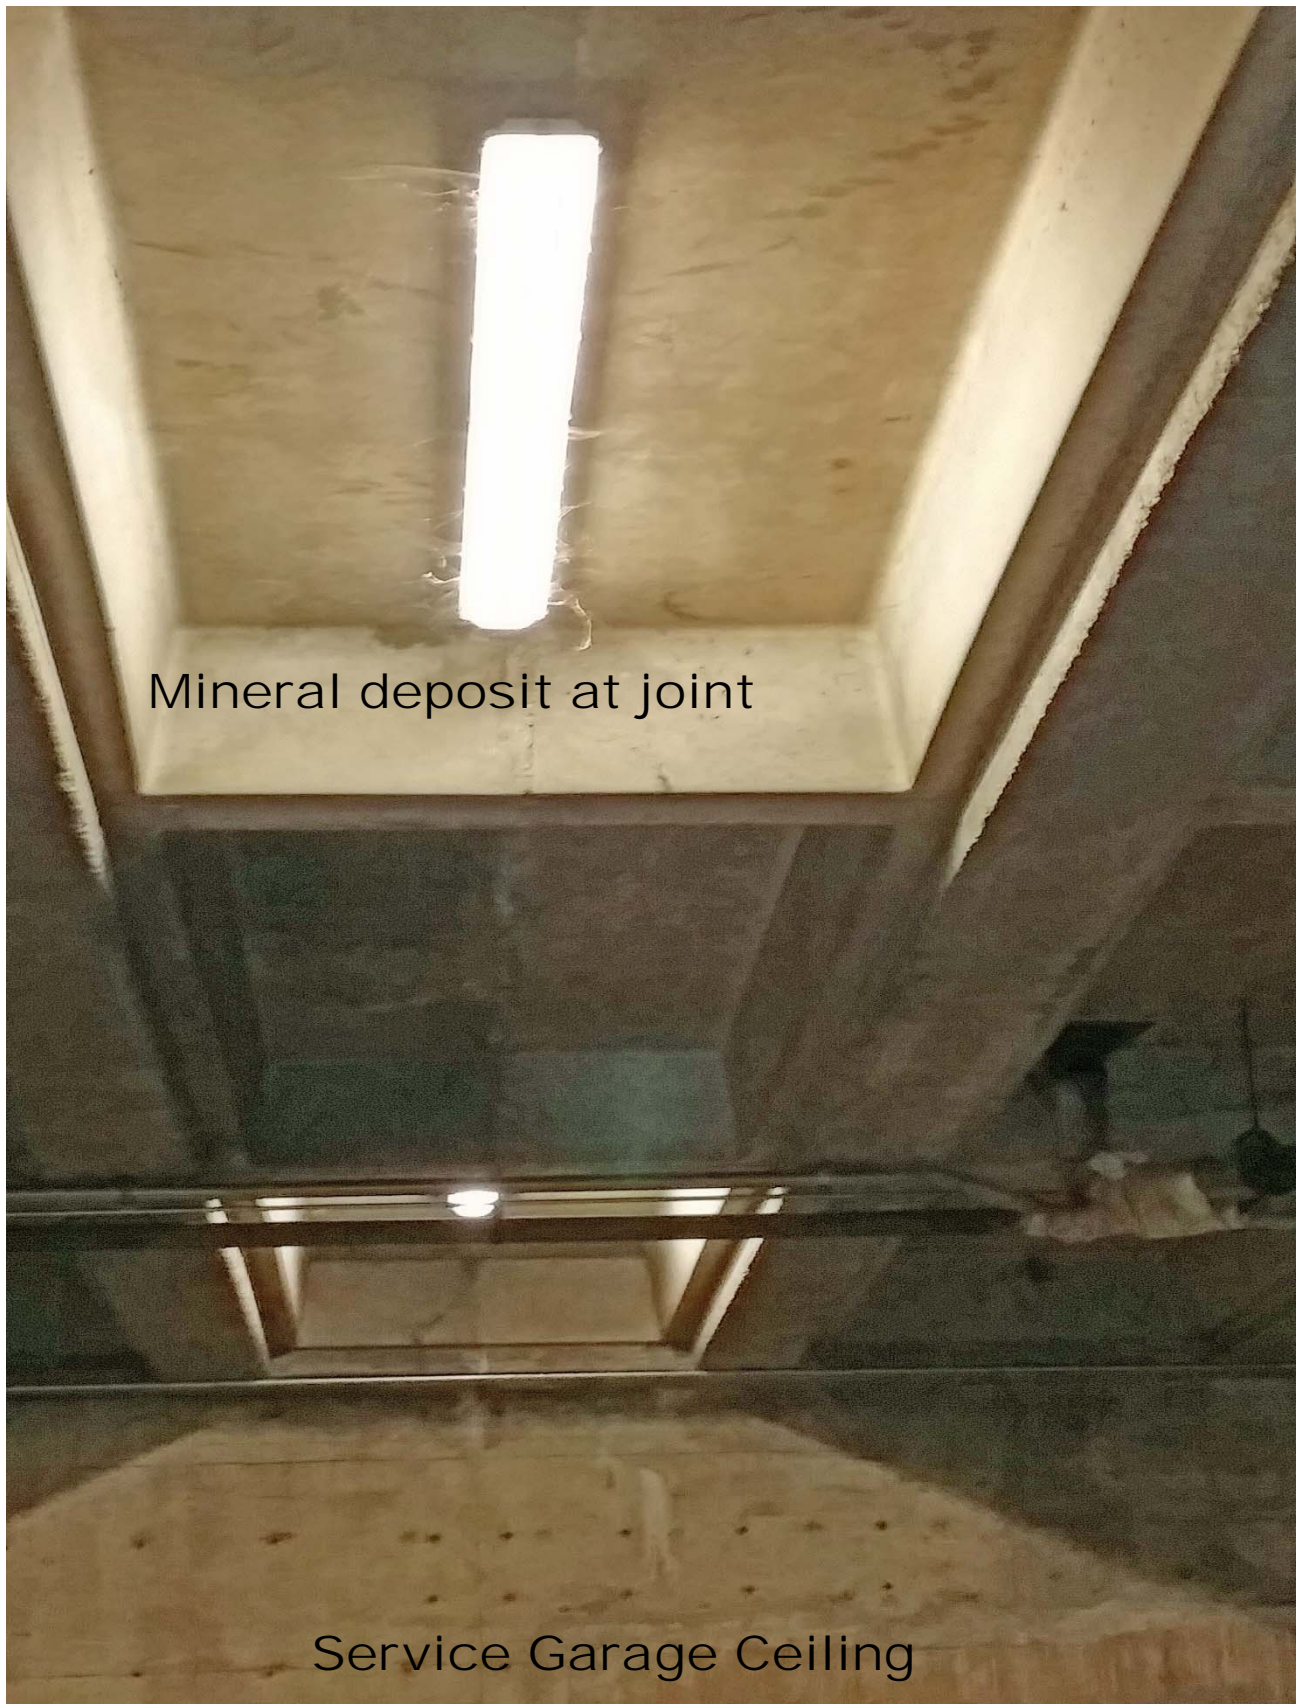
Service Garage Ceiling

Mineral deposit at joint
