FACILITY ASSESSMENT REPORT

APPENDIX D

Appendix D Service Garage

Knoxville Civic Auditorium and Coliseum Assessment

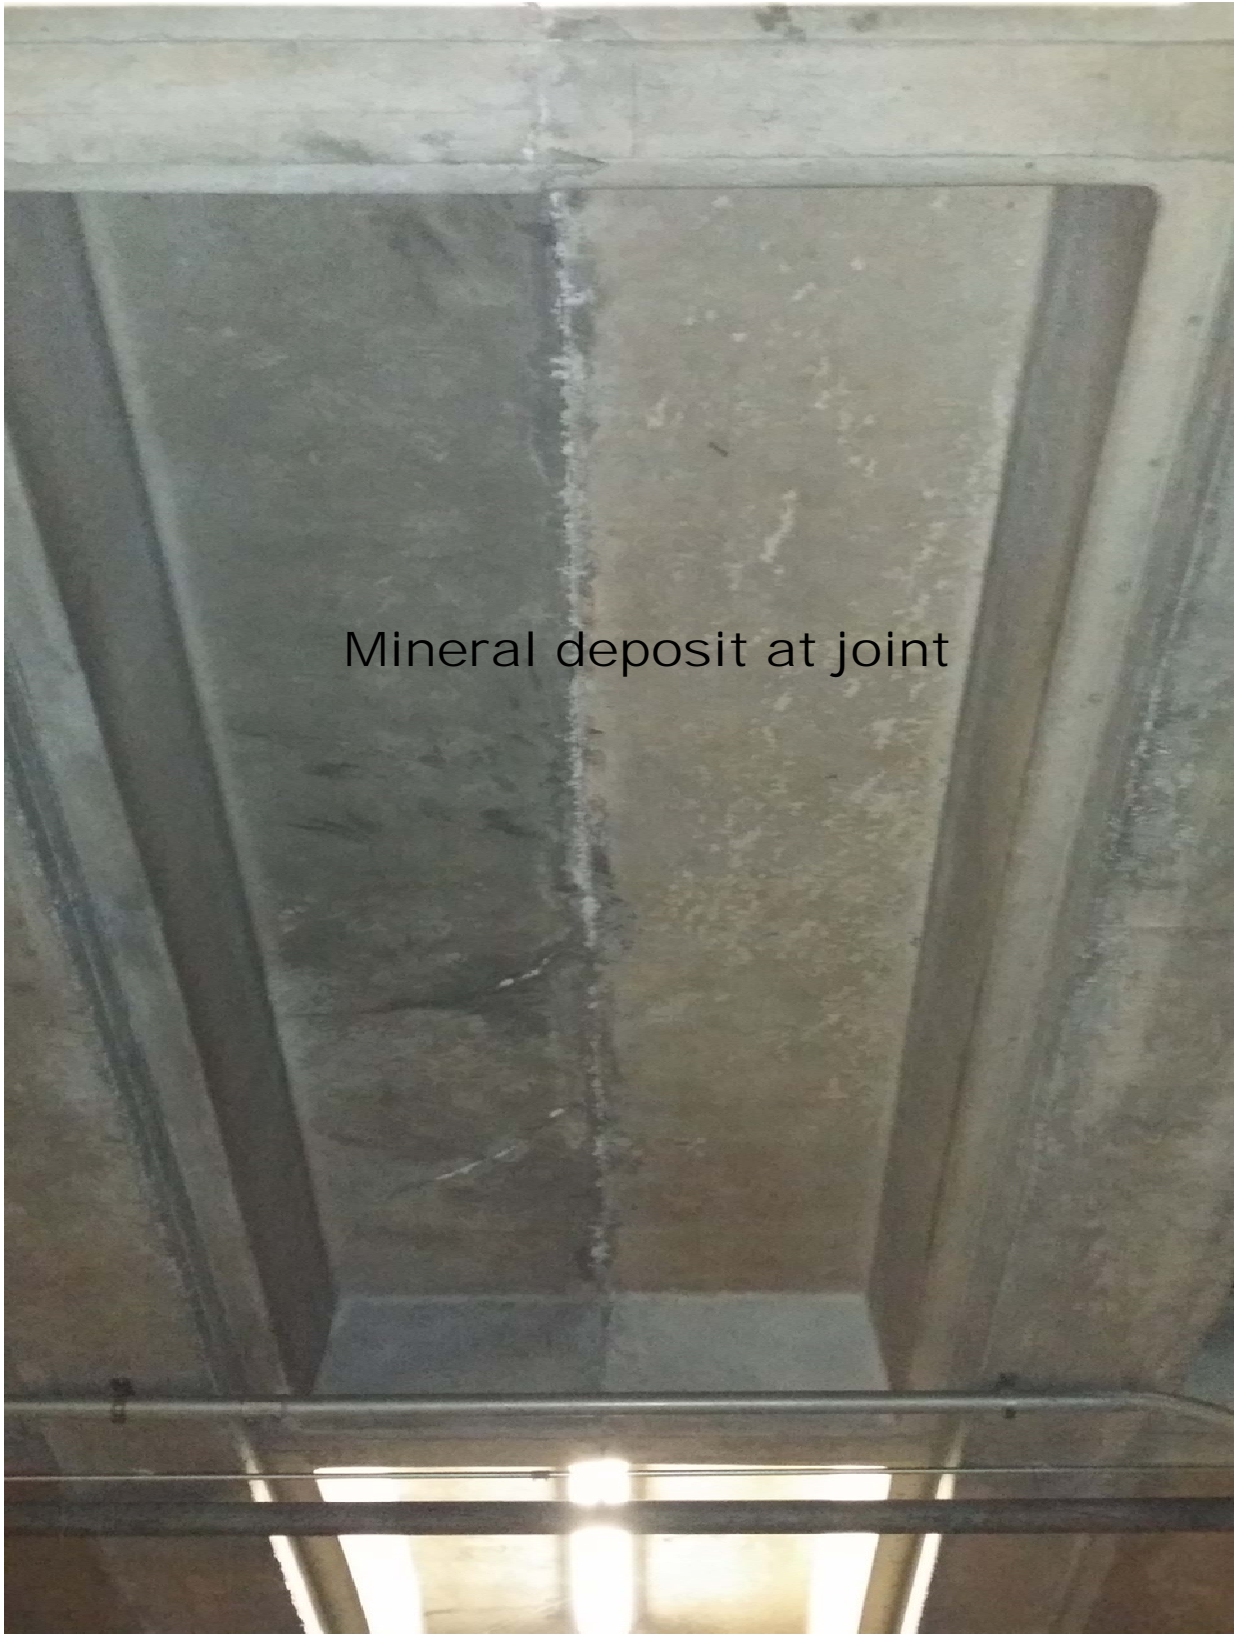
Service Garage Ceiling

Mineral deposit at joint

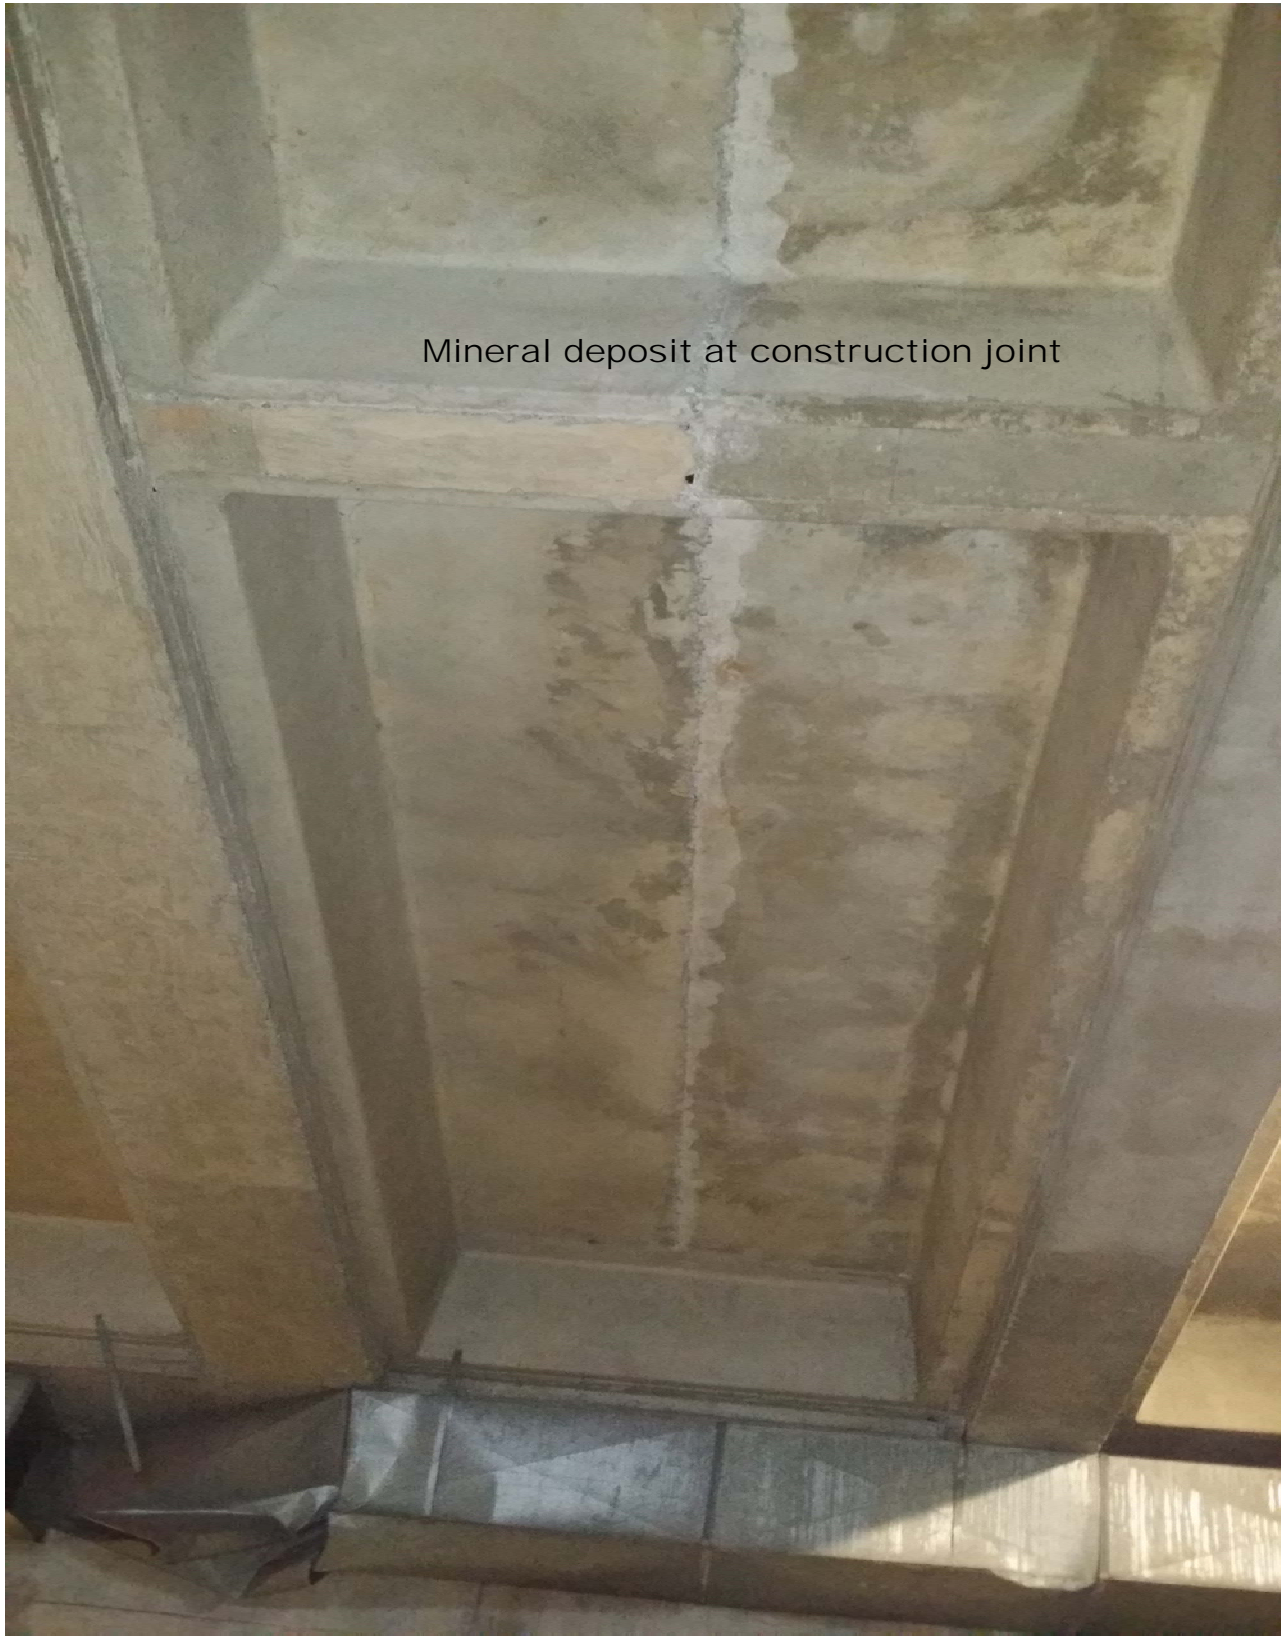
Service Garage Ceiling

Mineral deposit at construction joint

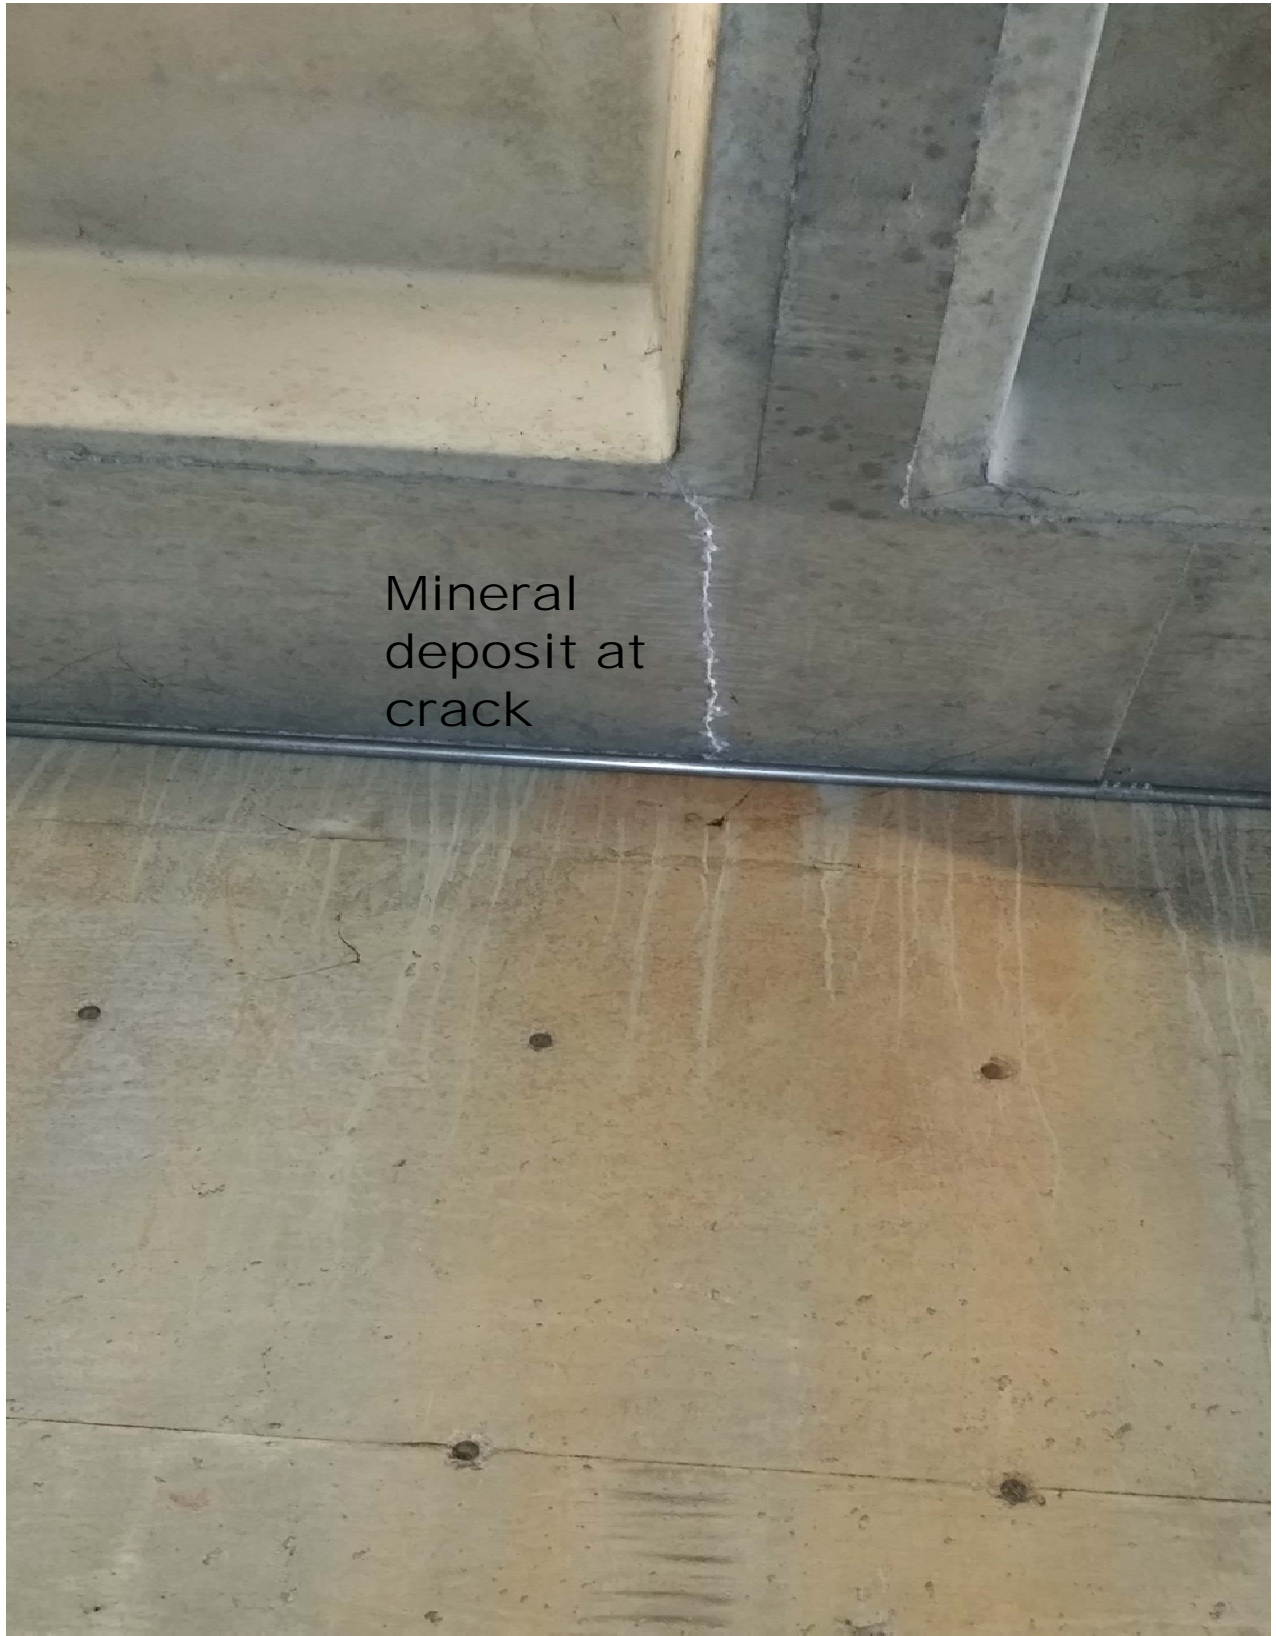
Service Garage Ceiling

Mineral
deposit at
crack

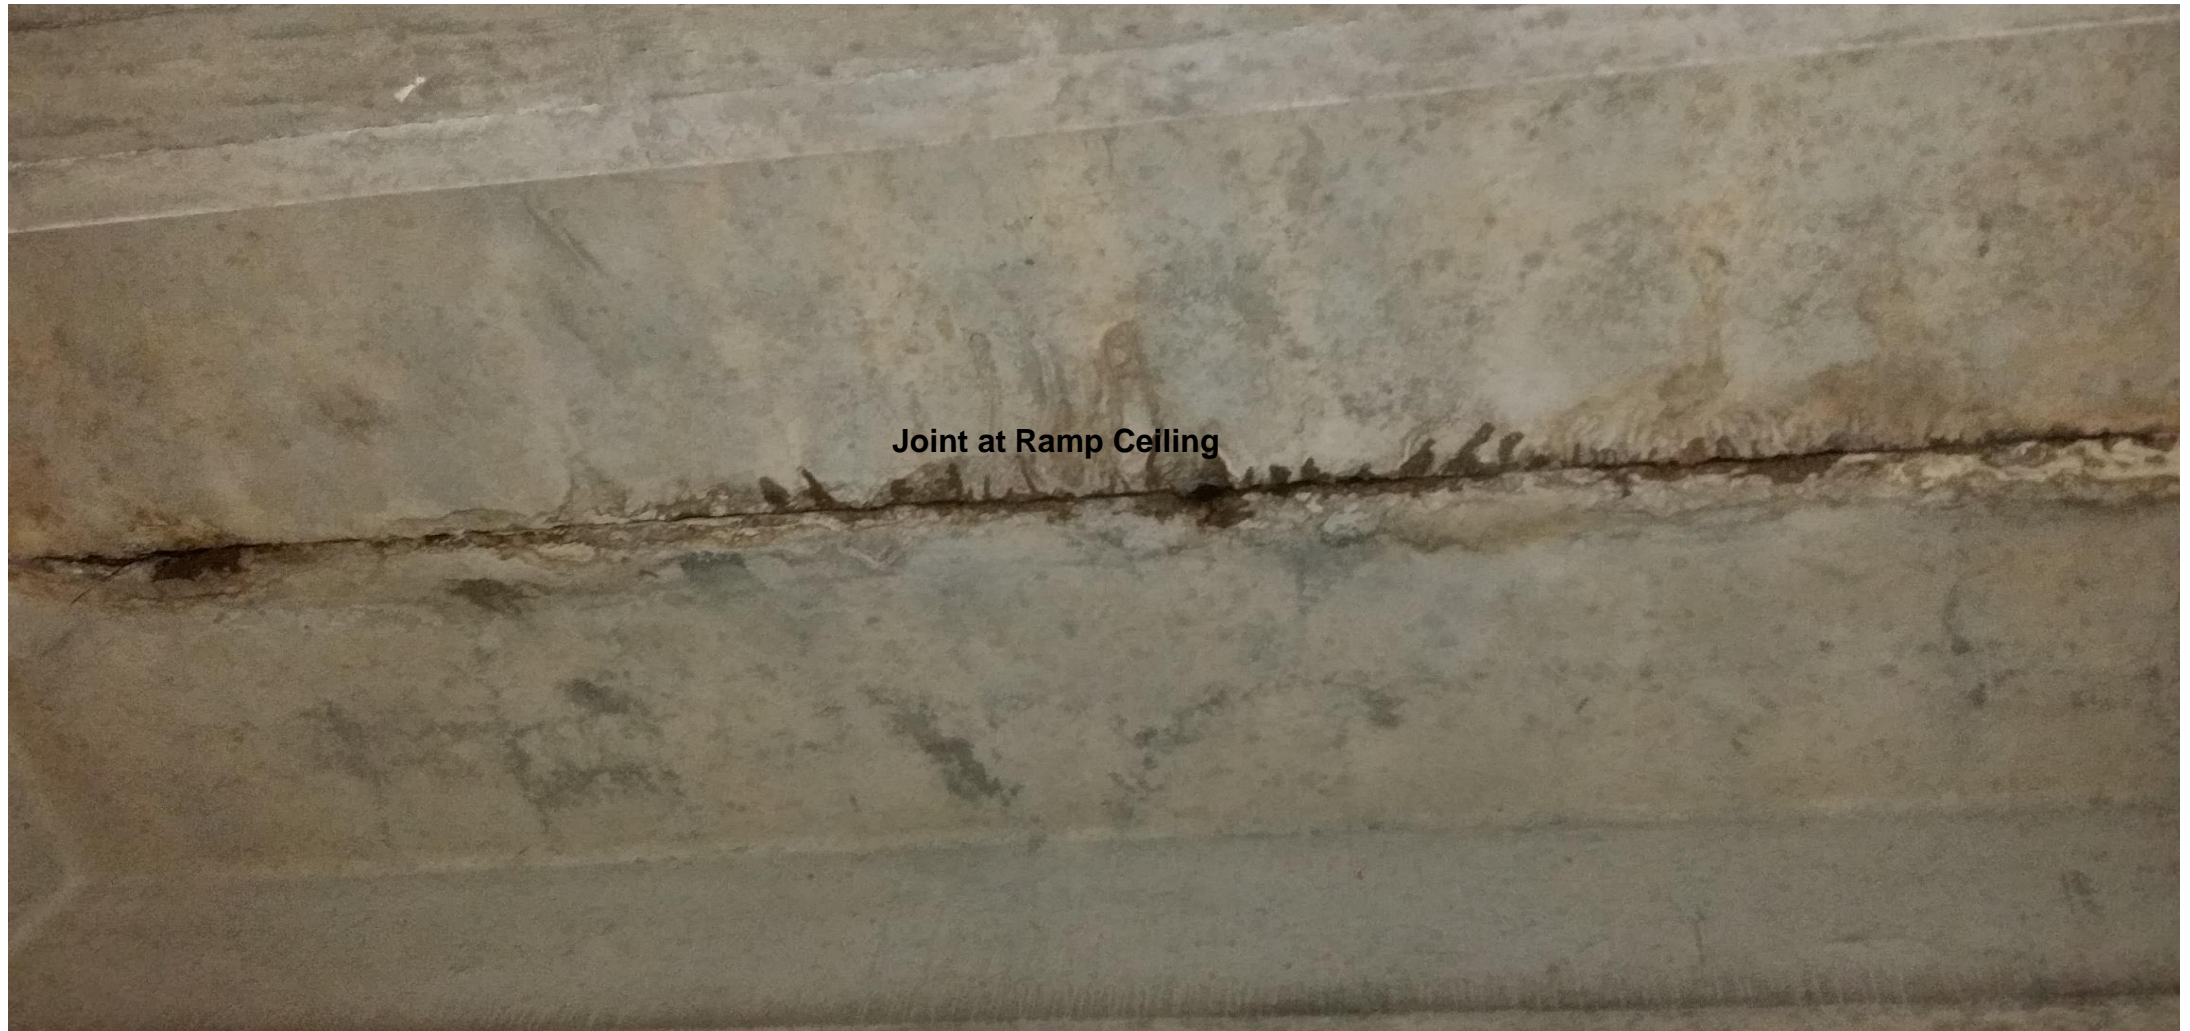
Joint at Ramp Ceiling

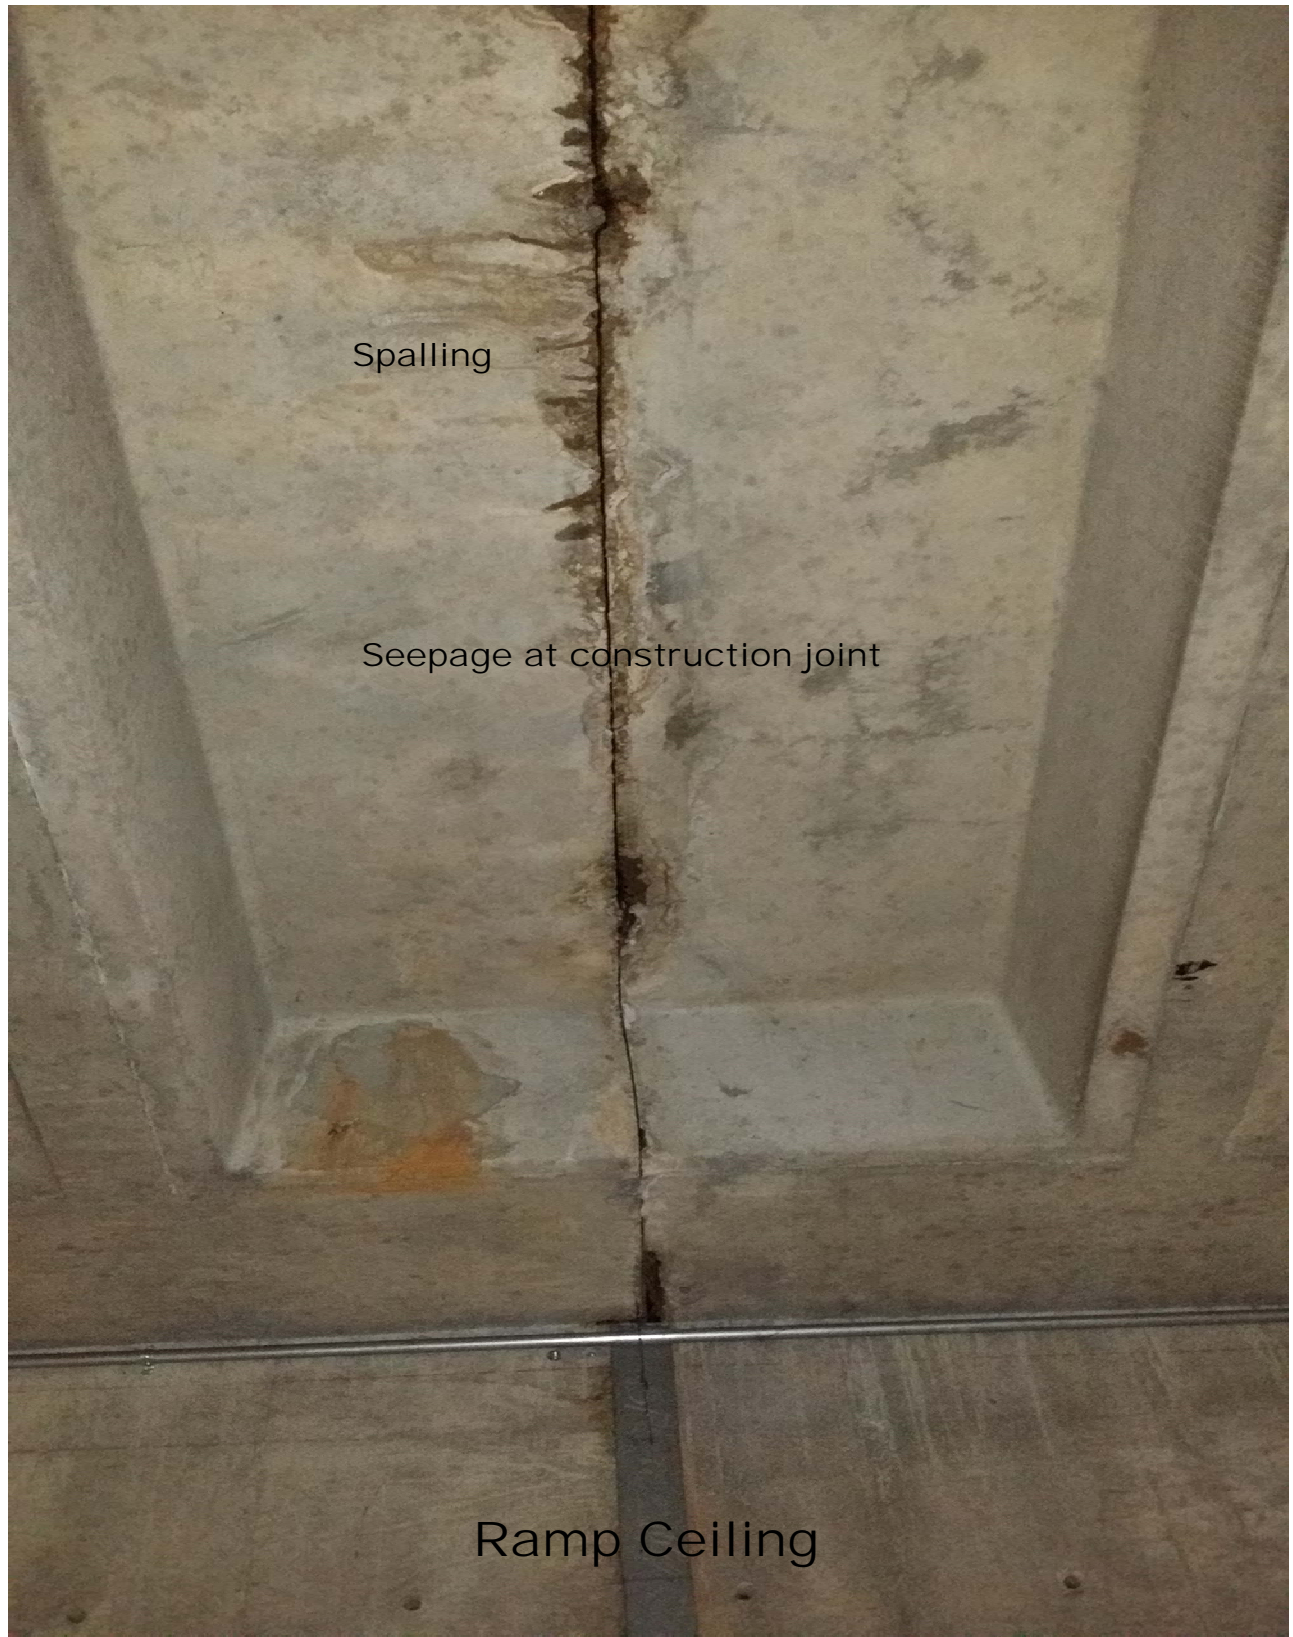
Ramp Ceiling

Spalling

Seepage at construction joint

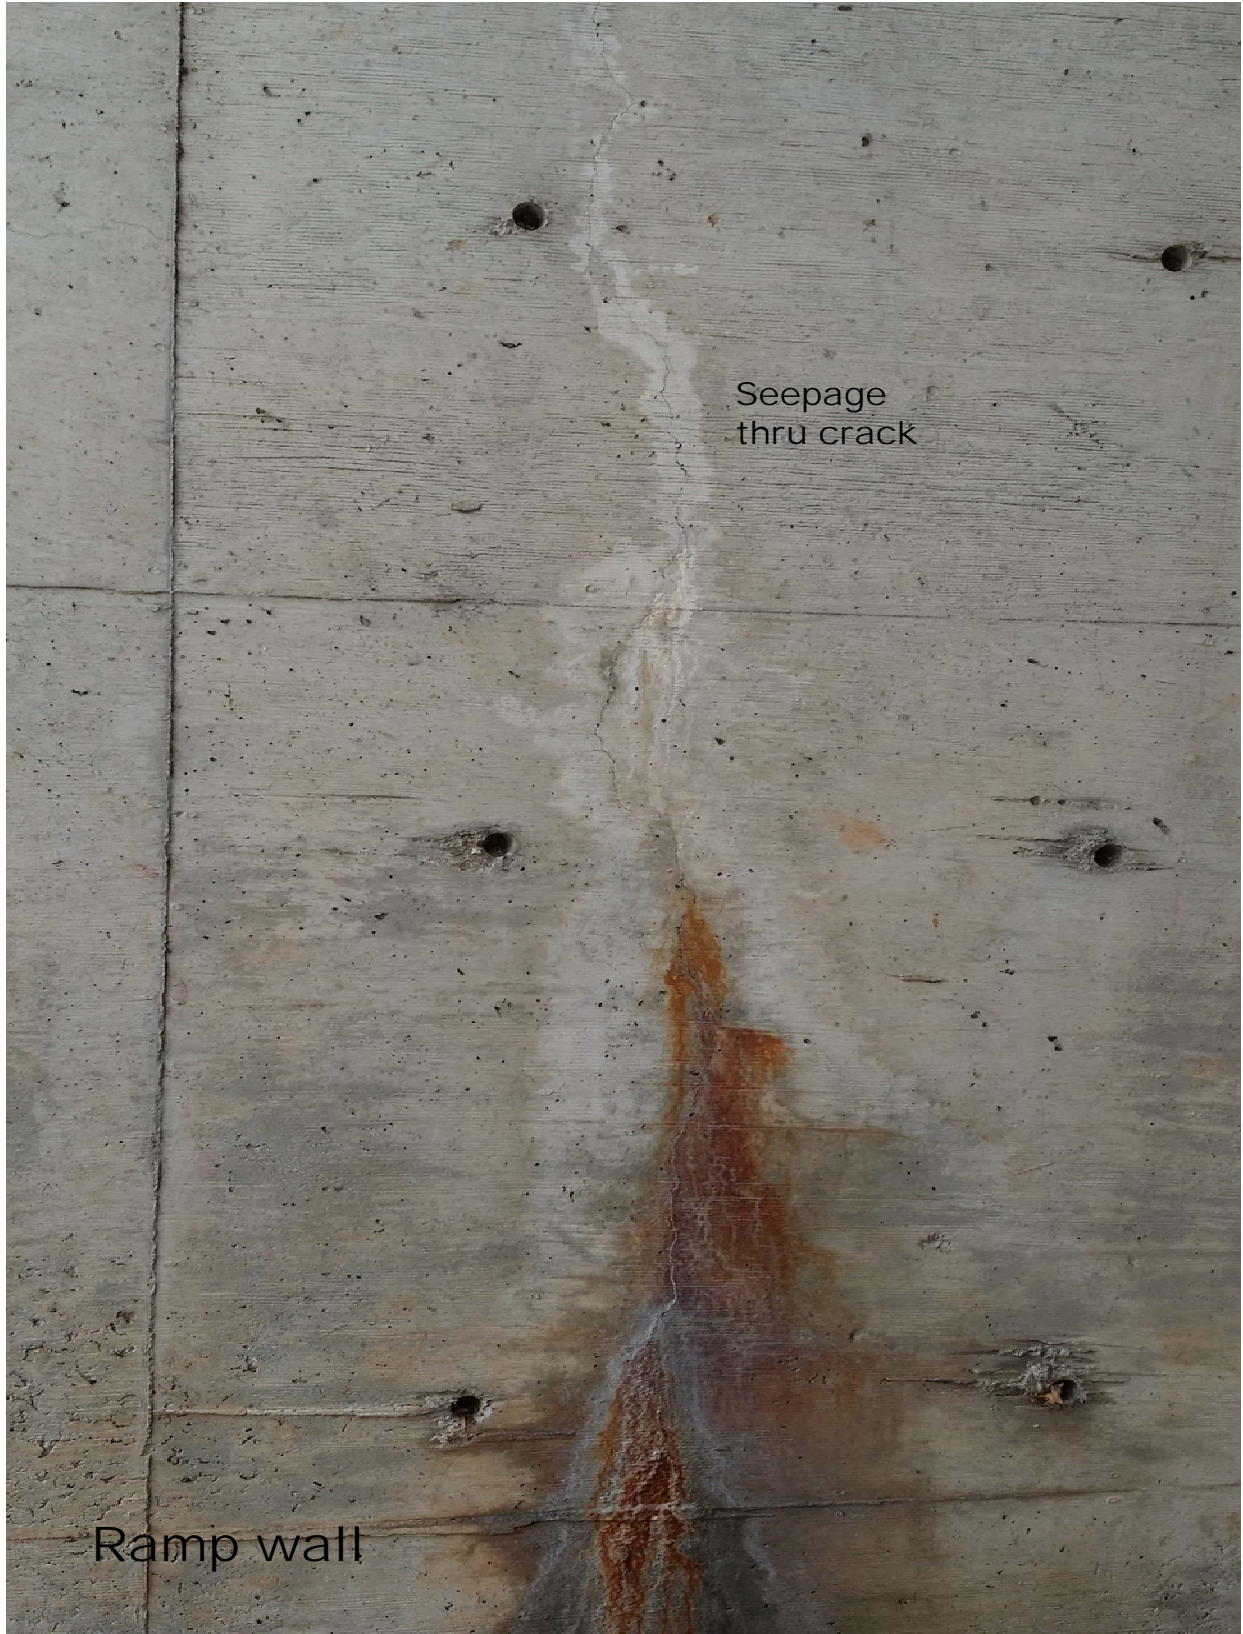
Ramp wall

Seepage
thru crack

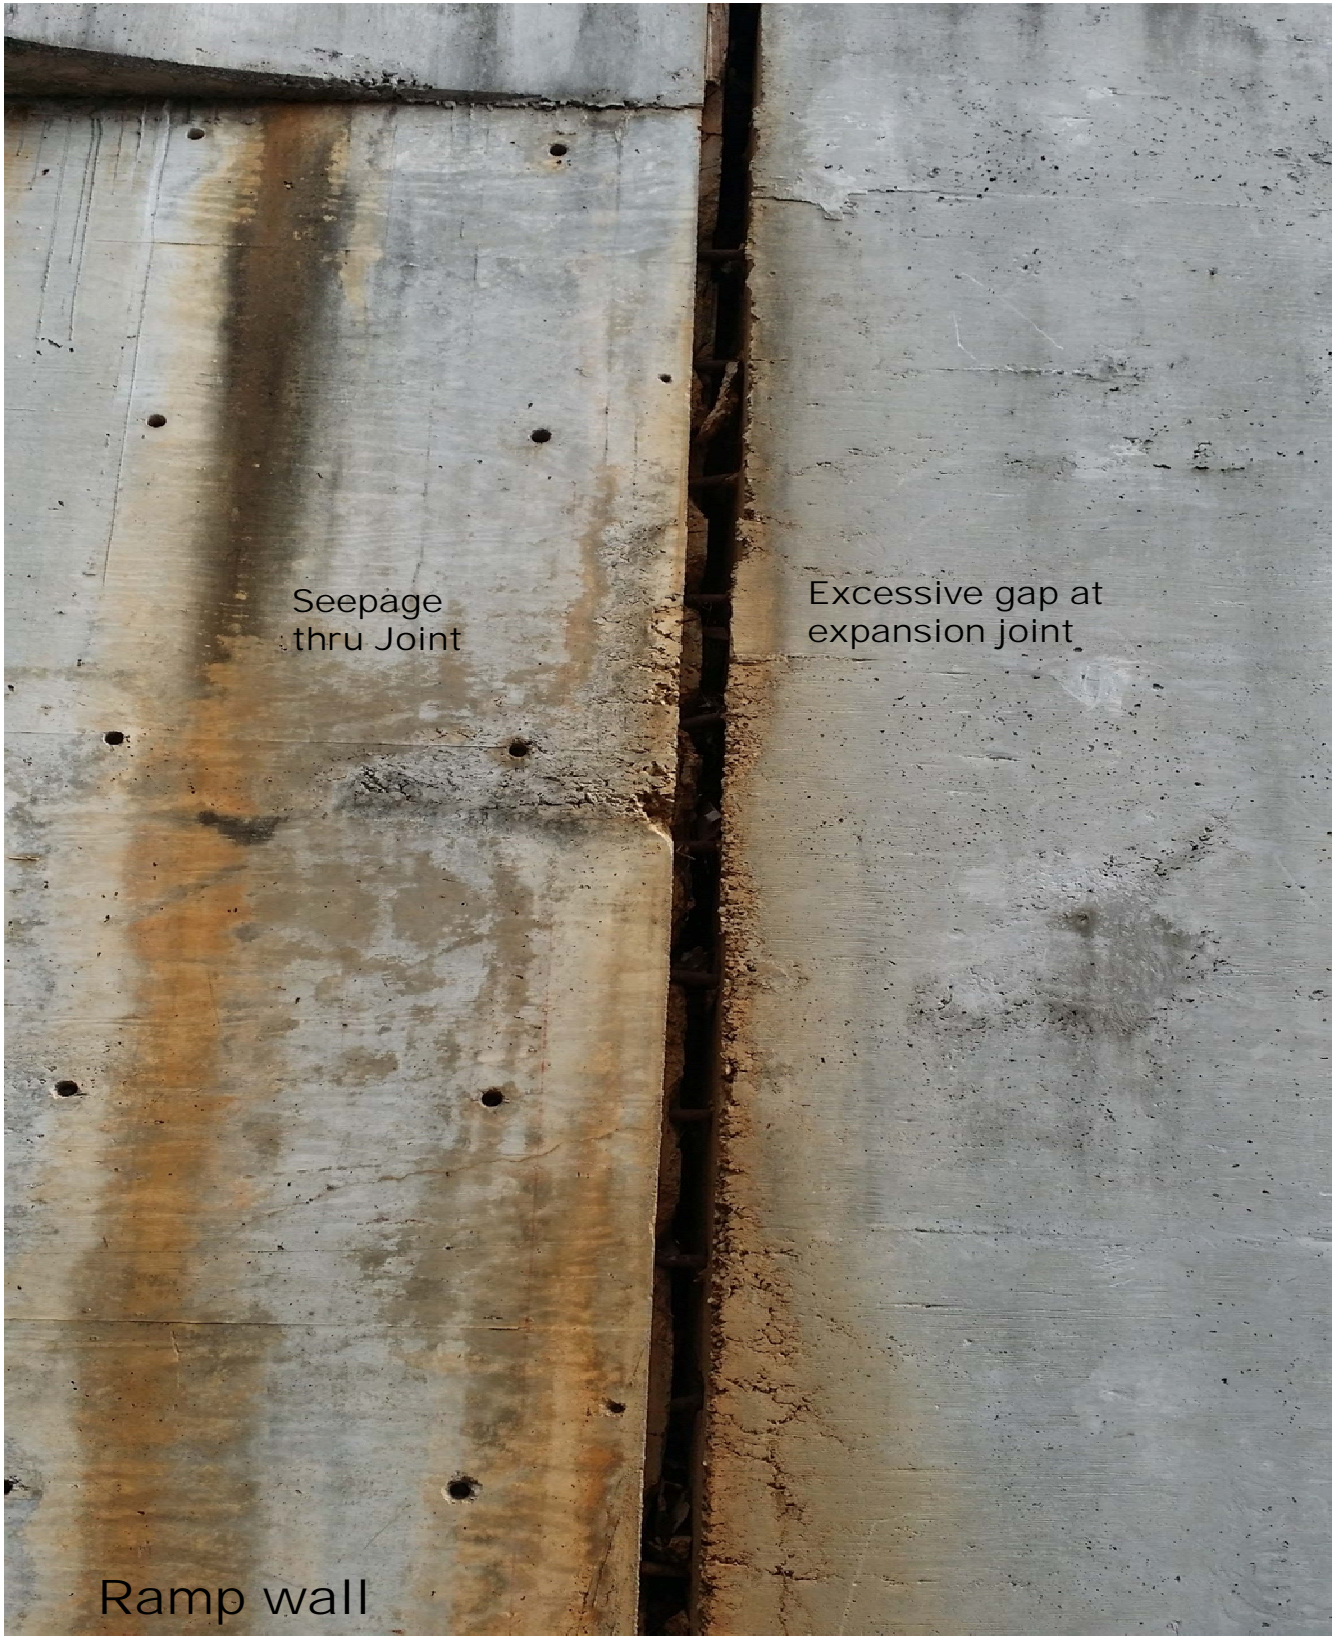
Ramp wall

Seepage
thru Joint

Excessive gap at
expansion joint

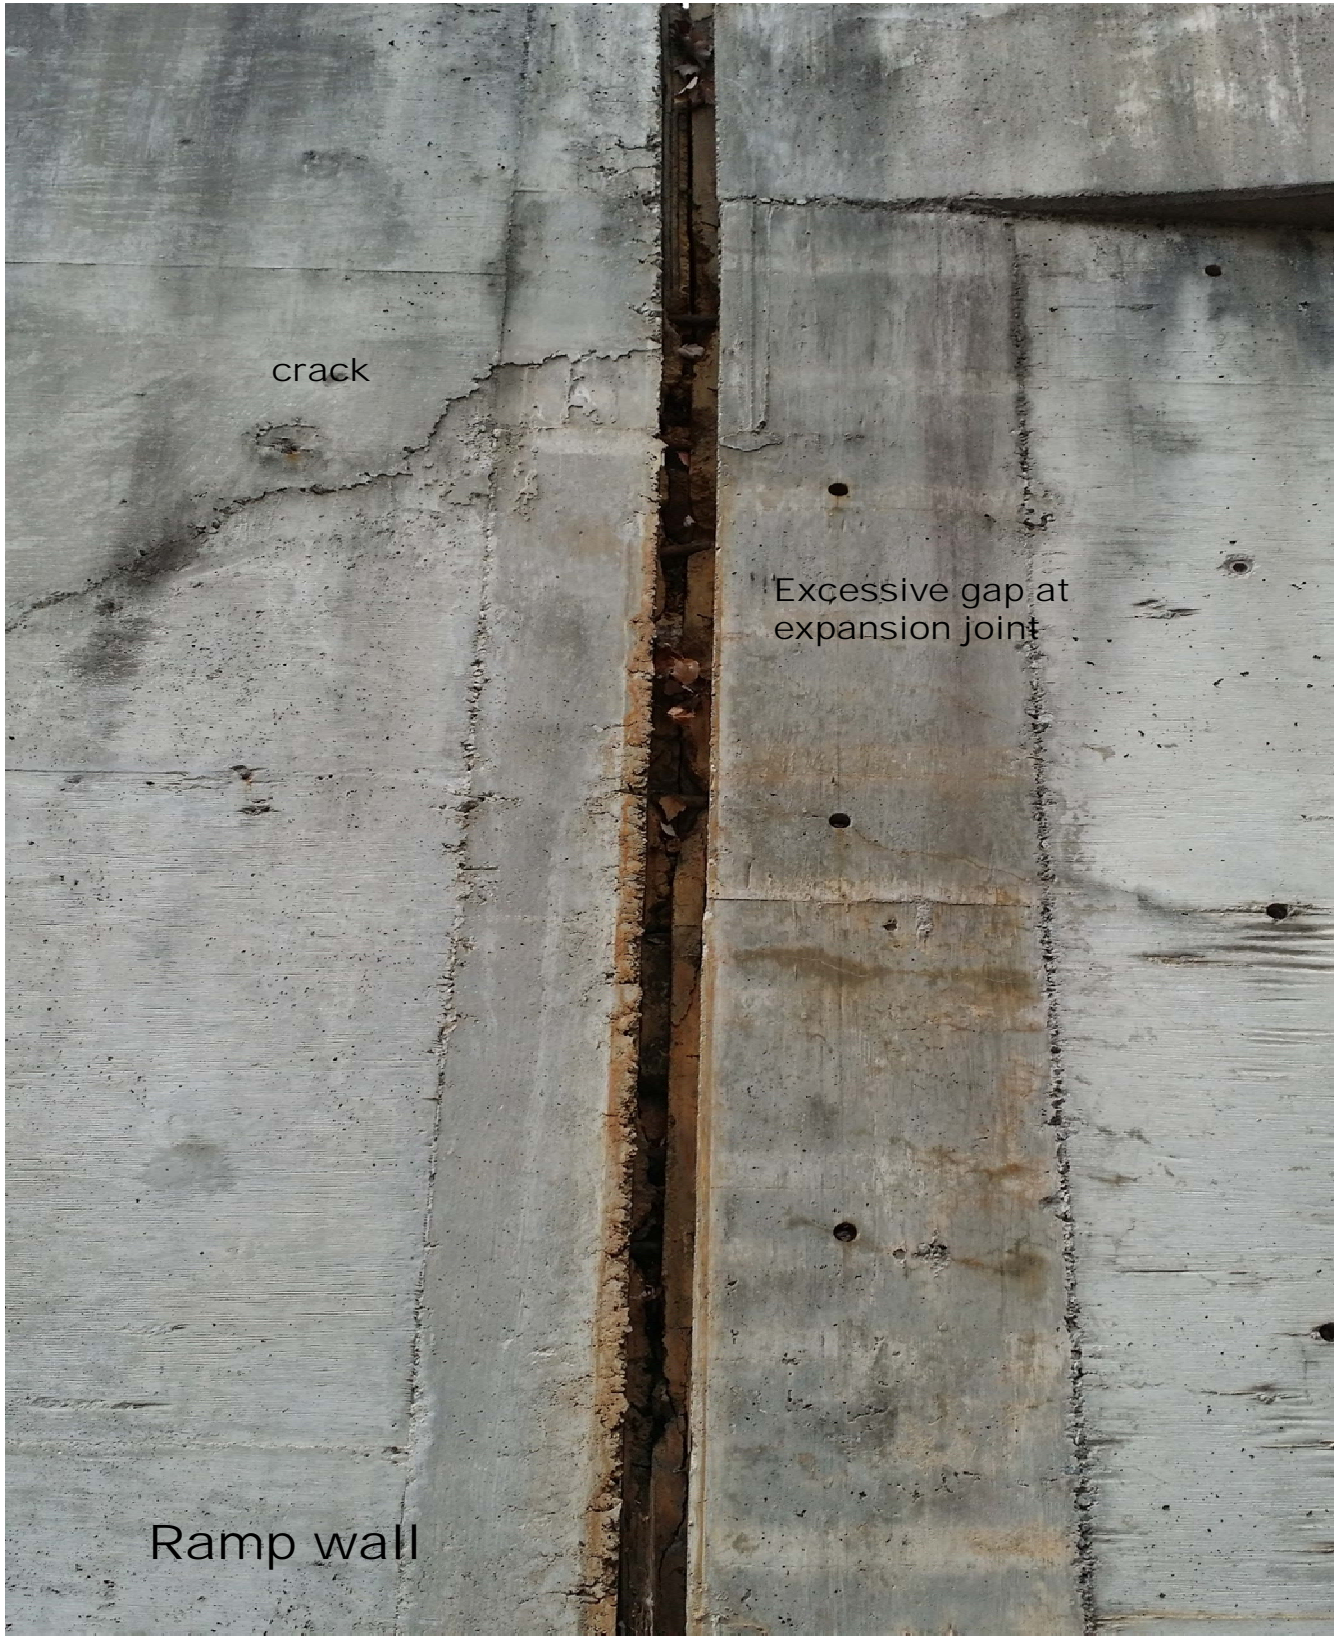
Ramp wall

crack

Excessive gap at
expansion joint

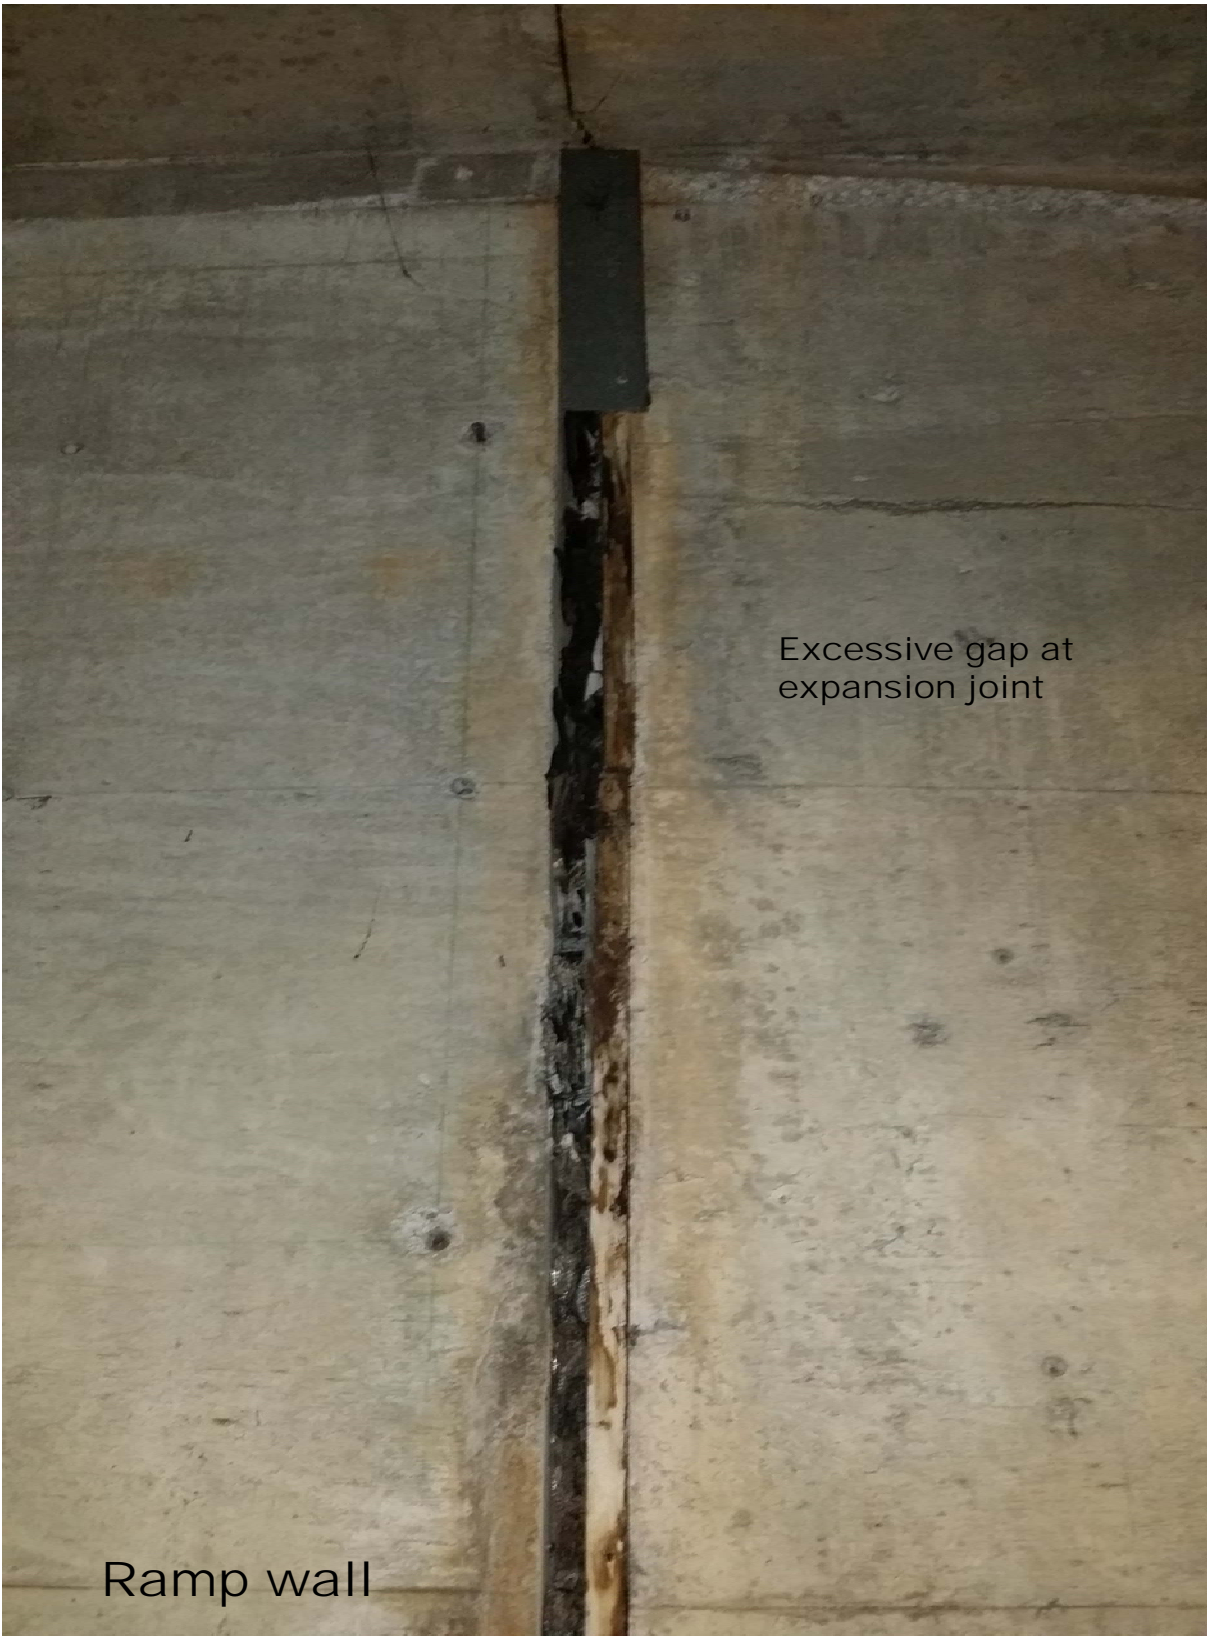
Ramp wall

Excessive gap at expansion joint

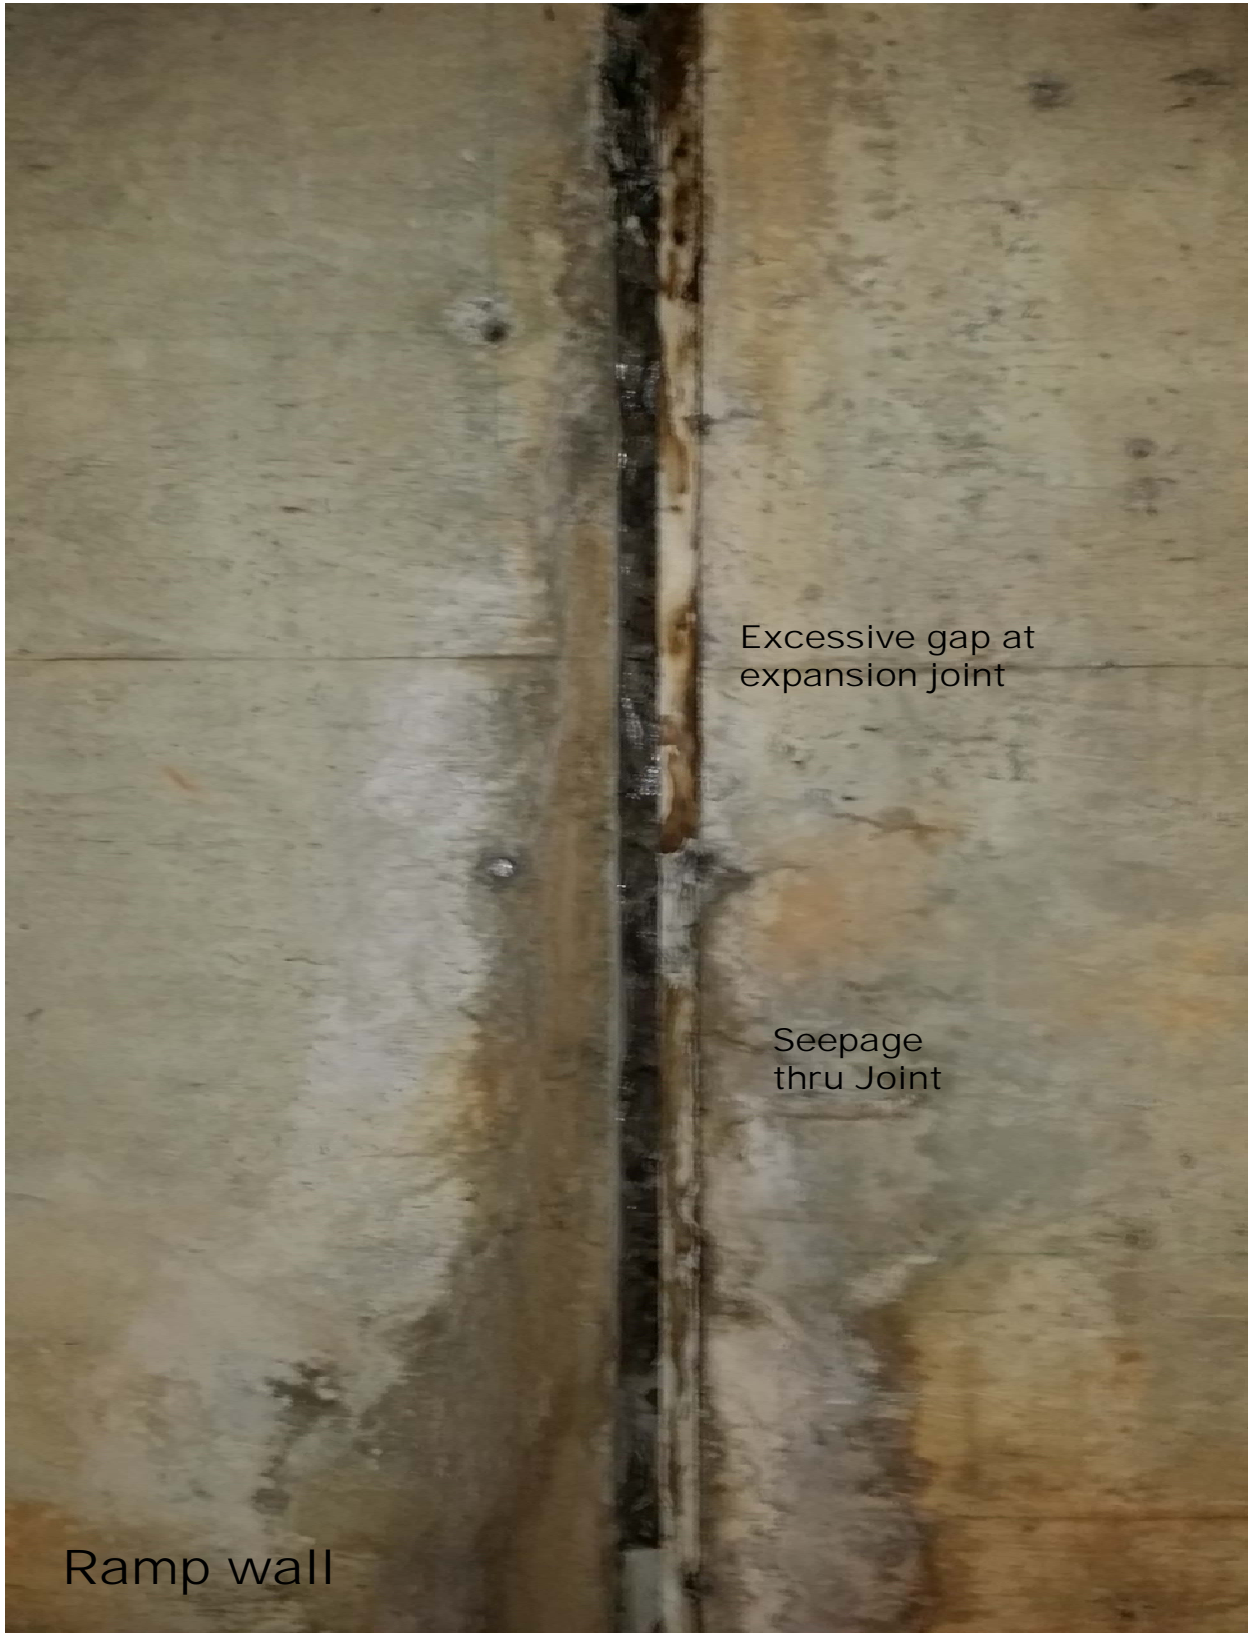
Ramp wall

Excessive gap at
expansion joint

Seepage
thru Joint

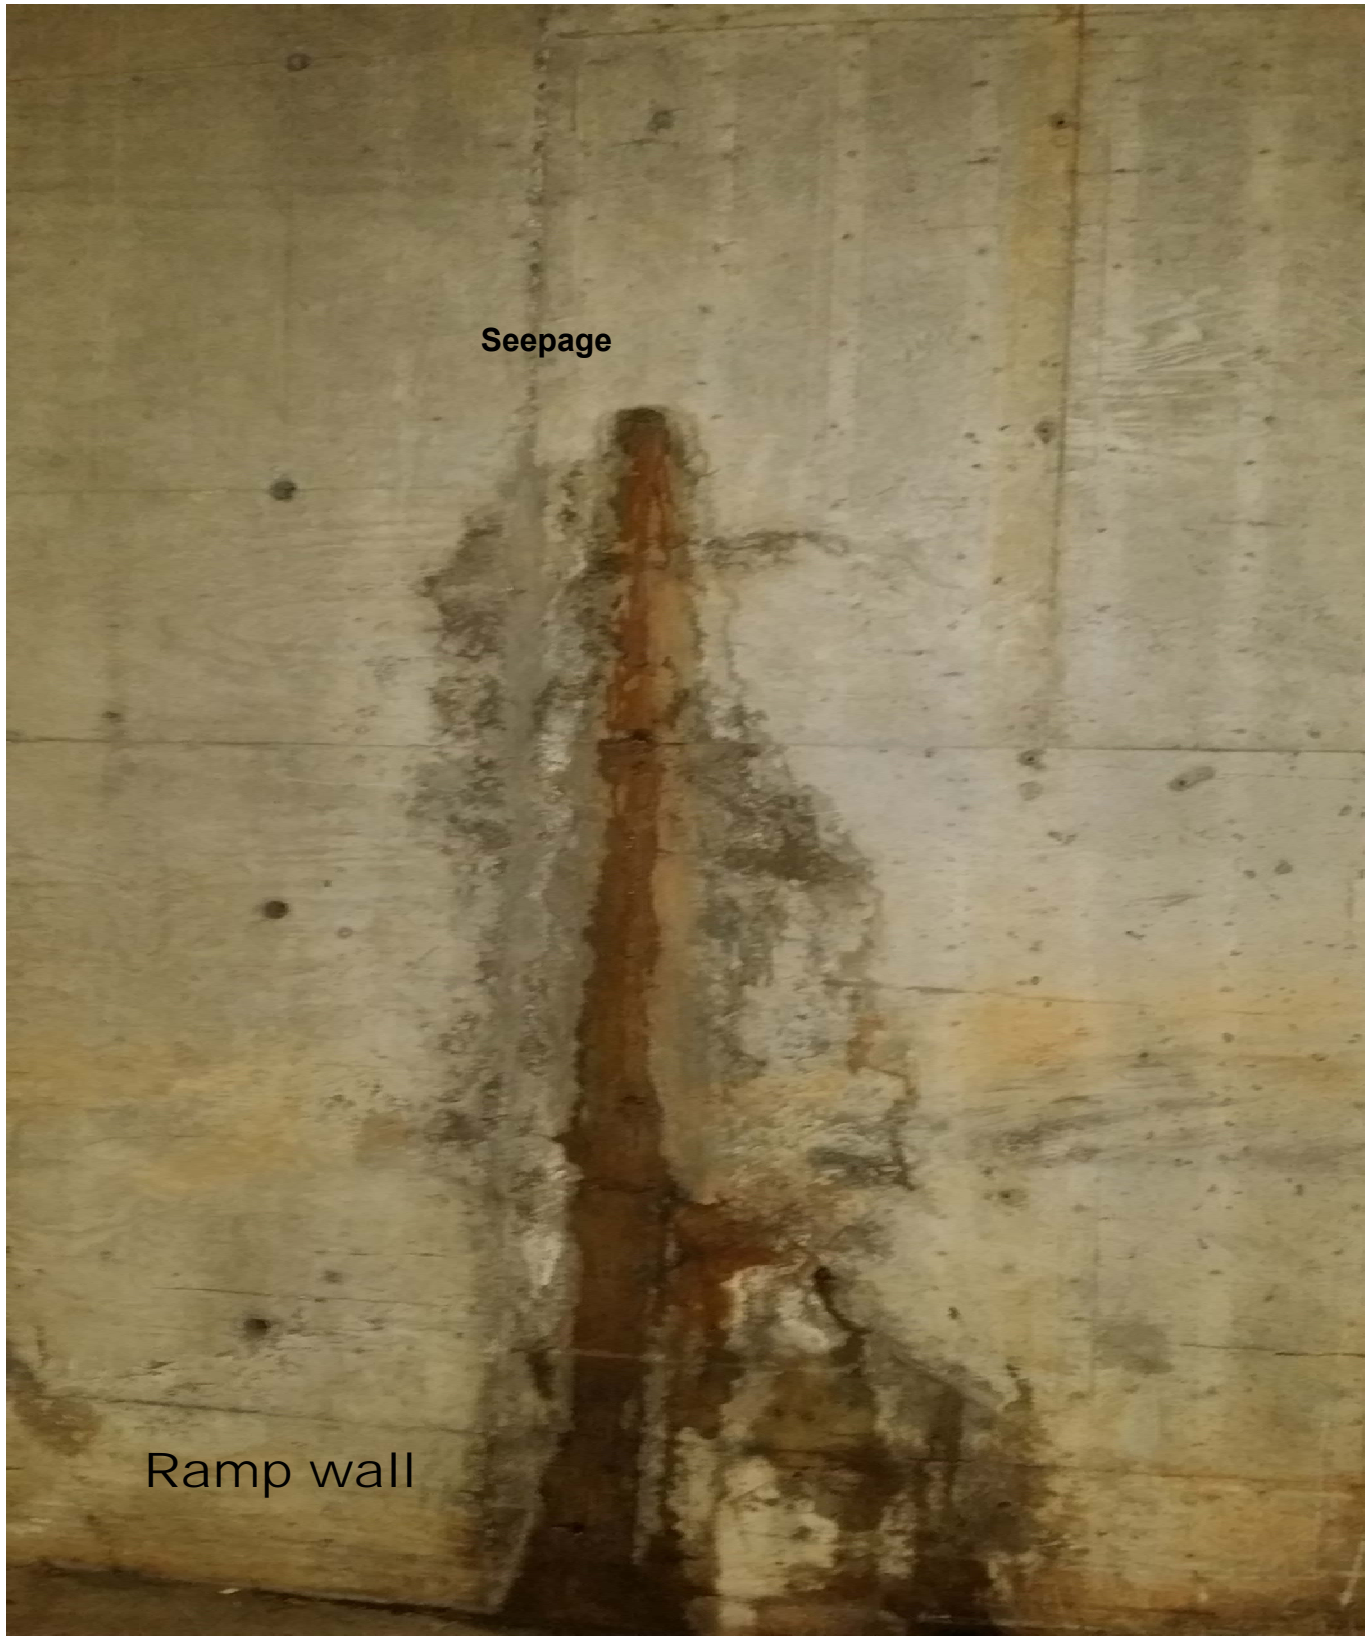
Ramp wall

Seepage
