FACILITY ASSESSMENT REPORT

APPENDIX D

Appendix D Service Garage

Knoxville Civic Auditorium and Coliseum Assessment

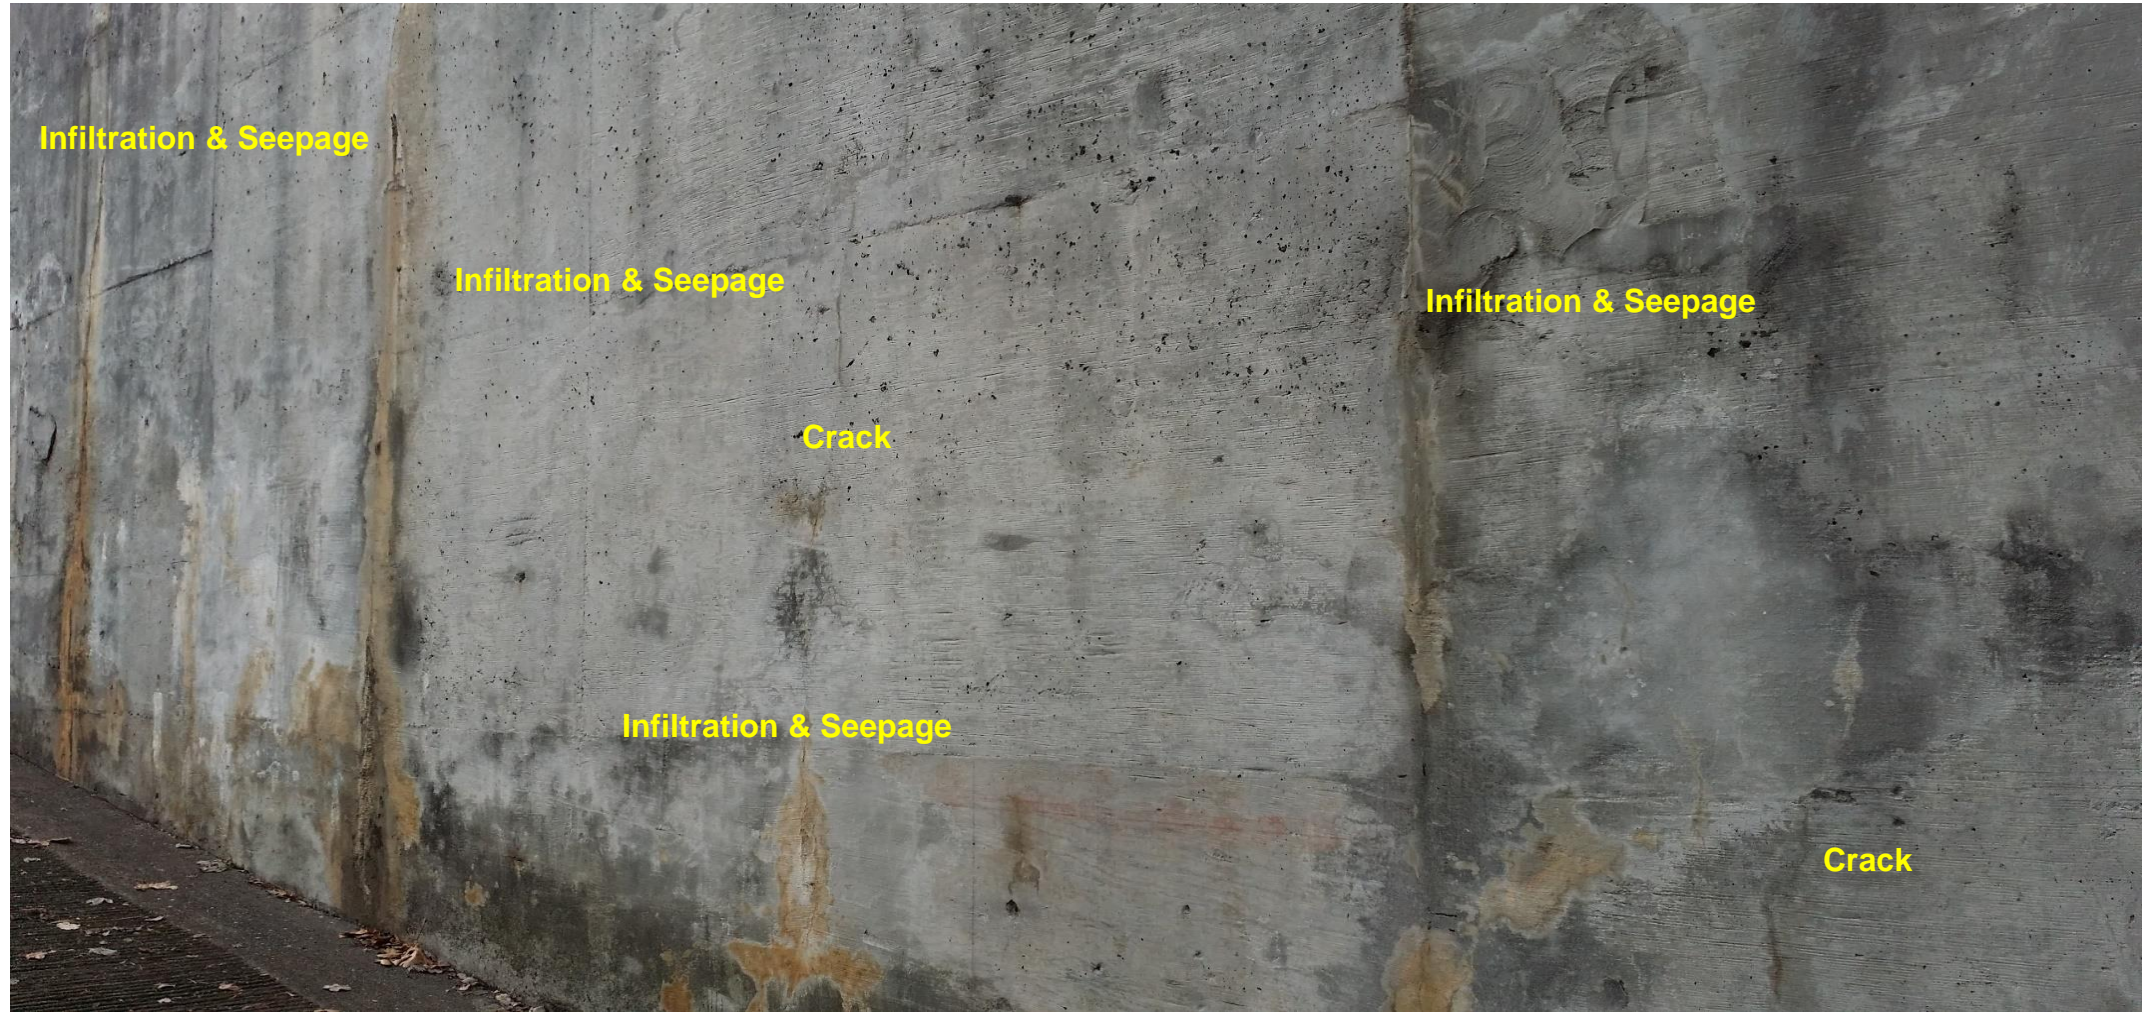
Ramp east wall

Infiltration & Seepage

Crack
