APPENDIX E: ARCHITECTURAL AND INTERIORS ASSESSMENT

Finishes and Overall Appearance

Coliseum

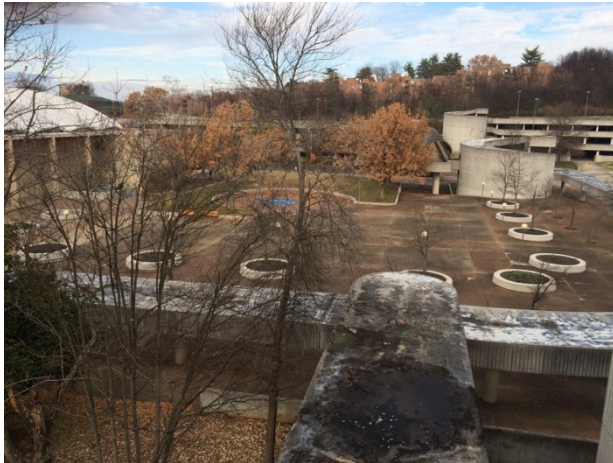
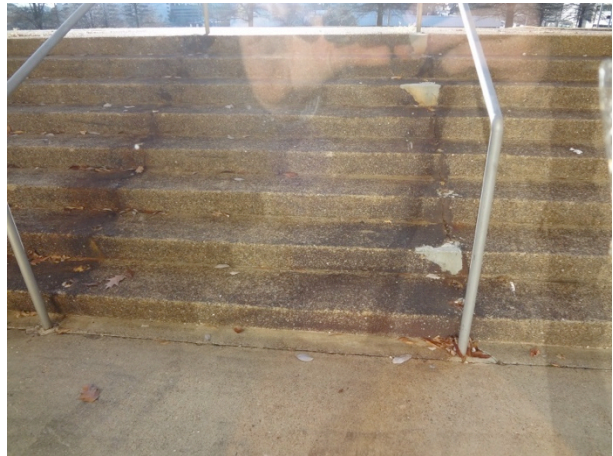
Exterior plaza, stairs and breezeway areas need patching, painting & re-finishing. Deterioration has begun in some locations.

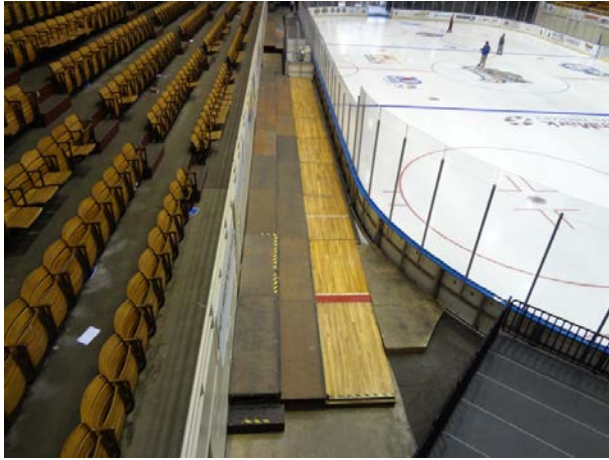
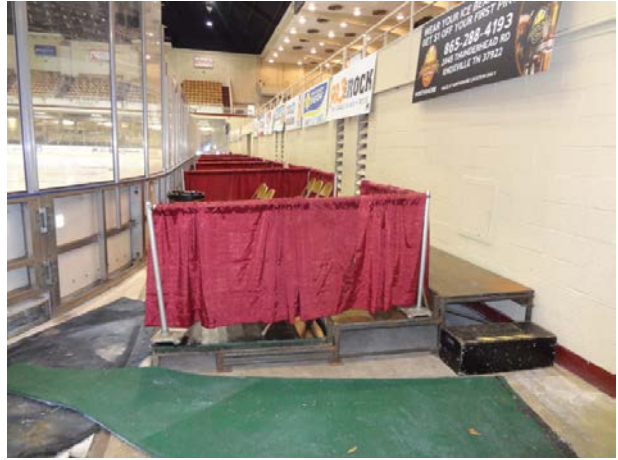
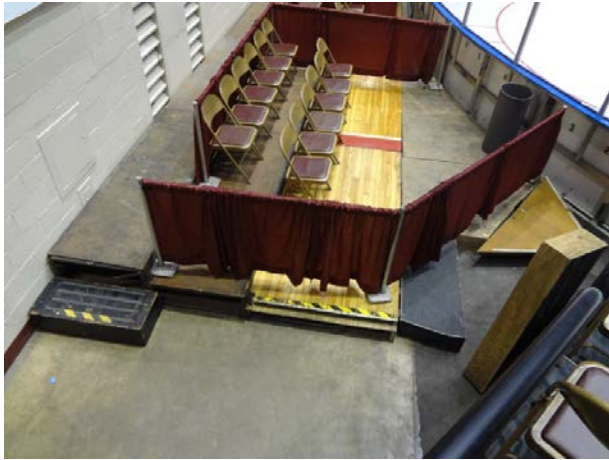
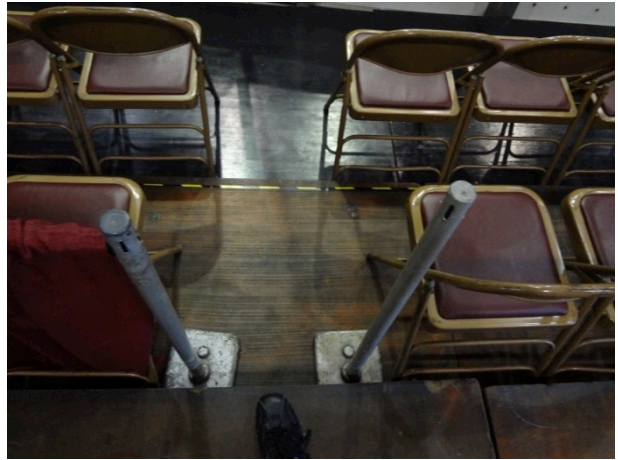
Loge boxes and temporary seating set up for ice hockey games do not meet code and presents a safety concern. Code compliant retractable risers and seating should be provided. Also, ADA accessibility must be a priority for the seating and furniture as well.

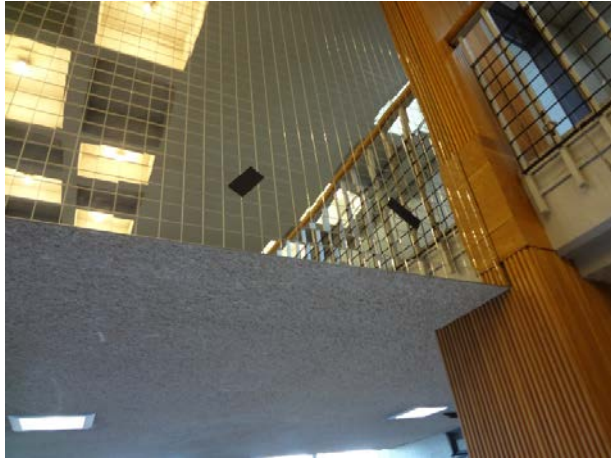
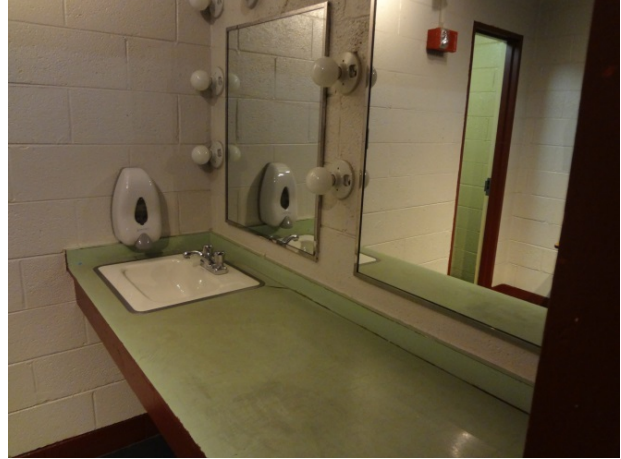
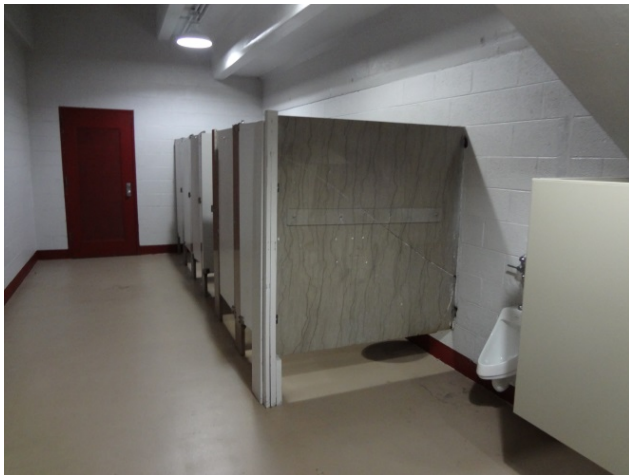
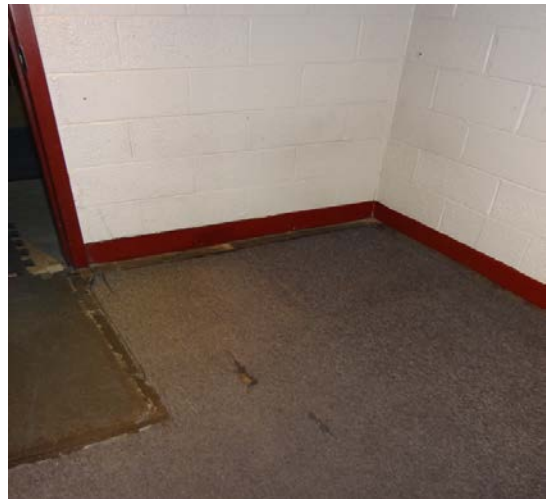
Overall finishes are out of date for the entire Coliseum. Areas in the star dressing rooms and visitor's locker room are especially deficient. Many of the restrooms have toilet dividers that need repair/replacement. Back of house spaces include plumbing fixtures are in need of replacement. There are also areas that pose a safety concern (ex. tile in atrium hallway – taped to wall. Concern that tile could fall from wall).

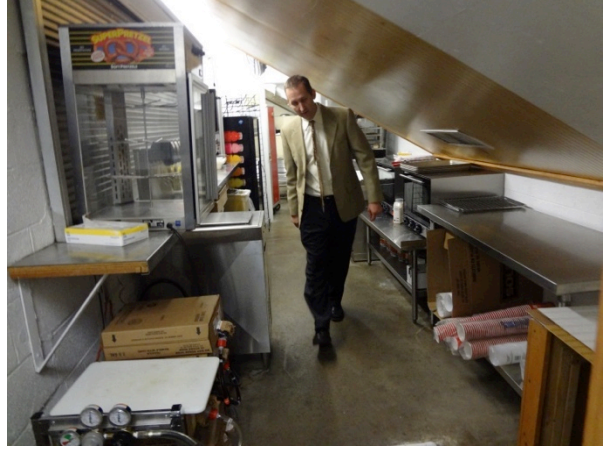
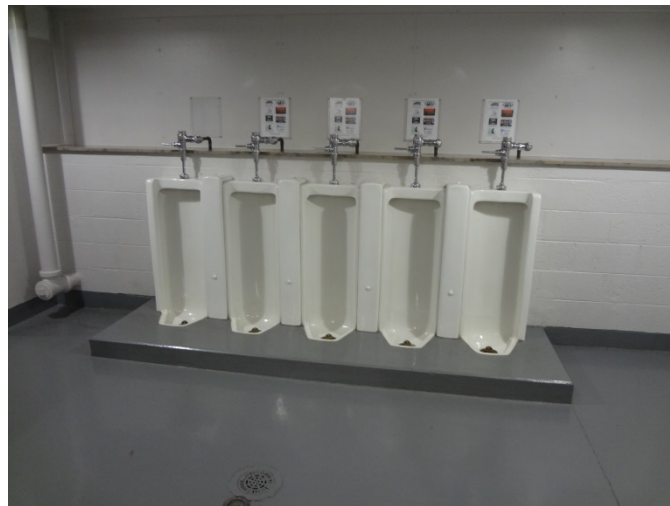
The facility needs to be upgraded from an ADA perspective. Increasing ADA toilet counts, increasing ADA concession counts, access to many of the event level areas (ex. star dressing rooms and locker rooms), access from event level to other levels – passenger elevator would be beneficial, also some of the interiors of the east and west concessions are not accessible from a disabled worker’s standpoint.

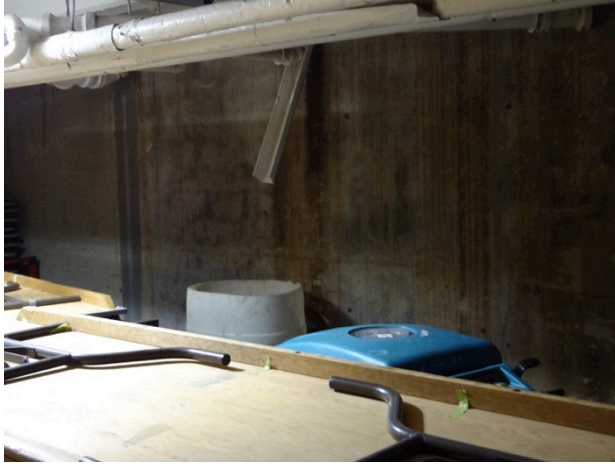
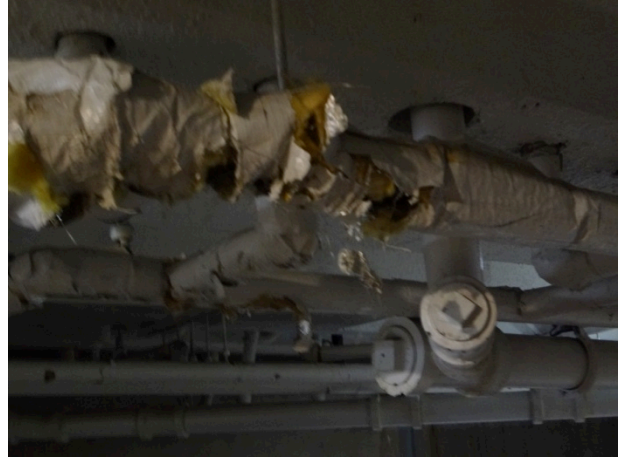
Major leaking and water infiltration on event level exterior walls. Patching has been done but water still finding its way in, so repair to areas is necessary. This leaking is also causing the nearby MEP and ductwork to deteriorate.

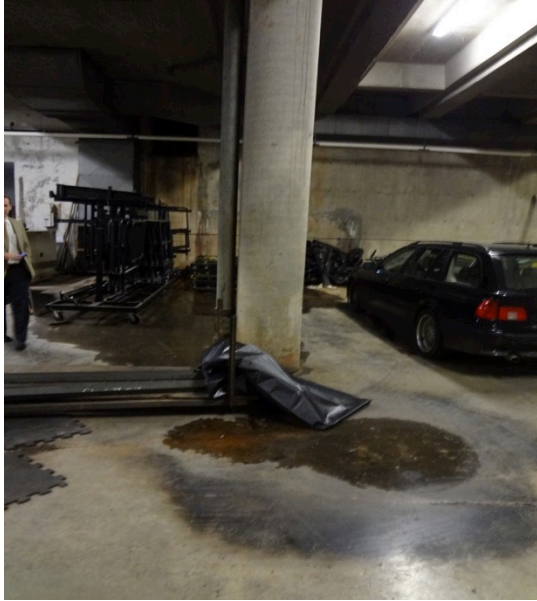
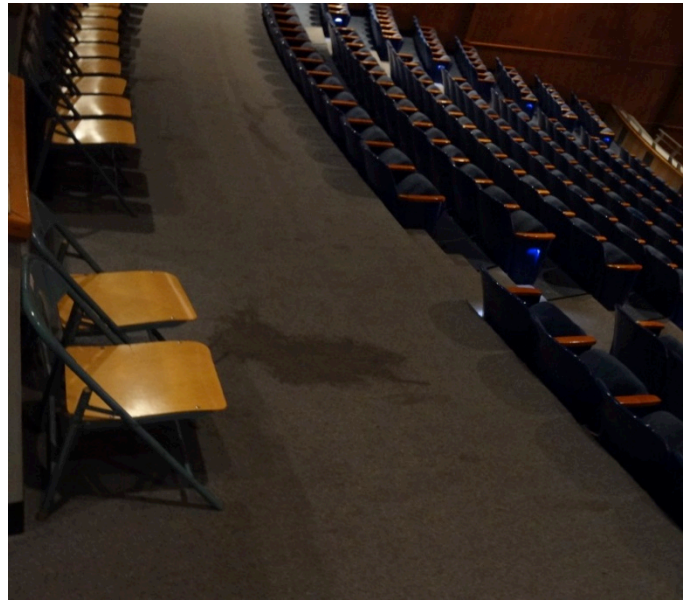
Loading dock has several large leaks and standing water. Repair to area is necessary.

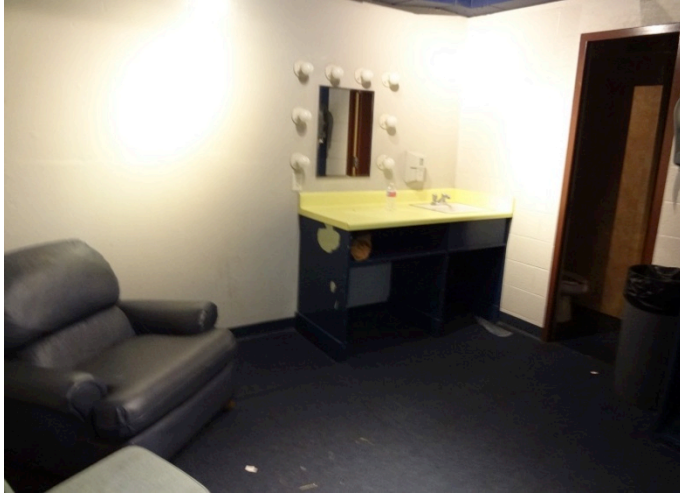
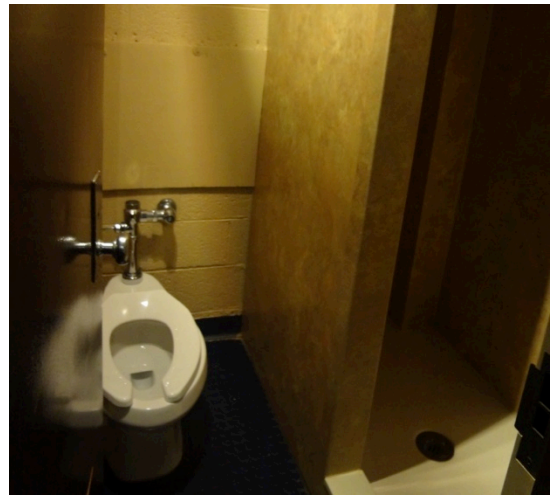
Overall finishes and décor are out of date – primarily the seats and carpeting need to be replaced. Many of the seats have ripped and stained fabric. The carpeting has several stains and tears.

Green room is severely out of date from a finish standpoint and lack ADA toilet access.

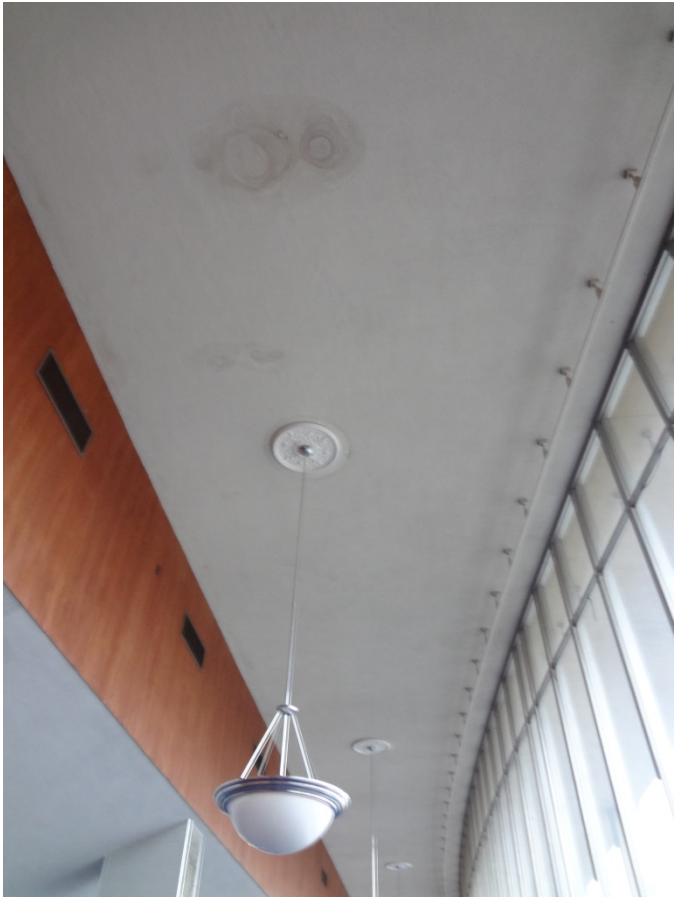
Major staining showing on ceiling of Auditorium atrium – building manager indicates roof leaks have been repaired, so this is a cosmetic issue.

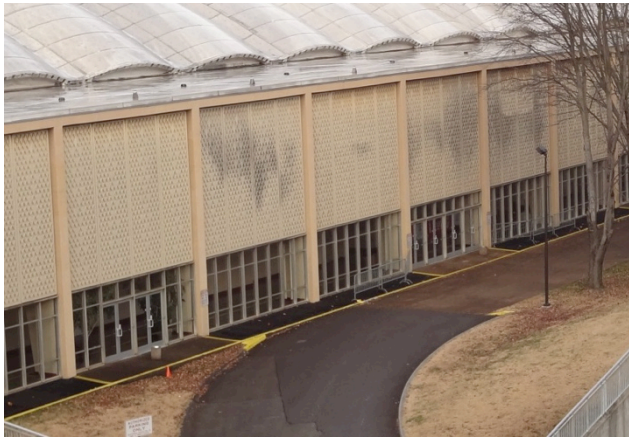
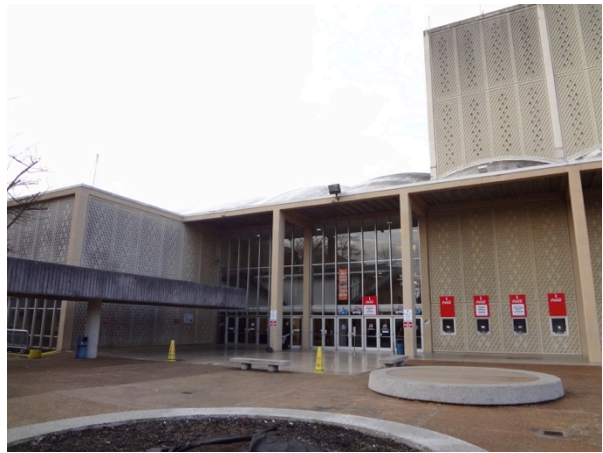
- Precast joints require re-sealing and regular examination/maintenance.
- Currently the panels under the overhangs at the east & west sides are in better condition than their exposed counterparts. Exposed precast panels show fair amounts of discoloration, indicating likely moisture infiltration.

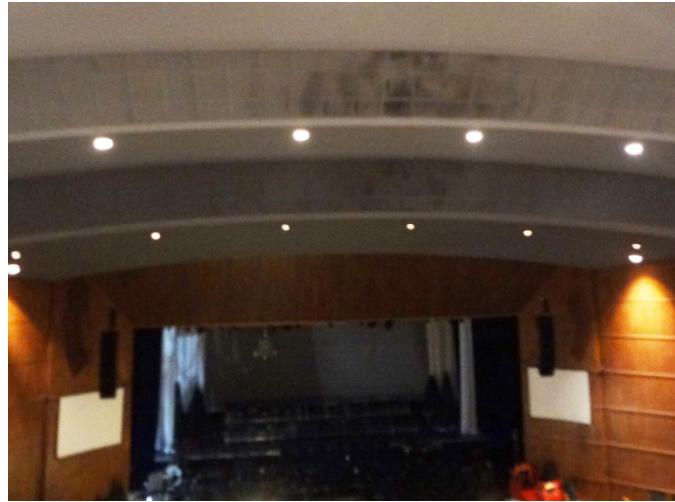
- Water damage throughout the ceilings of the Auditorium & Coliseum indicates history of roof infiltration/deterioration.

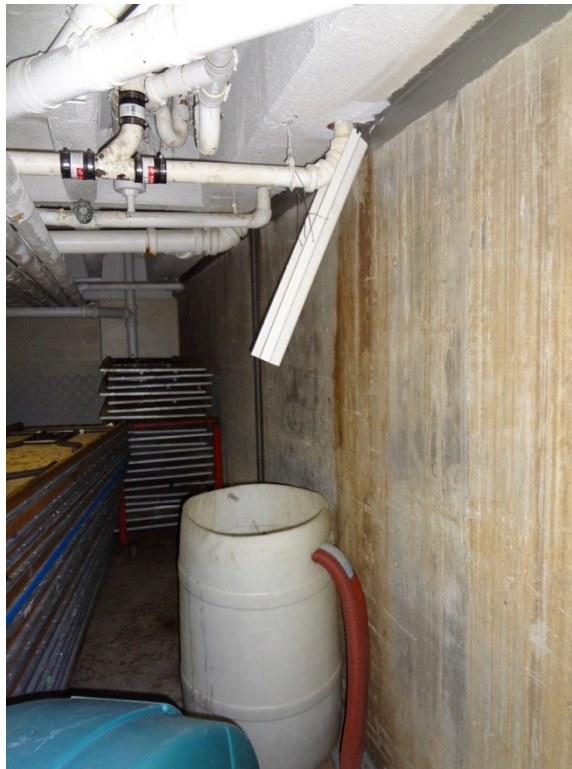
- Visible evidence of water infiltration at sub-grade concrete walls. Current cosmetic approach to sealing interior surface cracks & joints appears to have spread the issue. Some areas of infiltration have been handled with catchment bins.

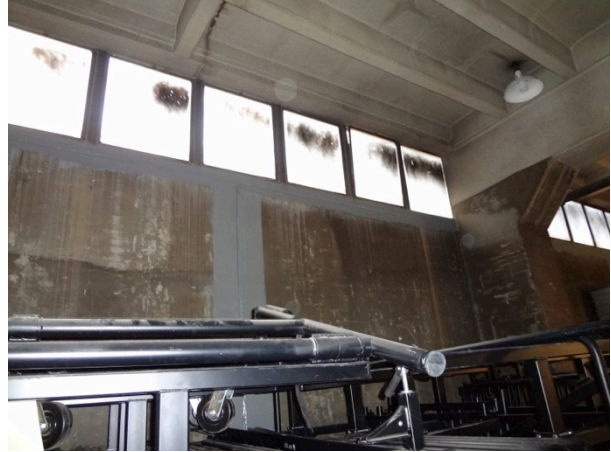
- Curtain wall and storefront glazing are single glazed systems. The system is in need of general maintenance including re-sealing/gasketing of glazing panels in a number of locations. The curtain wall frame itself appears to be stable. Glazing is in differing amounts of disrepair, including damage in the primary Auditorium entry façade.

- The single-glazed systems are likely taxing the current MEP systems and compromising the energy efficiency of the facility as a whole. We would recommend replacing the current glass with insulated glazing units.

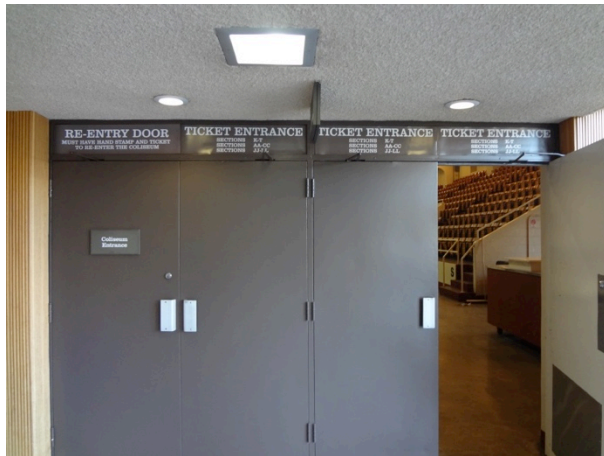
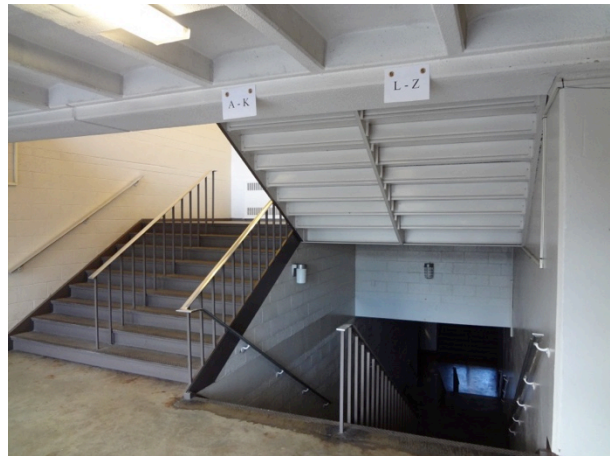
Way finding and signage overall should be more uniform and clear. Overhead signage at entries is inadequate in size & clarity to properly direct spectators to their seats. In addition signage at stair locations lacking permanent signage, as current signs are made of paper.

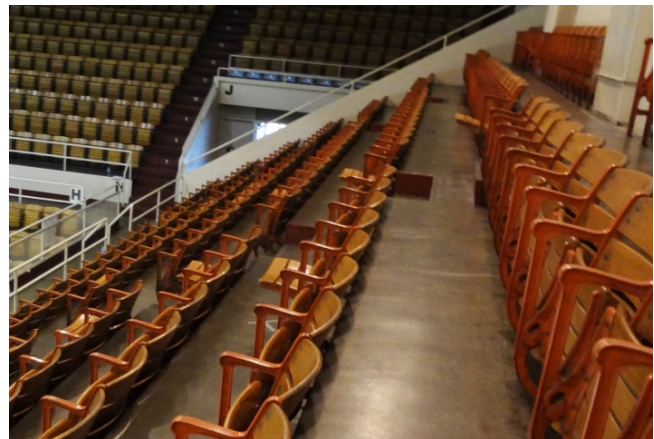
- Seating in (4) corner sections of the north & south seating areas have severely compromised views for many event types. This has negative impact on spectator experience and potential revenue for particular show configurations.
- The Coliseum contains no true premium seating amenities. Temporary loge style boxes at floor level are inadequate for current market standards. Lack of premium amenities represents a potential loss in revenue for the facility.

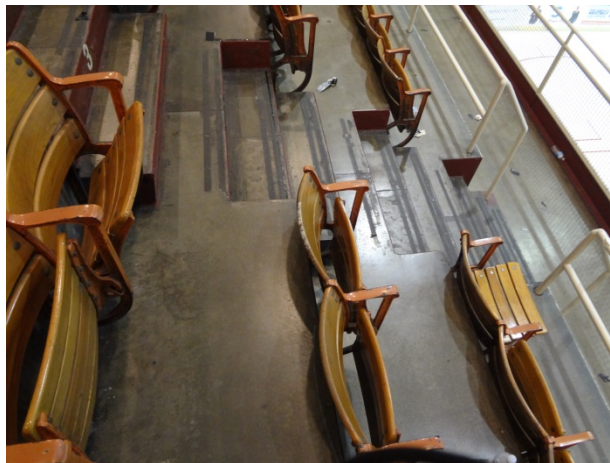
- Many of the wood slat seats are in disrepair. Self-rising mechanism have failed & material finishes are worn. This failure reduces the effective aisle width of the seating sections.
- While the seats themselves are an interesting character element for the age of the arena, they should be replaced with seats of those of modern standards & ergonomics.
- Seating aisles are narrower than current code requirements.
- Seating aisle steps have riser & tread dimensions that do not meet code. Aisle steps have tread depths of 10" at north & south sides and 8" at east & west sides.

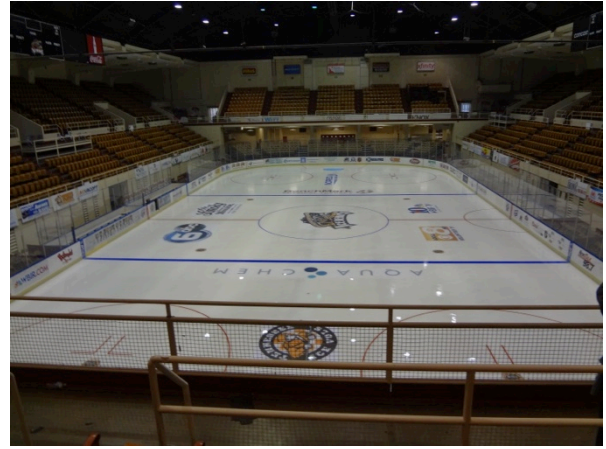
- Seating bowl sightlines are compromised for hockey, worth noting, as this is the current primary function/tenant (e.g. end zone seating does not have view to near goal).

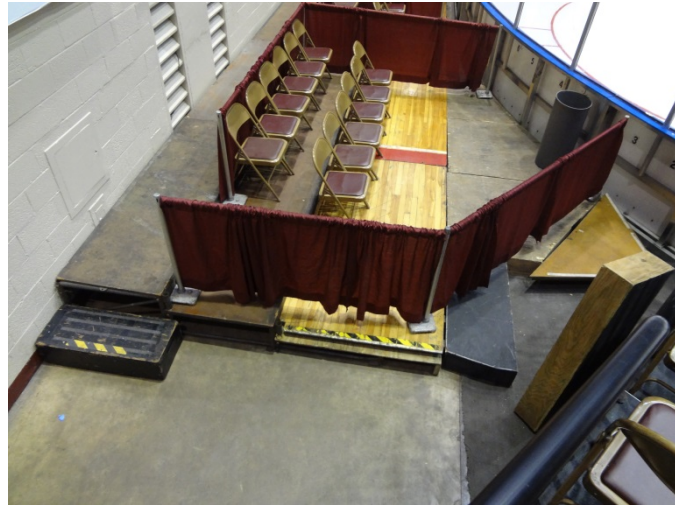
- Portable platforms at hockey sideline are built of combustible materials & not suitable for use. Use of temporary rails in these areas is inappropriate as well.

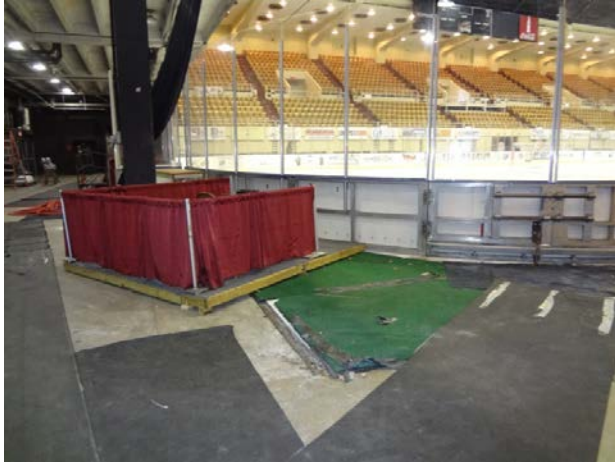
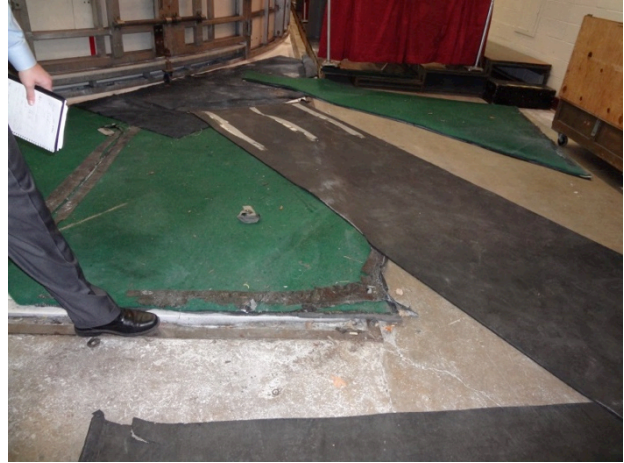
- Temporary floor coverings around floor seating need replacing and better planning. The current condition creates a number of accessibility hazards. Materials are torn, stained, & incoherently installed.

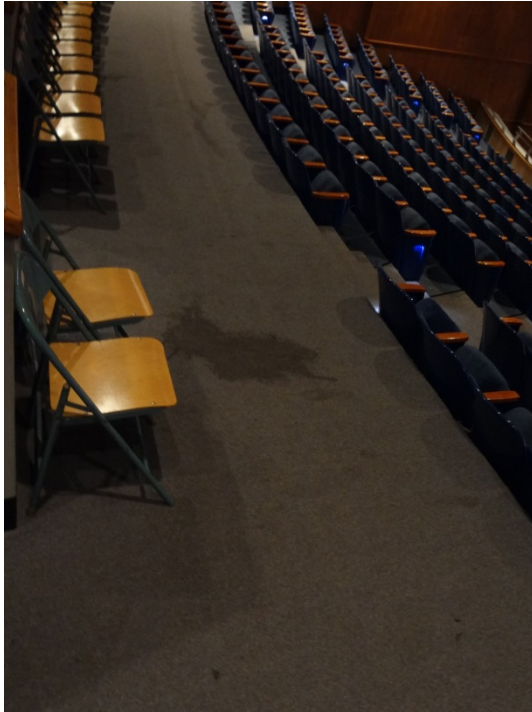
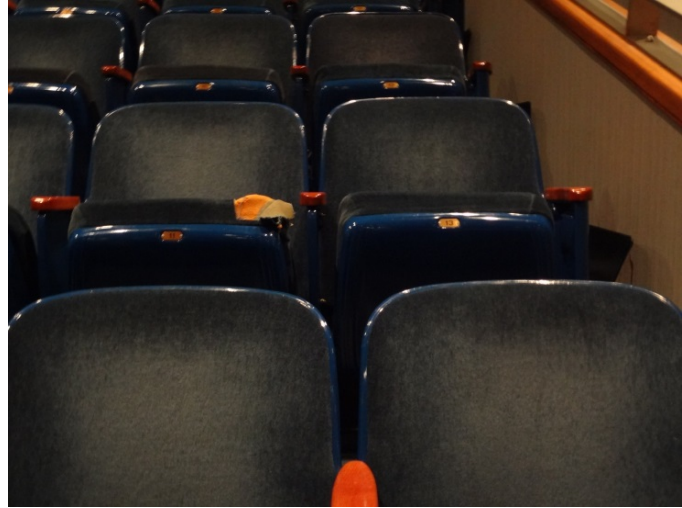
Seat materials have deteriorated. Many seats have torn fabric seats with exposed foam padding. Self-rising mechanisms need maintenance.

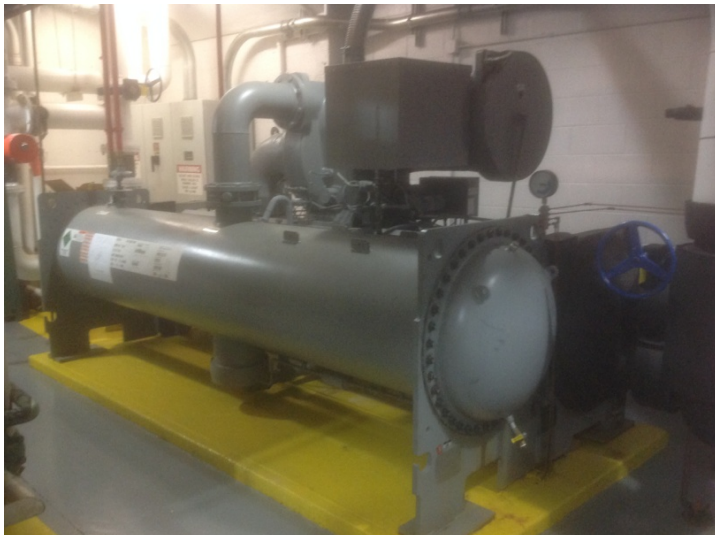
M.2 430 ton chiller

The chillers appear to be in good to fair condition based on their respective ages. The condenser tubes are brushed every year and the machines appear to be well maintained.

The median useful life span of a chiller is between 18 and 23 years. Therefore, the 300 ton and 60 ton chillers are well past their service life and should be replaced. A proactive maintenance routine for the chillers is essential to extend their useful life; however, as time passes, the chillers will become less energy efficient even with the best of service practices.

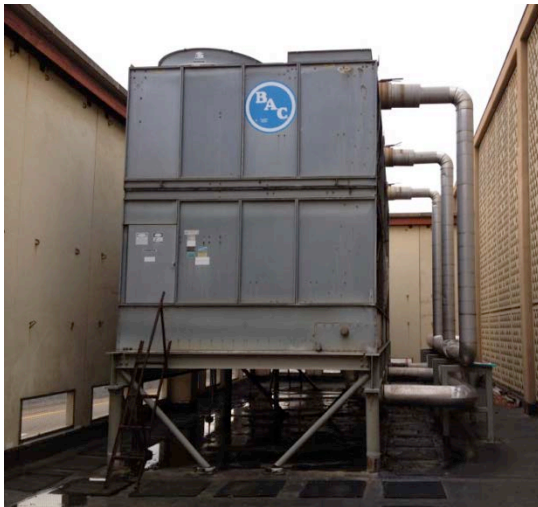
M.6 Cooling tower

The cooling tower cells are in fair condition. The indoor concrete basin is cleaned yearly and is in good condition. The median useful life of the cooling towers is between 17-1/2 and 20 years. Complete tower replacement should be considered in about 2 to 4 years. Chemical treatment for the condenser water system is good and seems to be managed effectively.

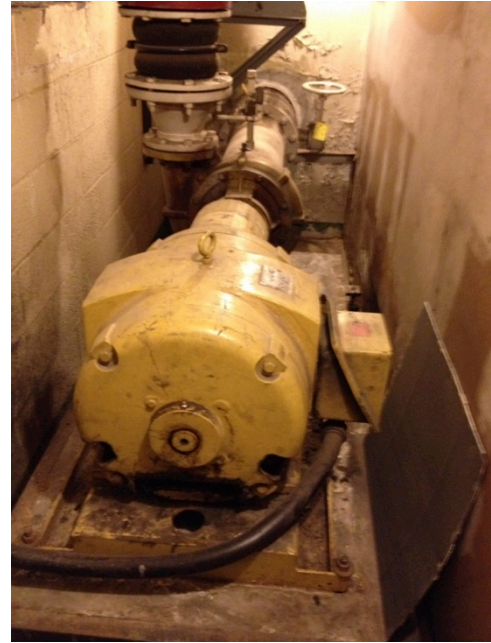
M.8 Condenser Water pump

Condenser water pumps appear to be in fair to poor condition. The median useful life of the condenser water pumps is also between 20 and 21 years and these pumps should be replaced.

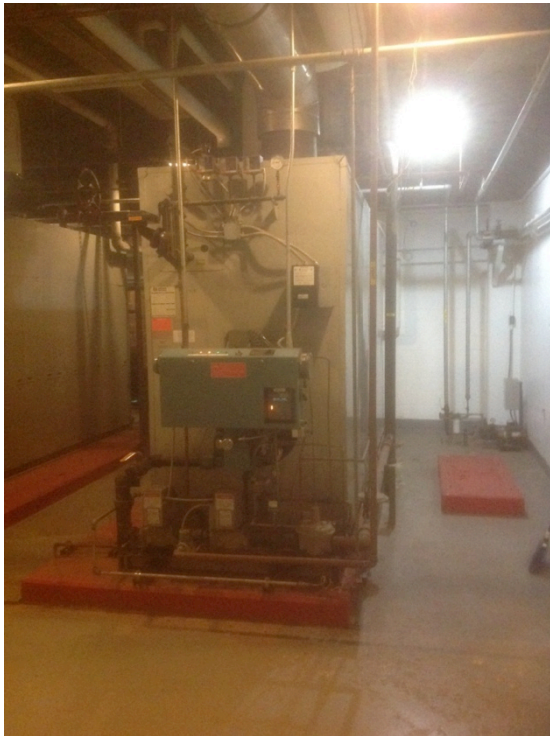
M.9 Steam boilers

The boilers appear to be in good condition with preventative maintenance ongoing. The median useful life span of a flexible tube boiler is between 15 and 20 years. However, as time passes, the boiler inherently will become less energy efficient even with the best of service practices.

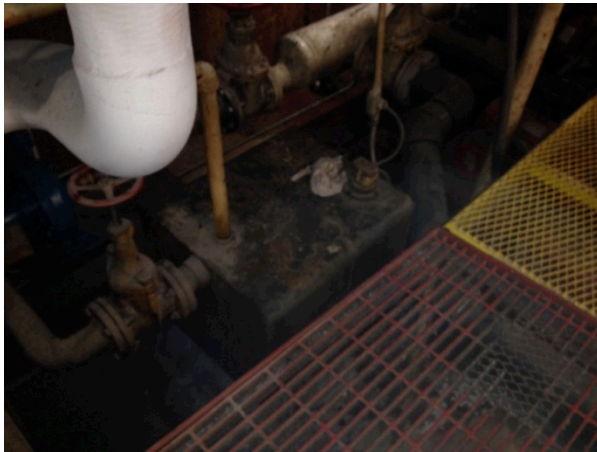
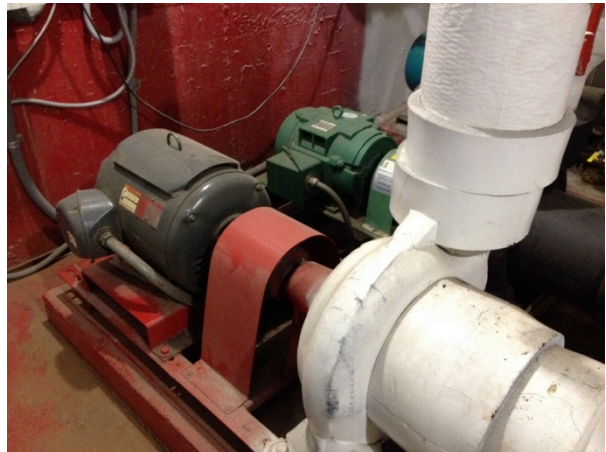
M.11 Steam condensate pumps for hot water heat exchanger Pumps M.12 Secondary Heating/Cooling water Pumps

Hot water pumps appear to be in fair condition based upon their age. The median useful life of the hot water pumps is between 20 and 21 years. Therefore, the primary loop heating water pumps appear to be close to the end of their service life.

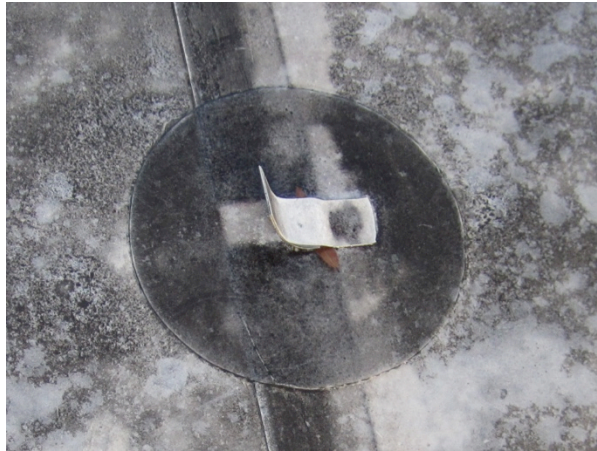
Covering strip that has lost its adherence. We observed a few instances of this condition, and recommend they be refastened.

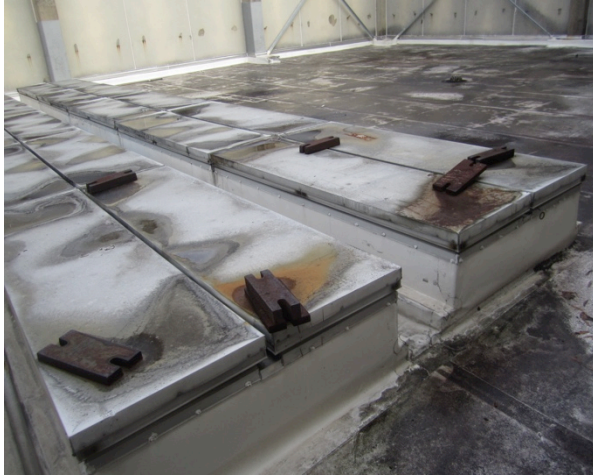
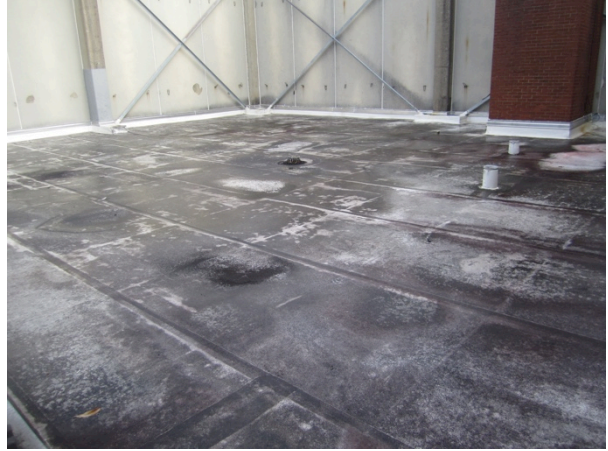
Weights used to keep exhaust doors from allowing rain penetration. Very dirty membrane surface.

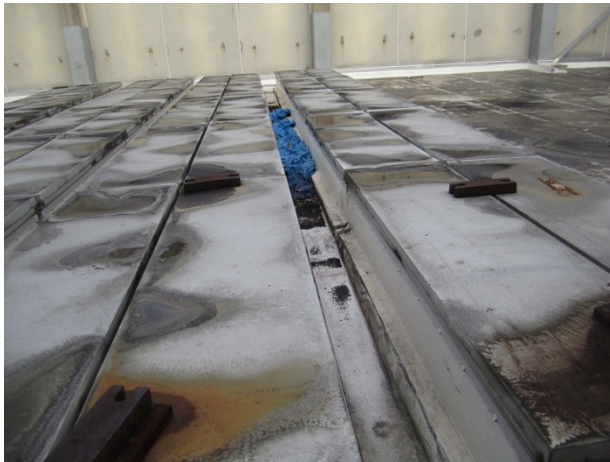
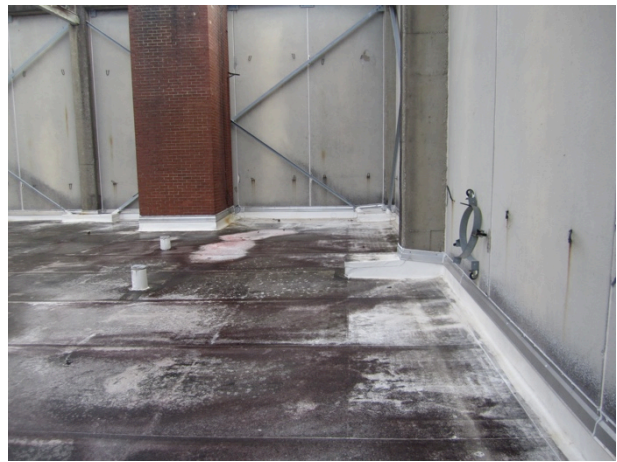
Abandoned blue tarp observed between exhaust vents.

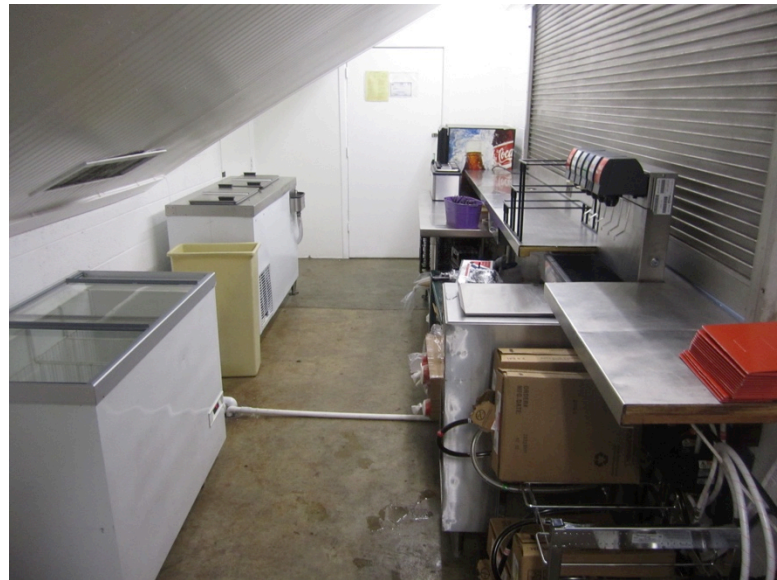
Freezers were the main equipment in the dessert stand, and they were in good condition. We recommend ramping over the PVC drain that extends across the walkway in order to minimize the trip hazard as well as protect the pipe.
