APPENDIX E: ARCHITECTURAL AND INTERIORS ASSESSMENT

Finishes and Overall Appearance

Coliseum

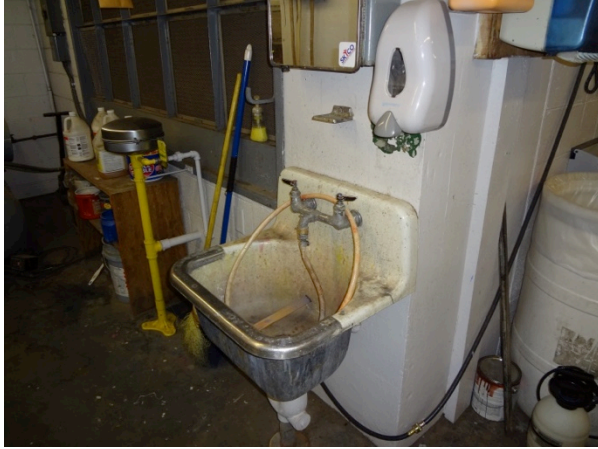
The facility needs to be upgraded from an ADA perspective. Increasing ADA toilet counts, increasing ADA concession counts, access to many of the event level areas (ex. star dressing rooms and locker rooms), access from event level to other levels – passenger elevator would be beneficial, also some of the interiors of the east and west concessions are not accessible from a disabled worker’s standpoint.

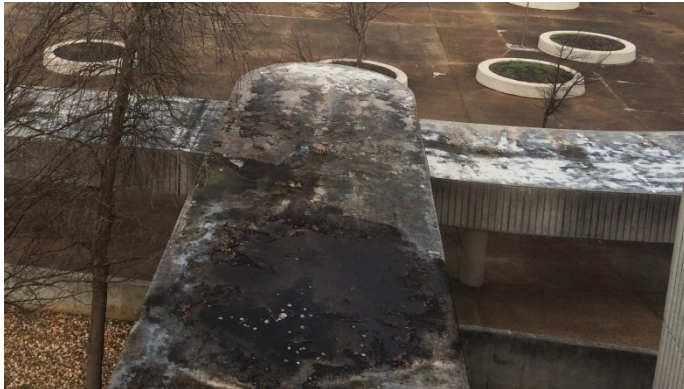
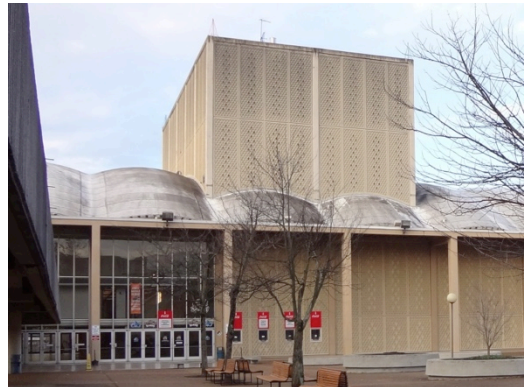
- Roofing materials are in need of cleaning and maintenance. Visible debris at a number of roof drains, including those on canopies and breezeways visible to the public. Full evaluation may be required, though most current issues appear to be aesthetic.

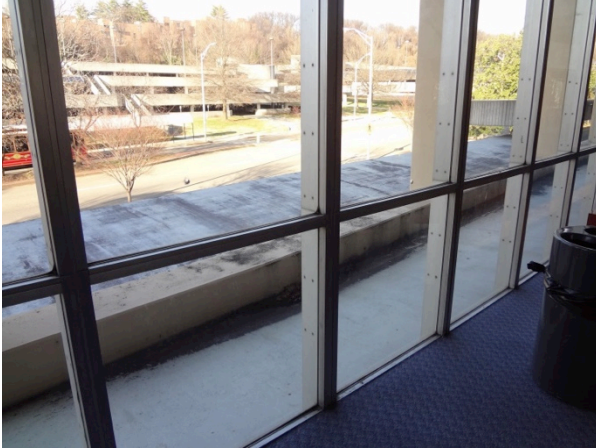
- Curtain wall and storefront glazing are single glazed systems. The system is in need of general maintenance including re-sealing/gasketing of glazing panels in a number of locations. The curtain wall frame itself appears to be stable. Glazing is in differing amounts of disrepair, including damage in the primary Auditorium entry façade.

- The single-glazed systems are likely taxing the current MEP systems and compromising the energy efficiency of the facility as a whole. We would recommend replacing the current glass with insulated glazing units.

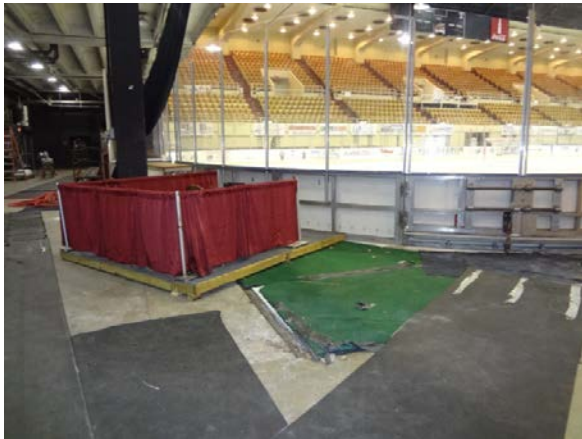
- Seating in (4) corner sections of the north & south seating areas have severely compromised views for many event types. This has negative impact on spectator experience and potential revenue for particular show configurations.
- The Coliseum contains no true premium seating amenities. Temporary loge style boxes at floor level are inadequate for current market standards. Lack of premium amenities represents a potential loss in revenue for the facility.

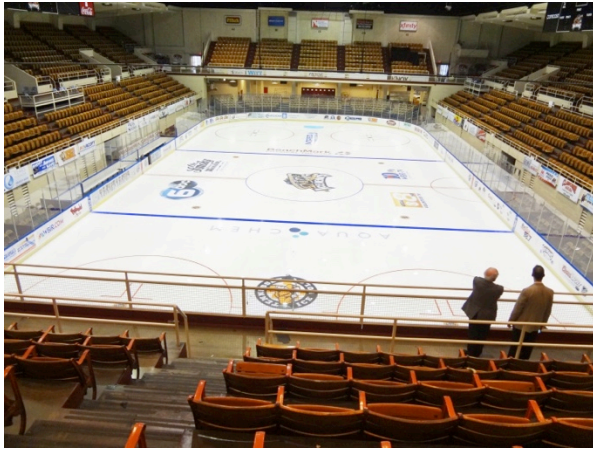
- Seating bowl sightlines are compromised for hockey, worth noting, as this is the current primary function/tenant (e.g. end zone seating does not have view to near goal).

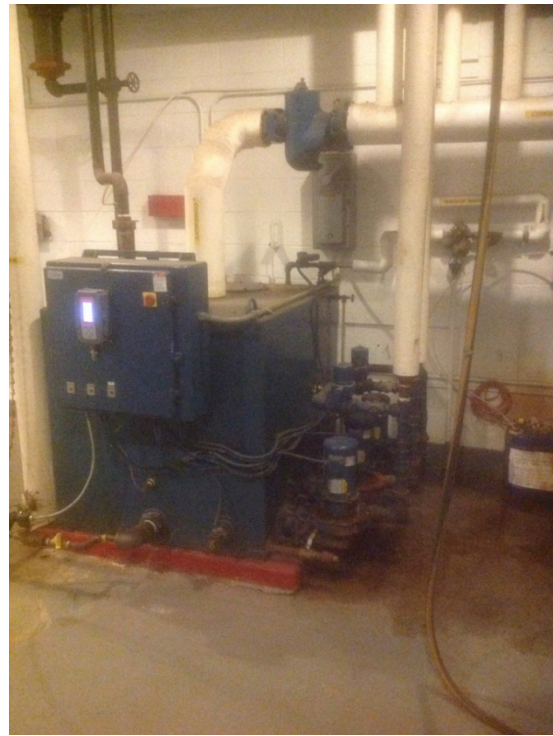
M.10 Steam condensate feed water pumps

The boilers appear to be in good condition with preventative maintenance ongoing. The median useful life span of a flexible tube boiler is between 15 and 20 years. However, as time passes, the boiler inherently will become less energy efficient even with the best of service practices.

Boilers are one of the largest energy consumers for the arena. As such, the boilers should be a priority for preventative maintenance and service planning. Heating hot water pumps should be completely replaced in 5 years.

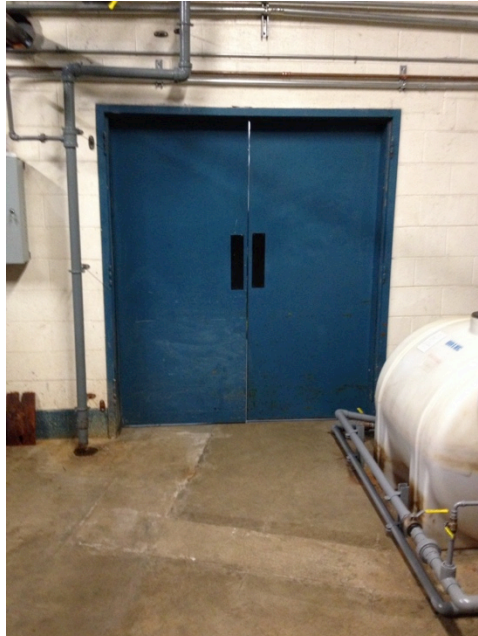
M.19 Ice Chiller Room doors

The ice chiller room doors appeared to remain typically closed between this room and the primary chiller room. These doors should remain open since the refrigerant leakage exhaust system is in the primary chiller room and the make-up air duct is in the ice chiller room. The refrigerant monitor is also located in the ice chiller room and this device is intended to monitor both rooms. Otherwise, the building systems seem to be well-maintained.

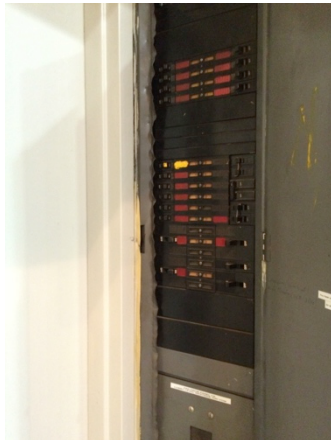
E.5 Electrical Panel Showing Considerable Wear.

One of our recommendations is not related to capital, but is an ongoing operating expense. Thermal scanning of electrical panels should occur annually (if not already being done) at least until the panels are replaced. Given their age and condition, panel scanning may identify issues before they become full blown failures. A budget of \$3,000 per year would be a reasonable amount, with different panels scanned every year for four (4) years. If KCAC were to undertake this work all at once, we suggest a budget of \$12,000.00.

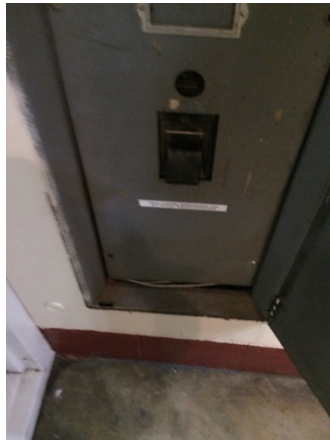
E.6 Electrical Panel cover not fitting properly and wires exposed.

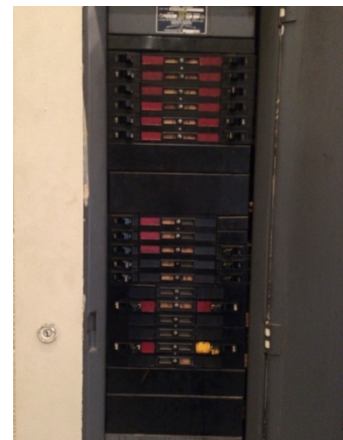
E.7. Electrical Panel cover not fitting properly.

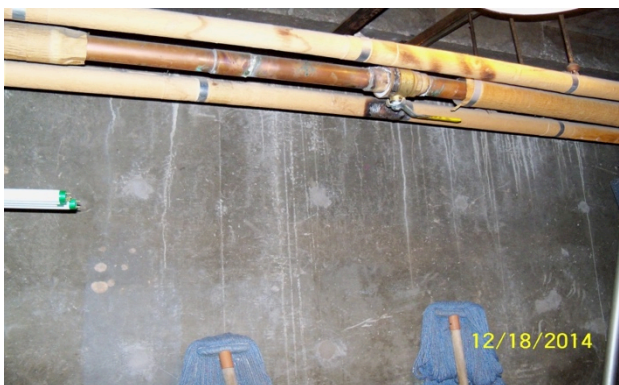
P.3 Insulation

Insulation in some of the original construction areas possibly contains asbestos. It was reported the system has had some abatement in the past. See P.3 & P.4 below.

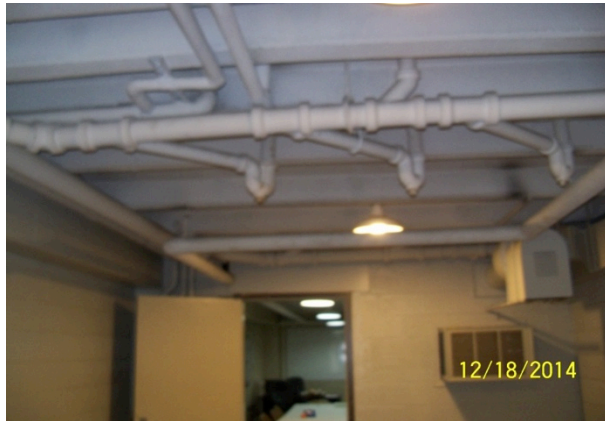
P.5 Screwed galvanized waste and vent piping material

Waste and vent piping materials vary from modern piping material from galvanized schedule 40 screwed DWV, cast iron lead and oakum pipe joint, to PVC material. No leaks were noted.

The condition of the galvanized screw waste and vent piping is a concern. Although the piping appears to be good condition outside, it is a known fact this type pipe reduces interior area as time goes on, leading to ongoing service calls or leaks. The galvanized pipe will corrode from the inside causing a reduced internal diameter, which then causes reduced flow issues. Eventually the corrosion will lead to leaks and pipe failure. This piping appears to be the majority of the facility piping. The piping will need to be replaced to maintain operation of the facility for the next 5 to 15 years. It could not be verified if it was installed below the floor slab but observation says it was.

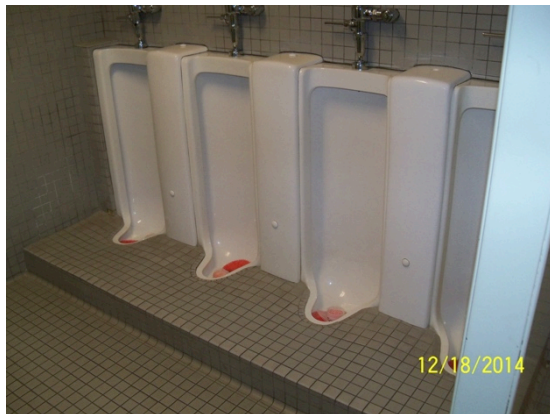
P.12 Plumbing fixtures – in floor urinals

Plumbing fixtures and trim were changed out for the most part in 2010. The one exception is the freestanding urinals located in the men's rooms. These are cast into the raised floor during the original construction and were not replaced.

The fixtures appear to be in relatively good condition with proper operation. A concern is the floor-mounted urinals are not a good sanitary type fixture, but they do operate normally.

The original in-floor urinals are in need of replacement with more modern wall hung units with separation barriers for privacy. While currently functional, these urinals are not ADA compliant, and with their age, there is always the concern of unexpected failure.

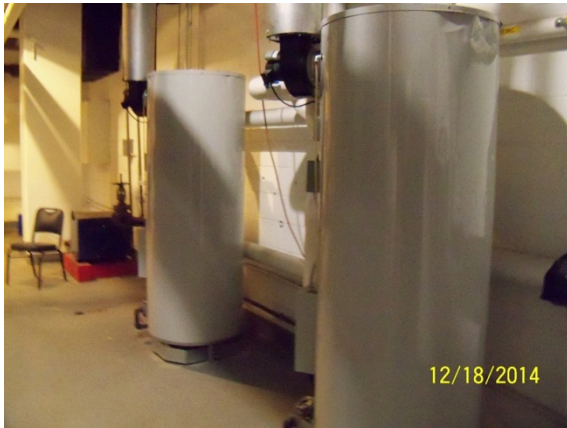
P.14 Gas water heaters

The majority of the building domestic hot water is produced by two power gas-fired hot water heaters located in the lower level boiler room. These have a capacity of 703 GPH recovery, each. These heaters were replaced in 2004, and staff reported minimal to no issues with the hot water heaters. The system does contain one hot water recirculating pump and piping from the boiler room area to serve the building. It appeared not to be very effective.

The domestic water heaters are in good condition and sufficient to meet the needs of the facility presently. Equipment replacement should be planned for in the next 6 to 8 years.

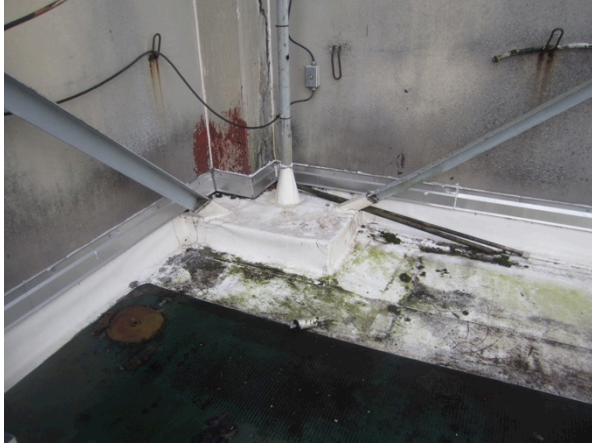
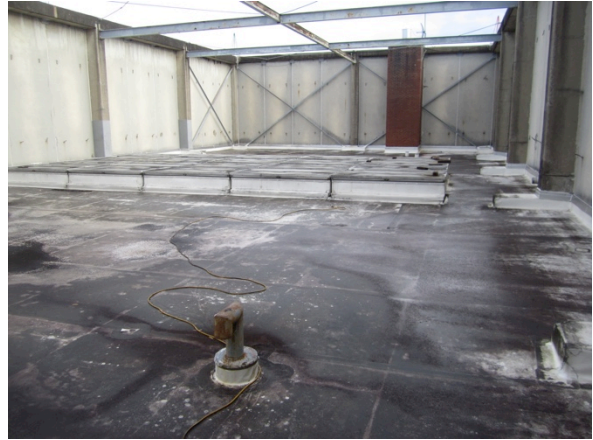
Clogged roof drain with built up organic debris. Standing water over time has resulted in discoloration of membrane.

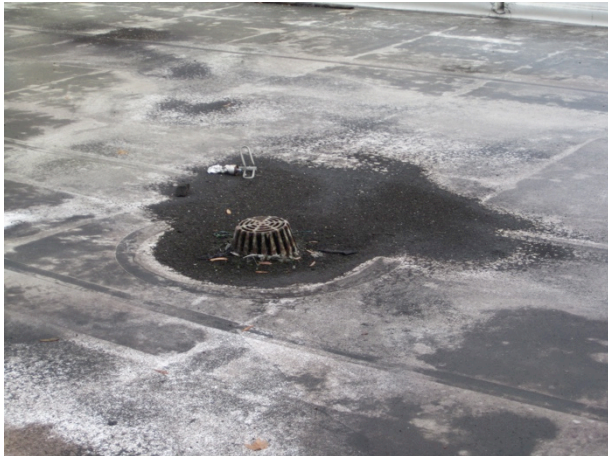
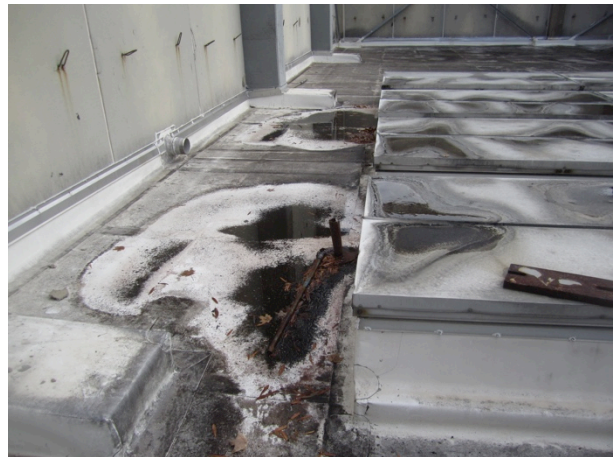
Weights used to keep exhaust doors from allowing rain penetration. Very dirty membrane surface.

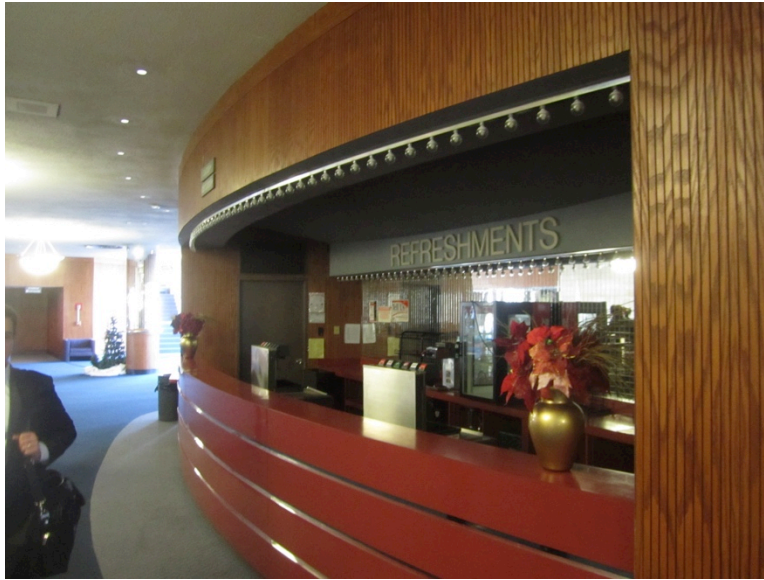
Main lobby concession stand. Equipment was in very good condition and the stand was clean. The main counter is not ADA height, although there is a portion that is lower (2nd photo) to accommodate wheelchair users.

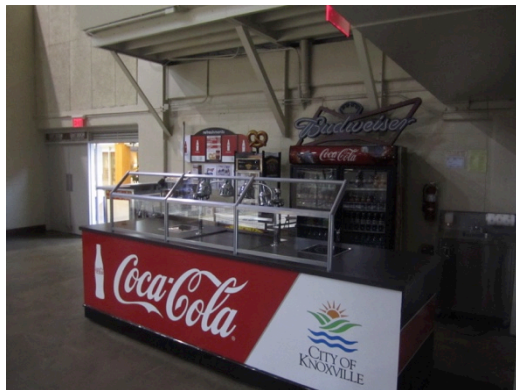
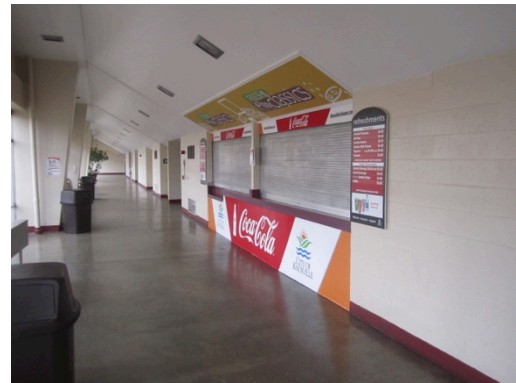
One of two portables inside the seating bowl. The equipment was in good condition. Typical main concourse concession stand. Rolling doors and stand graphics are in good condition.

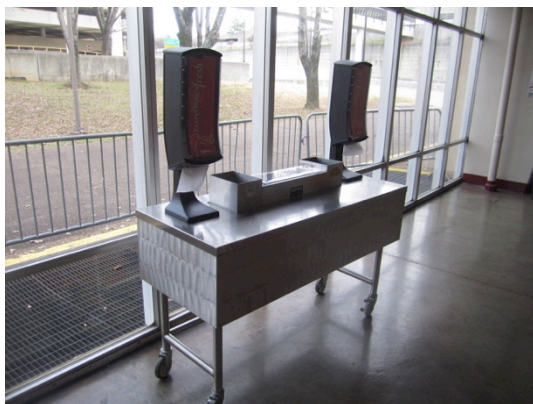
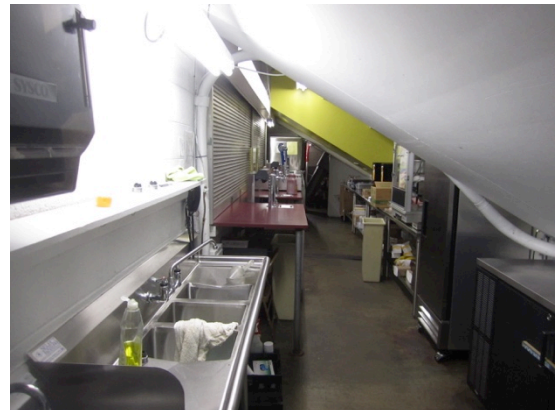
Typical condiment stand. These were in very good condition with adequate space for products. Interior of main concourse concession stand. Equipment was in good condition and area was clean.

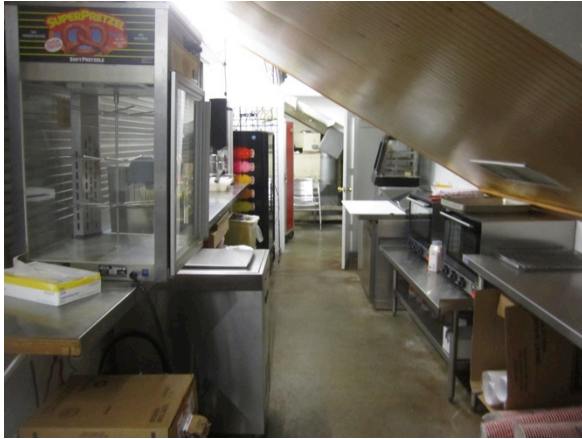
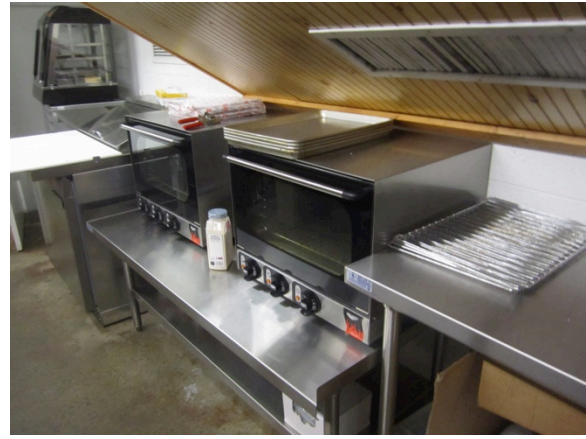
Interior of pizza concession stand on main concourse. Equipment was in good condition. Pizza ovens were in good condition.

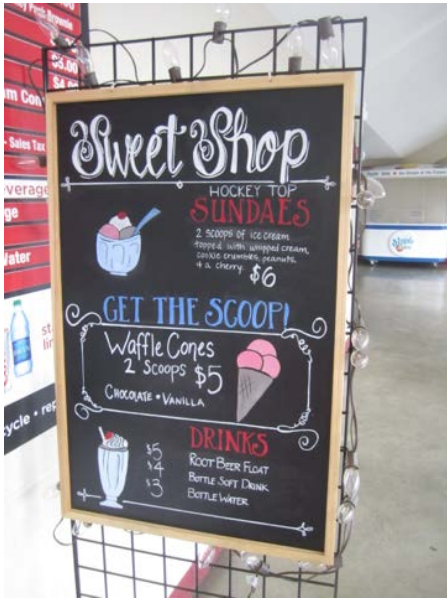
Signage for the dessert concession stand (permanent stand) on the main concourse.

Freezers were the main equipment in the dessert stand, and they were in good condition. We recommend ramping over the PVC drain that extends across the walkway in order to minimize the trip hazard as well as protect the pipe.

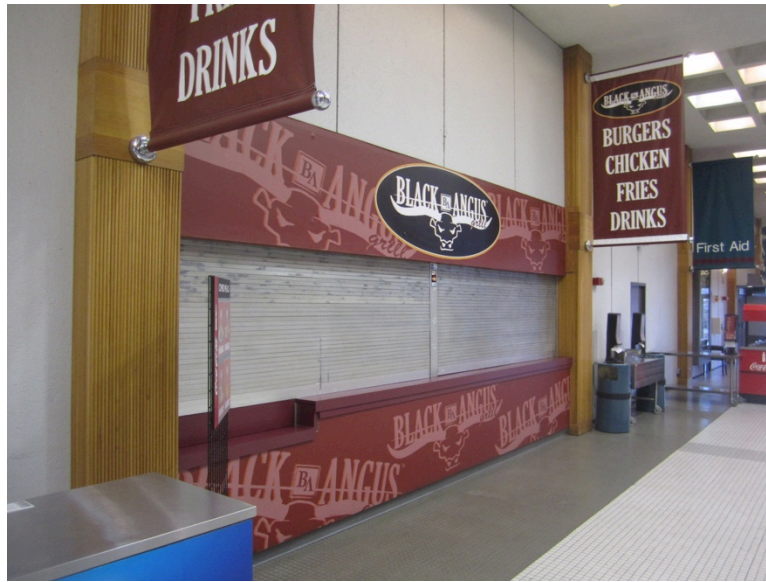
This is the only cooking (fryer and griddle) concession on the property, and it's located in the main hallway outside the Coliseum. This stand has the most appealing graphics. All the equipment observed was in good or very good condition.

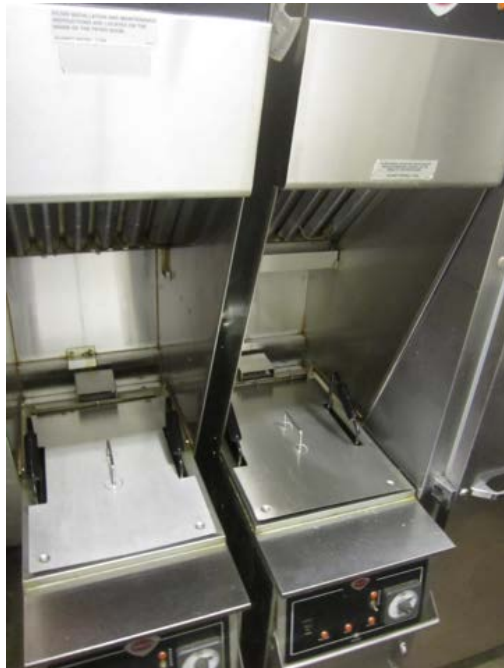
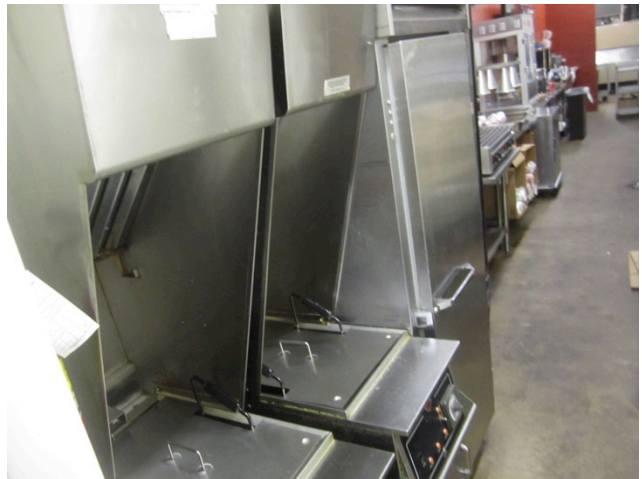
Two vent less fryers were in very good condition.

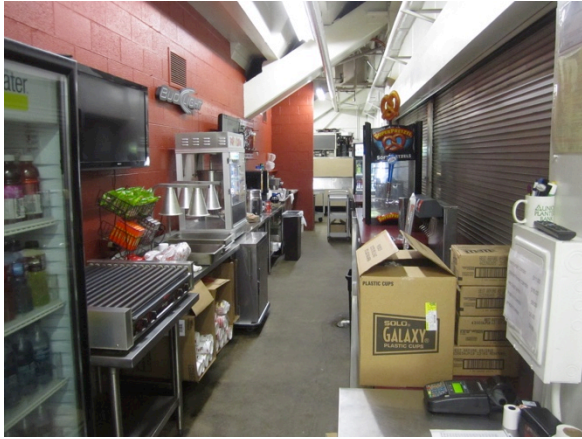
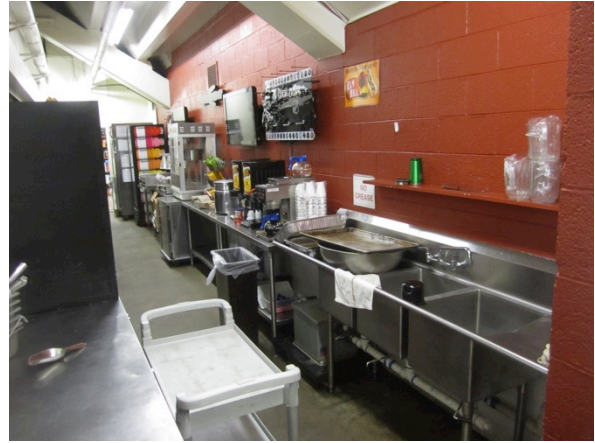
Vent less griddle was in very good condition.

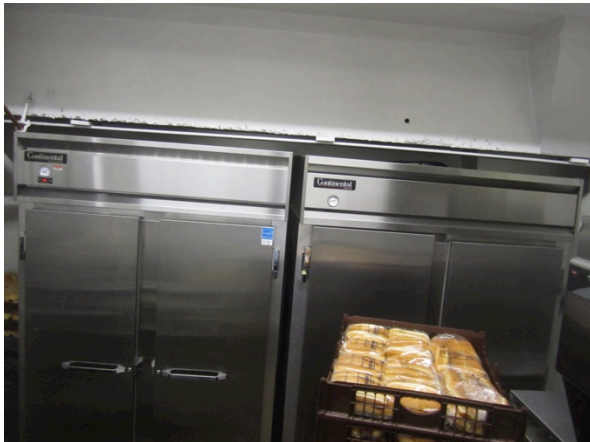
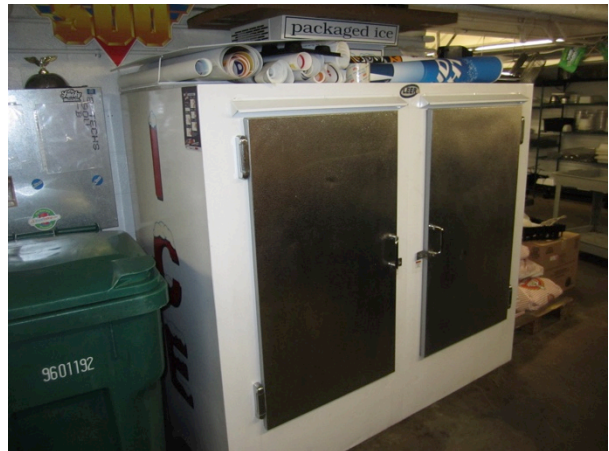
Refrigeration units were in very good condition. Freezer on event level was in good condition.

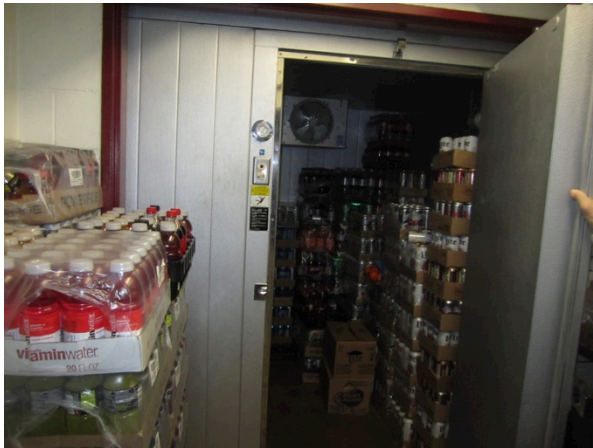
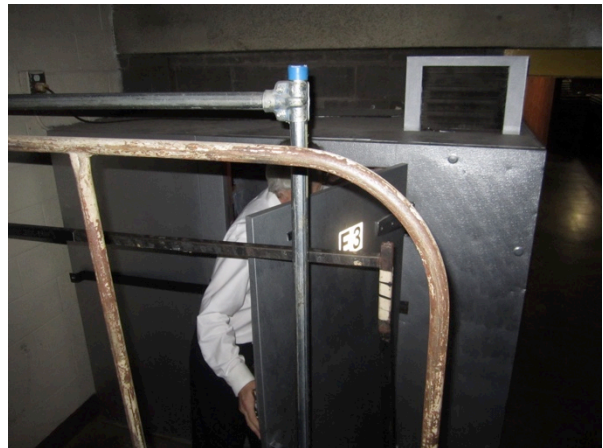
Walk in cooler on event level was in good condition. A second walk in cooler on event level was in good condition.

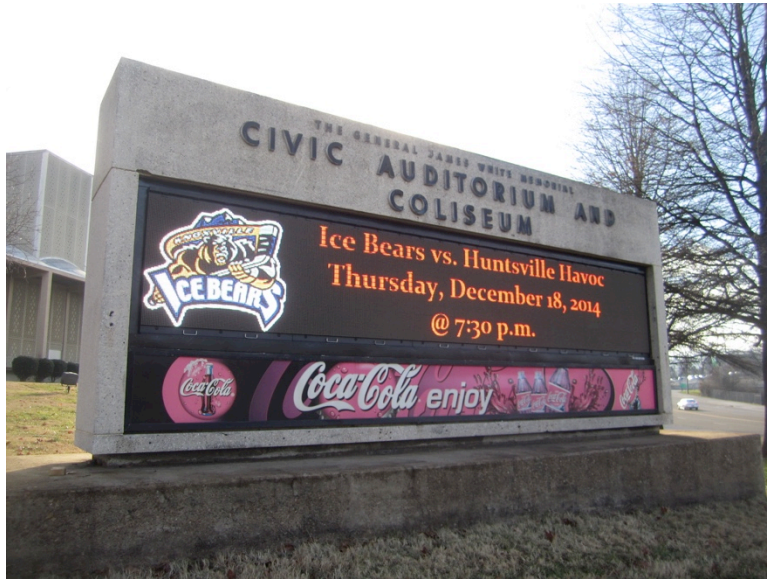
Exterior marquee at corner of
Howard Baker Jr. Blvd. and S Hall of Fame Drive.

The marquee housing appears to be an original structure from 1961, or constructed soon thereafter, but the video portion was installed in the fall of 2014. It measure approximately 4' tall x 21' long, and was installed by Datatronic Control, Inc. (Rowland, TX). The video board is full color with 10 mm pixel spacing. It is of a quality that is typically found in outdoor installations, and was observed to be functional and in excellent condition. While LED video boards can have a wide range of life expectancy, DCI has indicated the performance of this type of board will peak between years 5 and 7. After this time period, there can be a discernable level of brightness, and as with typical electronics, those components can start to fail. Towards the end of the warranty period for this sign we recommend compiling a list of electronic components, and for ones that can be replaced by building staff, maintaining an inventory of spares.

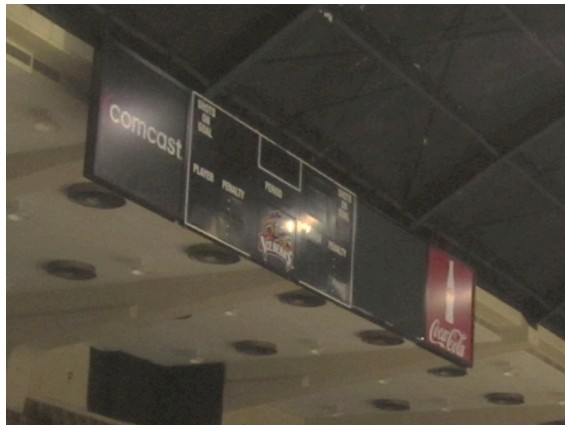
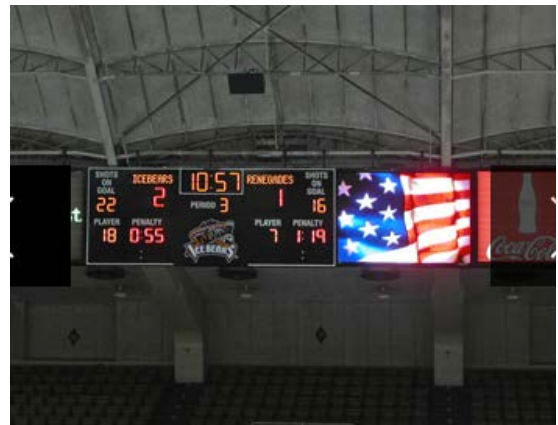
Coliseum Scoreboard

At the base of the roof level along of each long side of the arena there are 7'10" x 10'11", 20 mm, GalaxyPro displays from Daktronics (including Show Control software), including an adjacent hockey scoreboard system. The boards and scoring system were installed in 2008, and are in very good condition. Since the boards are located along the long sides of the hockey floor, at the time when they are to be replaced, we recommend the City consider locating new boards on the ends of the Coliseum in order to be more player-friendly. Additionally, since the current video boards are unable to display a live feed from a camera (according to information from the manufacturer), any future replacements should include a consideration to remedy that situation, as the current or future tenant(s) may have a desire for a live feed in order to improve their fan experience.

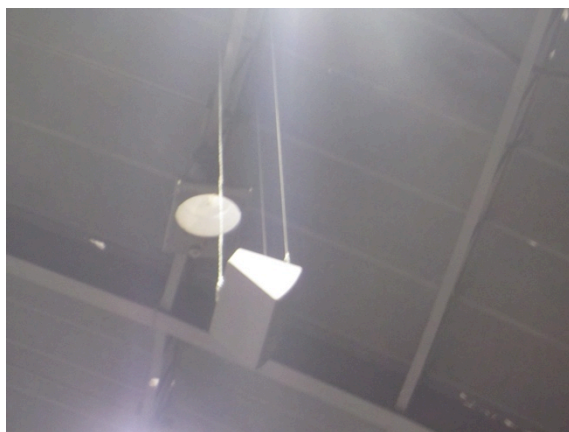
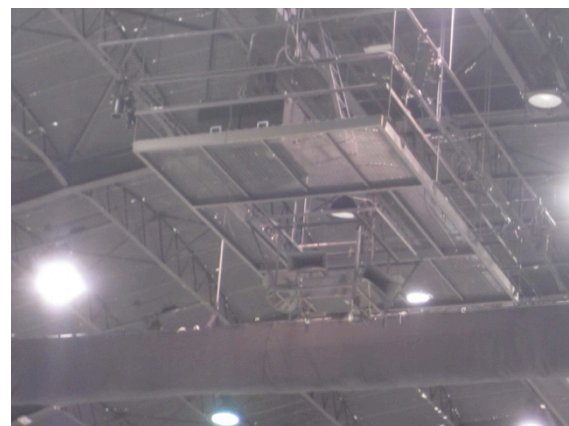
Coliseum sound system

The PA/sound system in the Coliseum was installed in 2005 and is adequate for permanent seating, but needs upgrading in the lower floor area in order to provide coverage. This is a common problem among smaller municipal buildings, and one that can be rectified at the time when the system needs to be replaced. If the current problem in this area at KCAC is significant enough, it may be worth hiring a sound design firm to develop a solution to address floor coverage.
